MINERALS PROGRAM INSPECTION REPORT
PHONE: (303) 866-3567

MINE NAME: Revenue Mine	MINE/PROSPECTING ID#: M-2012-032	MINERAL: Lead, silver and gold	COUNTY: Ouray
INSPECTION TYPE: Monitoring	INSPECTOR(S): Travis H. Marshall	INSP. DATE: November 1, 2016	INSP. TIME: 11:00
OPERATOR: Ouray Silver Mines Inc.	OPERATOR REPRESENTATIVE: Brian Briggs	TYPE OF OPERATION: 112d-1 - Designated Mining Operation	
REASON FOR INSPECTION: Normal I&E Program	BOND CALCULATION TYPE: None	BOND AMOUNT: \$464,333.79	
DATE OF COMPLAINT: NA	POST INSP. CONTACTS: None	JOINT INSP. AGENCY: None	
WEATHER: Clear	INSPECTOR'S SIGNATURE:

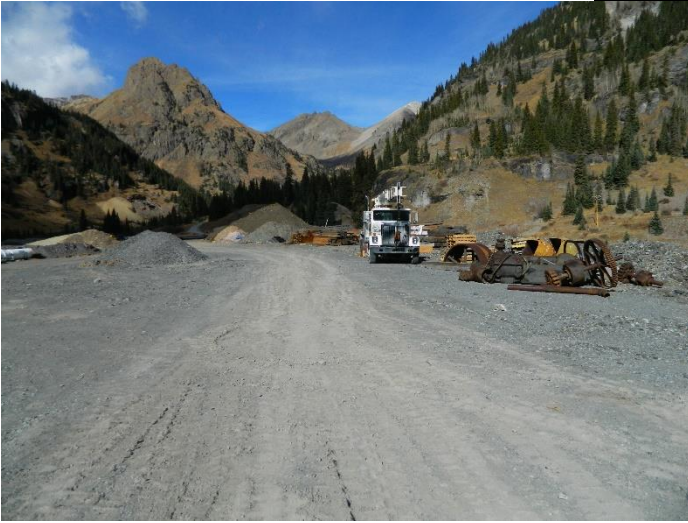
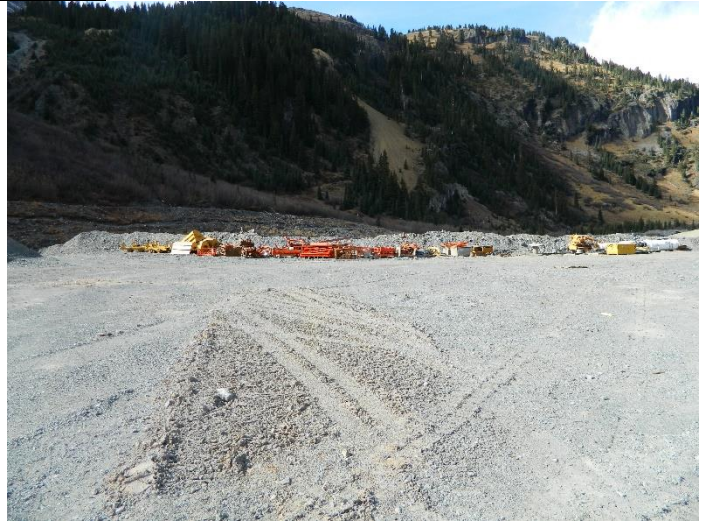
The main focus of the inspection was to observe the recently constructed bio-reactive bed and groundwater infiltration treatment system for the management of mine discharge water which was approved in Technical Revision No. 8 (TR-08). The treatment system was functioning during the inspection. Some minor changes were made to the final configuration of the structure that are different than what was submitted in TR-08, the operator provided "as-built" drawings to the DRMS. Overall the treatment system appeared to be properly functioning during the inspection. The operator is testing surface and groundwater down gradient of the infiltration zone to monitor for any changes in water quality.

Overview of the recently installed passive treatment structure.
