## Fwd: First bentonite notes ready to be sent to DRMS

William was back out onsite after we had the operator cut the swale a little deeper. Attached are the notes.

**Reclamation Notes on 11292016 Site Visit.pdf**

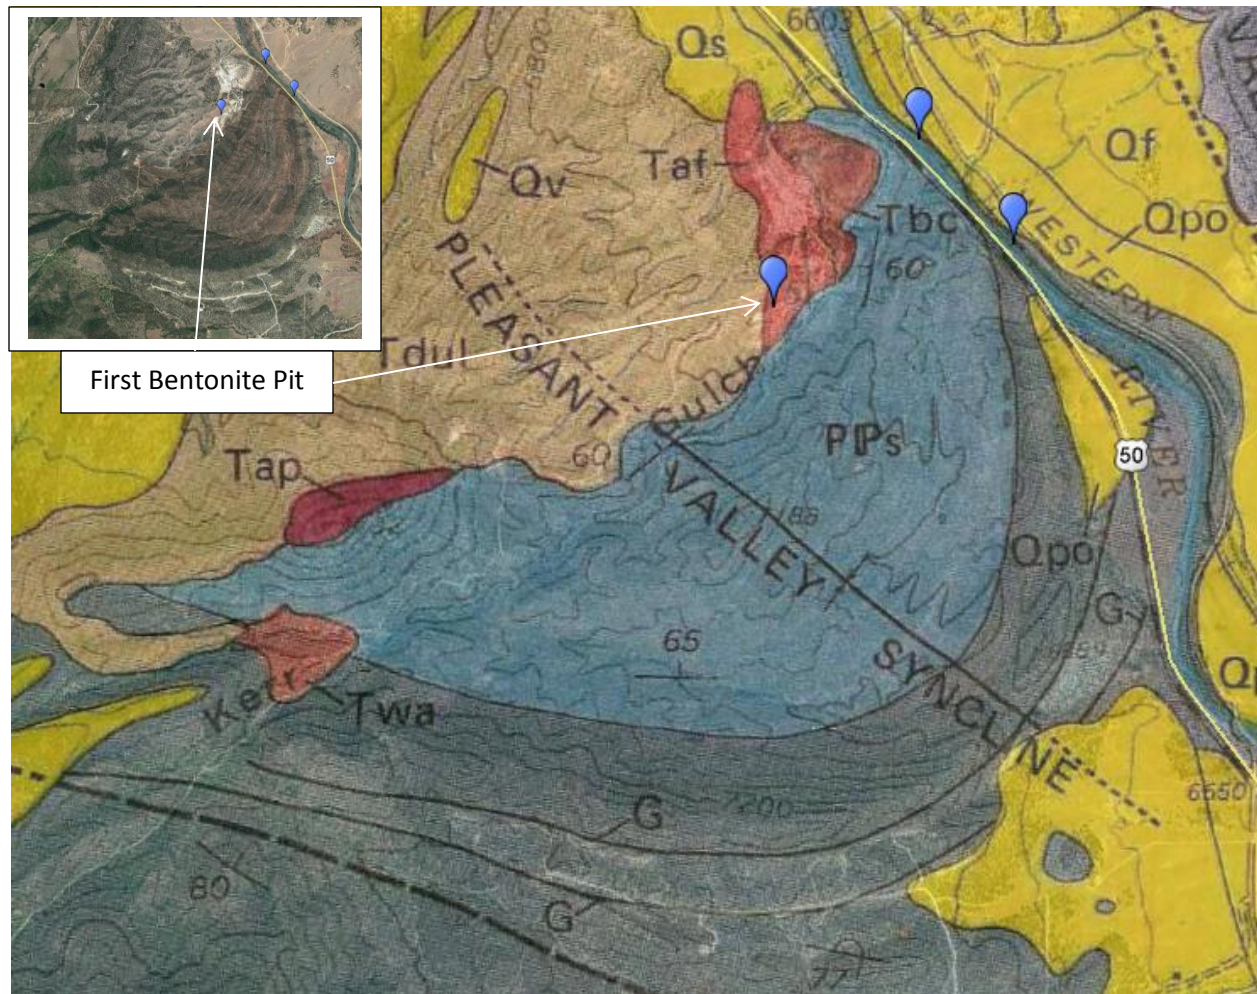
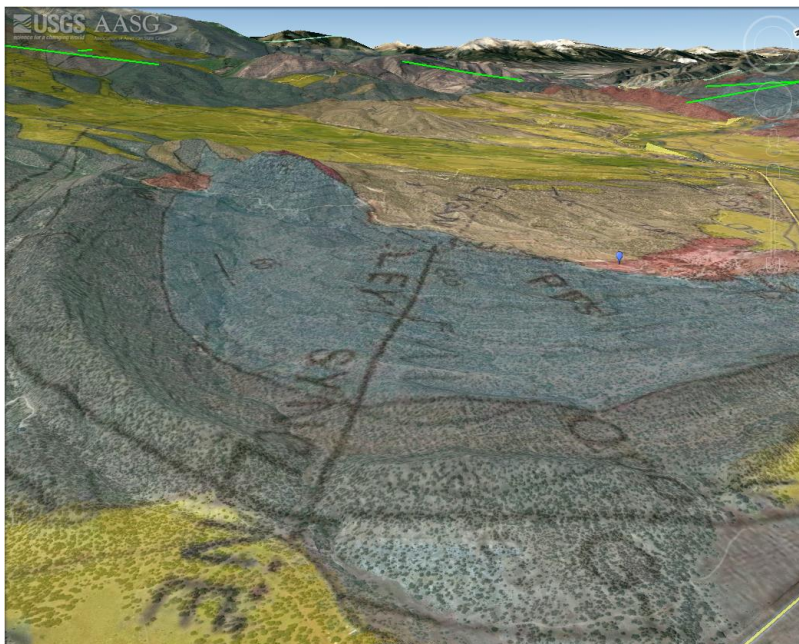
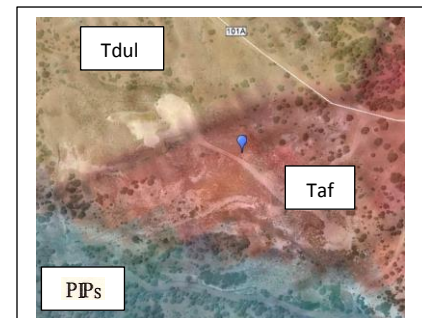
## Surrounding Structural Geology

According to the USGS maps on this page, the First Bentonite pit is located within the pleasant valley syncline. The highwall is shown in occurring in the Dry Union Formation (Tdul - tan), comprised of interlayered clay, silt, sand, and gravel (volcanic fragments). The formation also contains white to gray volcanic ash beds (composed of ash shards). It is likely that the Bentonite being mined at this location stems from one of these ash beds, or the adjacent Ashflow sequence (Taf-red).
