**MINERALS PROGRAM INSPECTION REPORT****PHONE: (303) 866-3567**

<b>MINE NAME:</b> Schumacher Pit #3	<b>MINE/PROSPECTING ID#:</b> M-2006-072	<b>MINERAL:</b> Gravel, clay (general)	<b>COUNTY:</b> Logan
<b>INSPECTION TYPE:</b> Monitoring	<b>INSPECTOR(S):</b> Jared L. Ebert	<b>INSP. DATE:</b> December 15, 2016	<b>INSP. TIME:</b> 10:30
<b>OPERATOR:</b> Jeffrey L. Schumacher	<b>OPERATOR REPRESENTATIVE:</b> None	<b>TYPE OF OPERATION:</b> 112c - Construction Regular Operation

Schumacher Pit #3, M-2006-072, December 15, 2016 Inspection

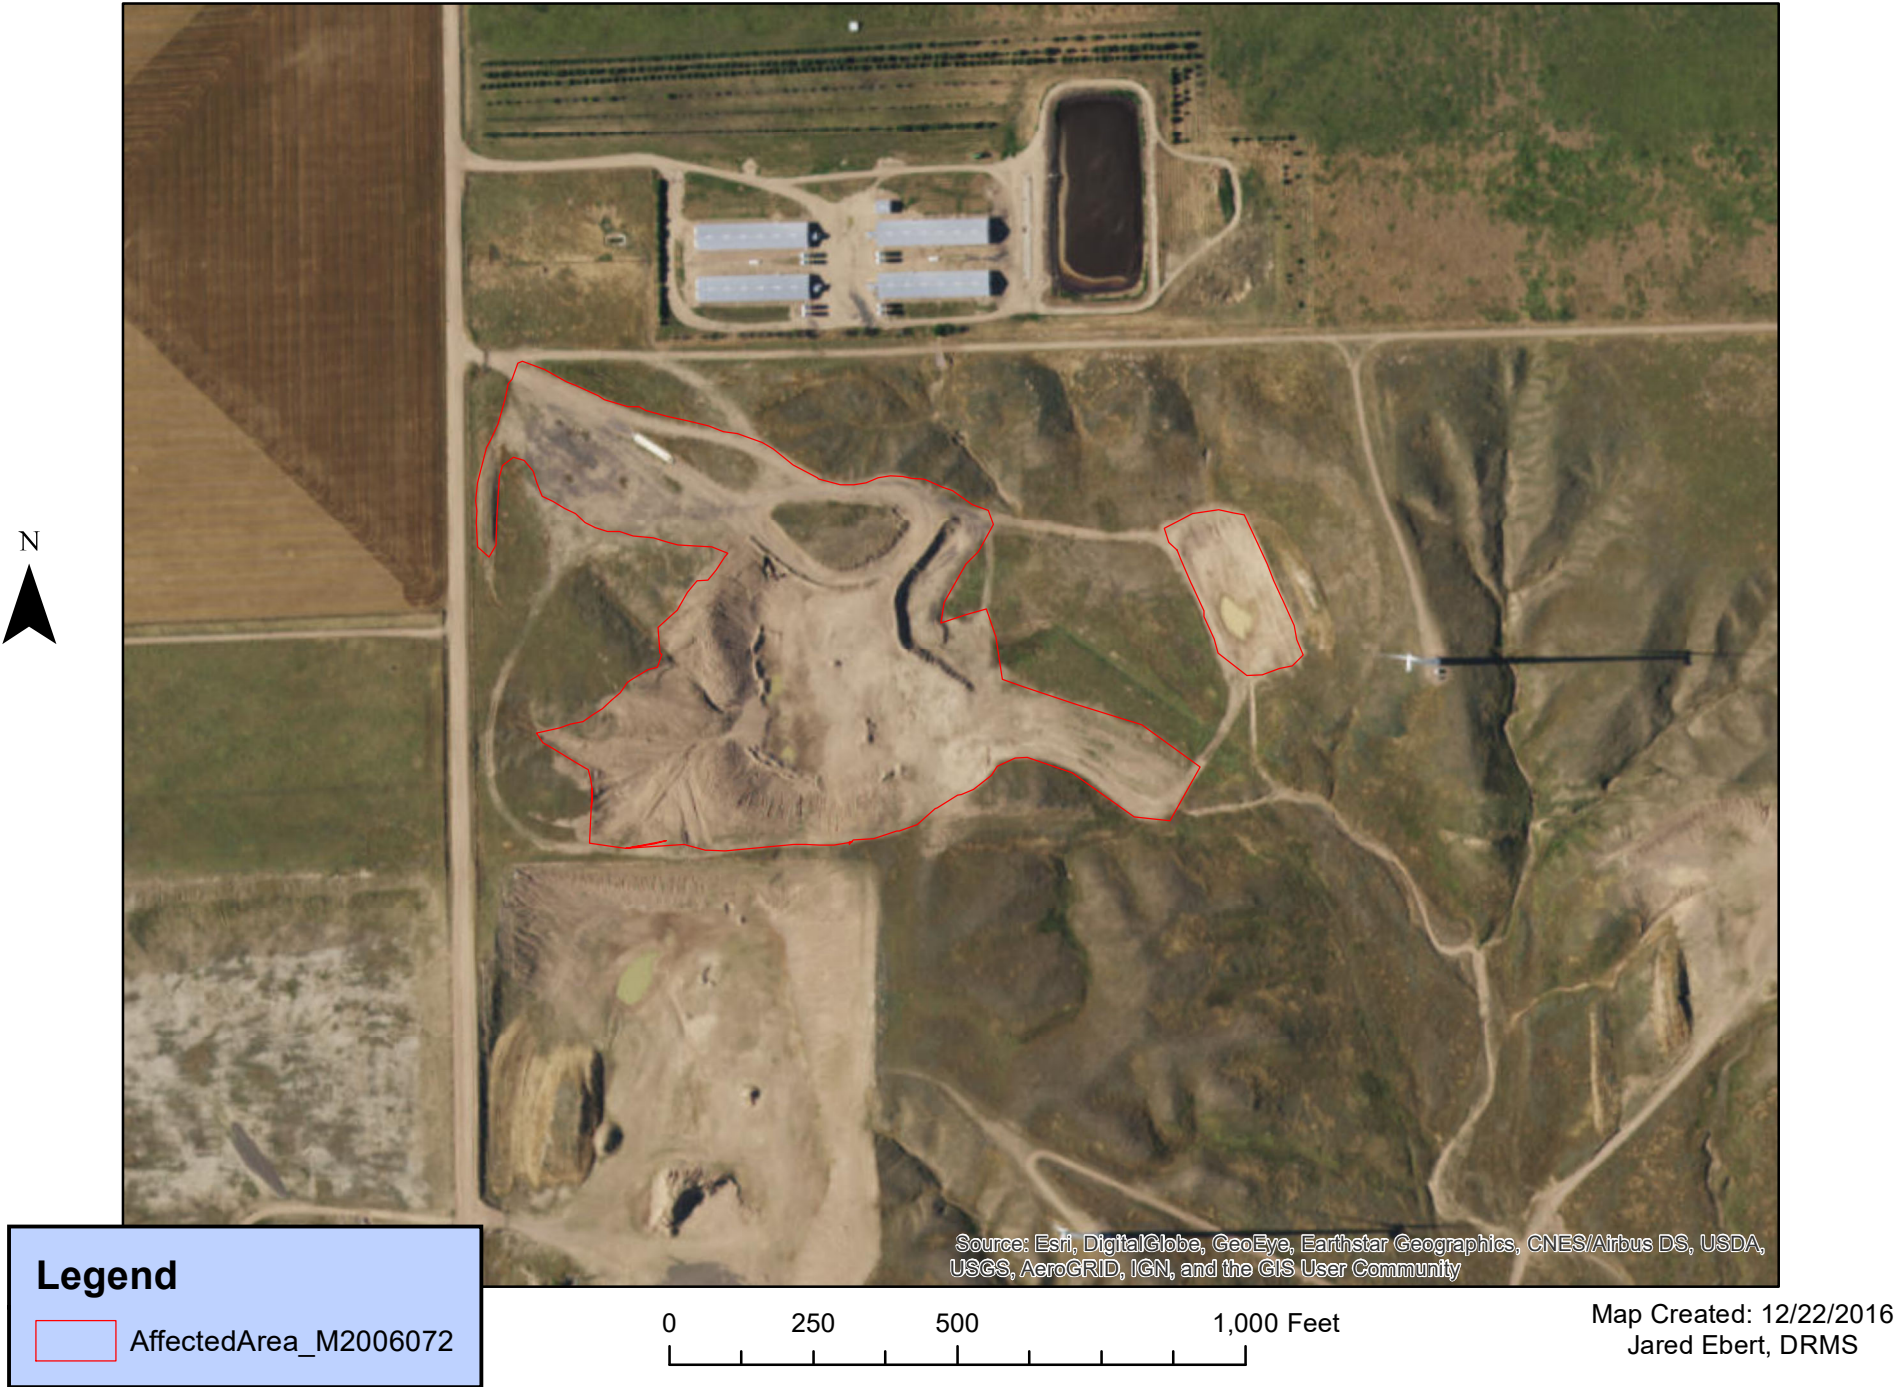
**PROBLEM/POSSIBLE VIOLATION:** Problem: The affected area boundary markers are missing or incorrectly placed. This is a problem for failure to maintain boundary markers around the affected area as required by Section 3.1.12(2) of the rule.

The mine entrance sign was in place. The affected area boundaries were not clearly marked. Several markers were observed at the southern end of the site, however these markers appear to be associated with the adjacent Logan County operations (M-1995-063).

**CORRECTIVE ACTIONS:** The operator shall conduct a survey and replace the boundary markers in the correct location(s). The operator shall provide proof to the Division that this has been done by the corrective action date.
