MINERALS PROGRAM INSPECTION REPORT
PHONE: (303) 866-3567

MINE NAME: Robinson Sons Gravel Pit No. 1	MINE/PROSPECTING ID#: M-2008-076	MINERAL: Sand and gravel; borrow material for construction	COUNTY: Las Animas
INSPECTION TYPE: Monitoring	INSPECTOR(S): Amy Eschberger, Wally Erickson	INSP. DATE: November 23, 2016	INSP. TIME: 09:30
OPERATOR: Robinson Sons Inc	OPERATOR REPRESENTATIVE: None	TYPE OF OPERATION: 112c - Construction Regular Operation	
REASON FOR INSPECTION: Priority	BOND CALCULATION TYPE: None	BOND AMOUNT: \$52,815.00	
DATE OF COMPLAINT: NA	POST INSP. CONTACTS: None	JOINT INSP. AGENCY: None	
WEATHER: Clear	INSPECTOR'S SIGNATURE:

SIGNATURE DATE: January 23, 2017

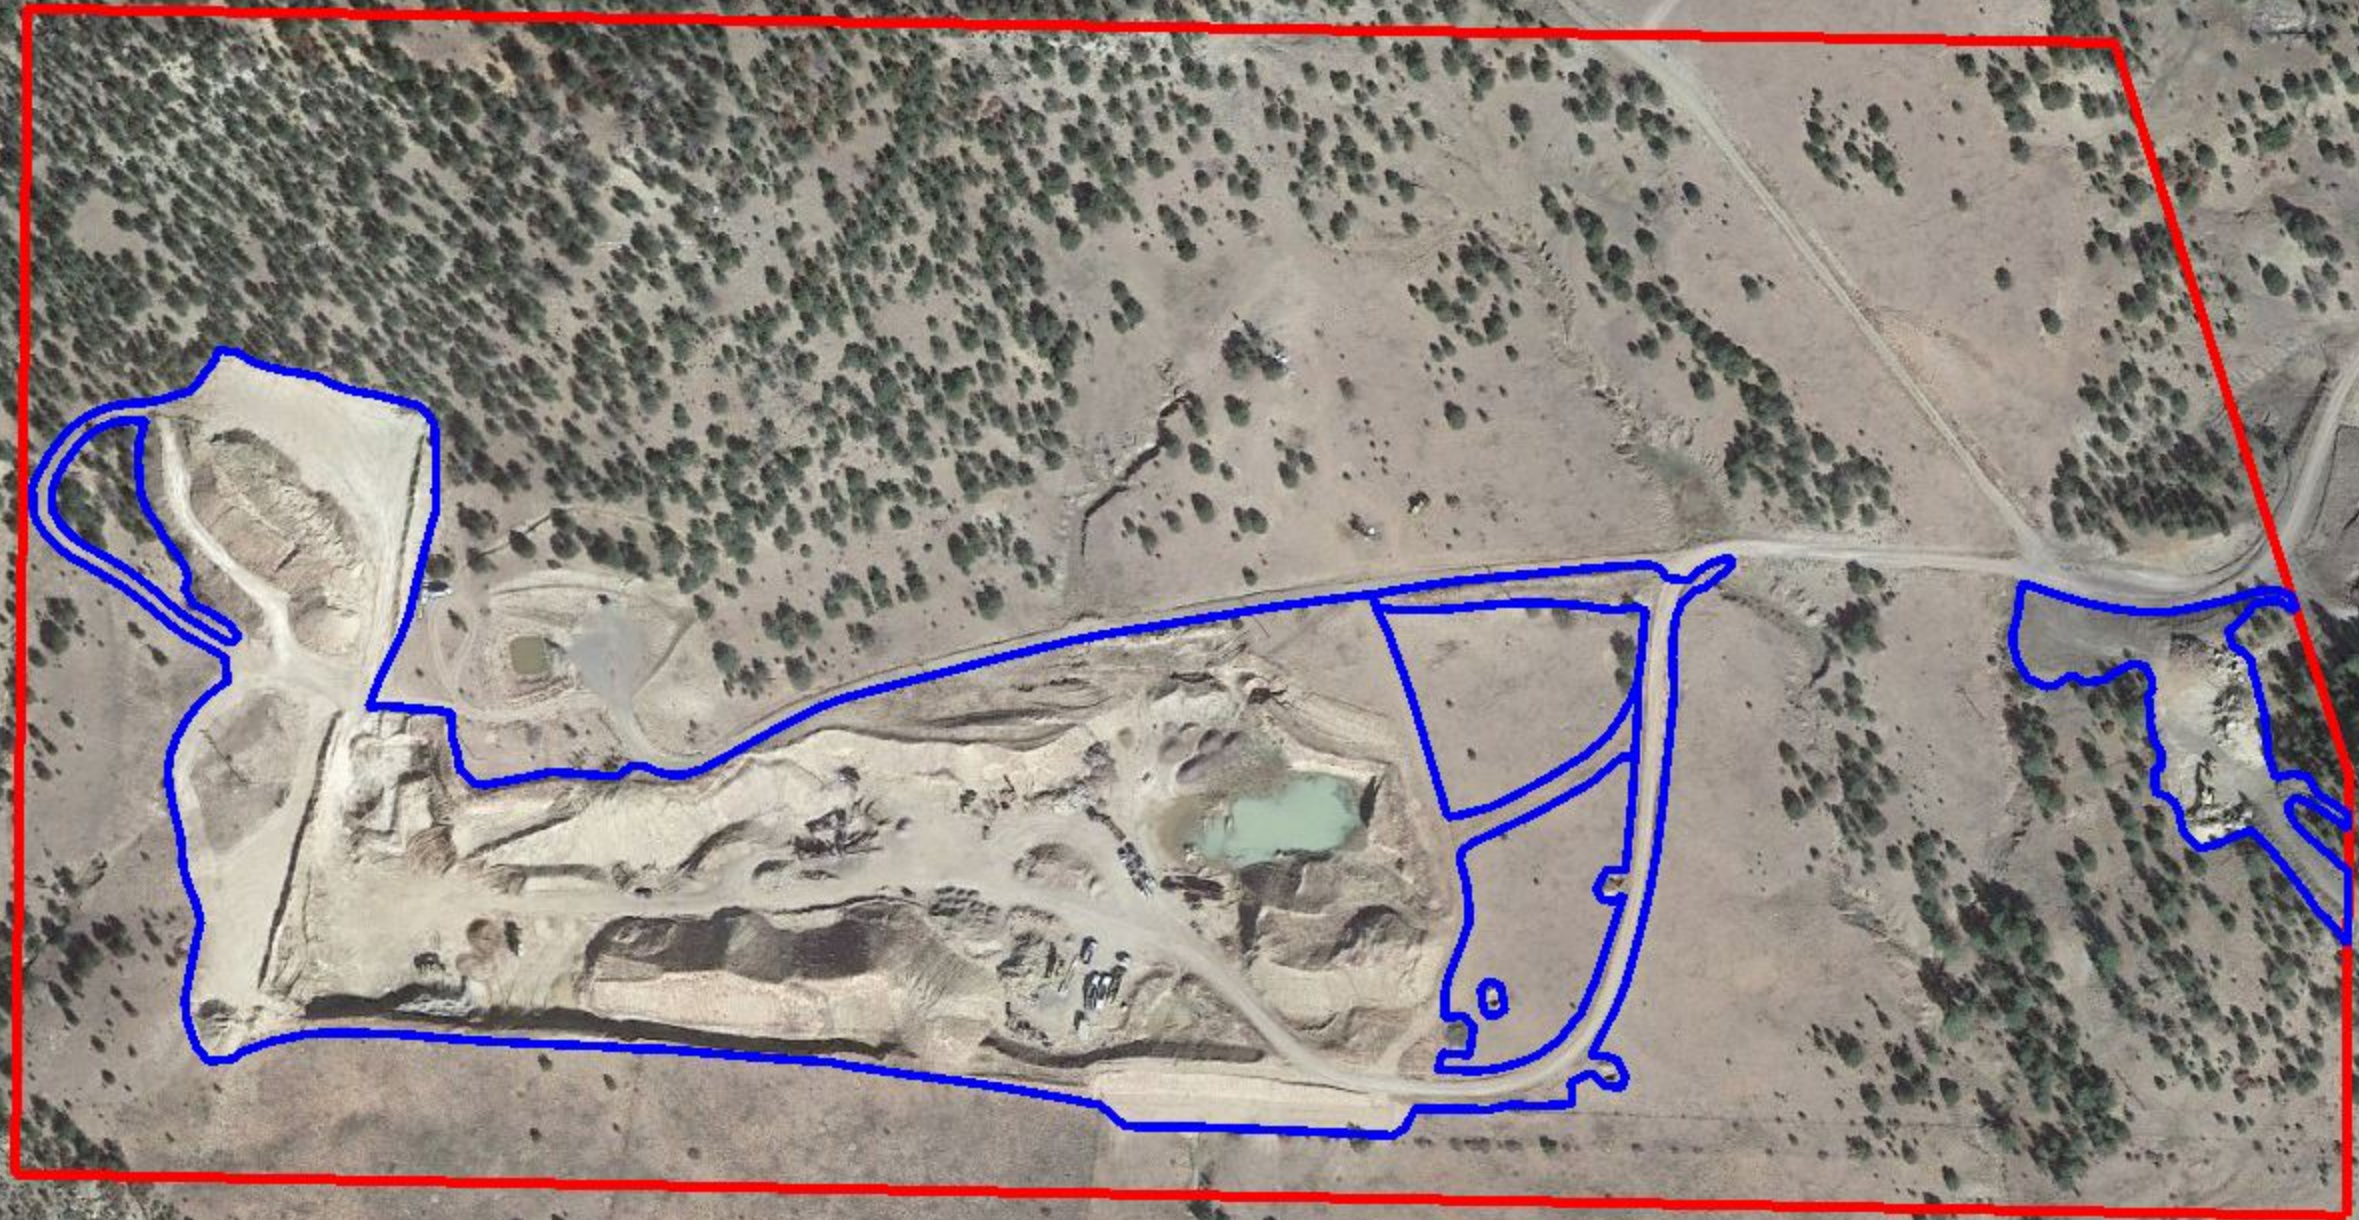
Google Earth image 2

Close-Up of southern portion of site showing portion of fenceline that was covered by stockpile

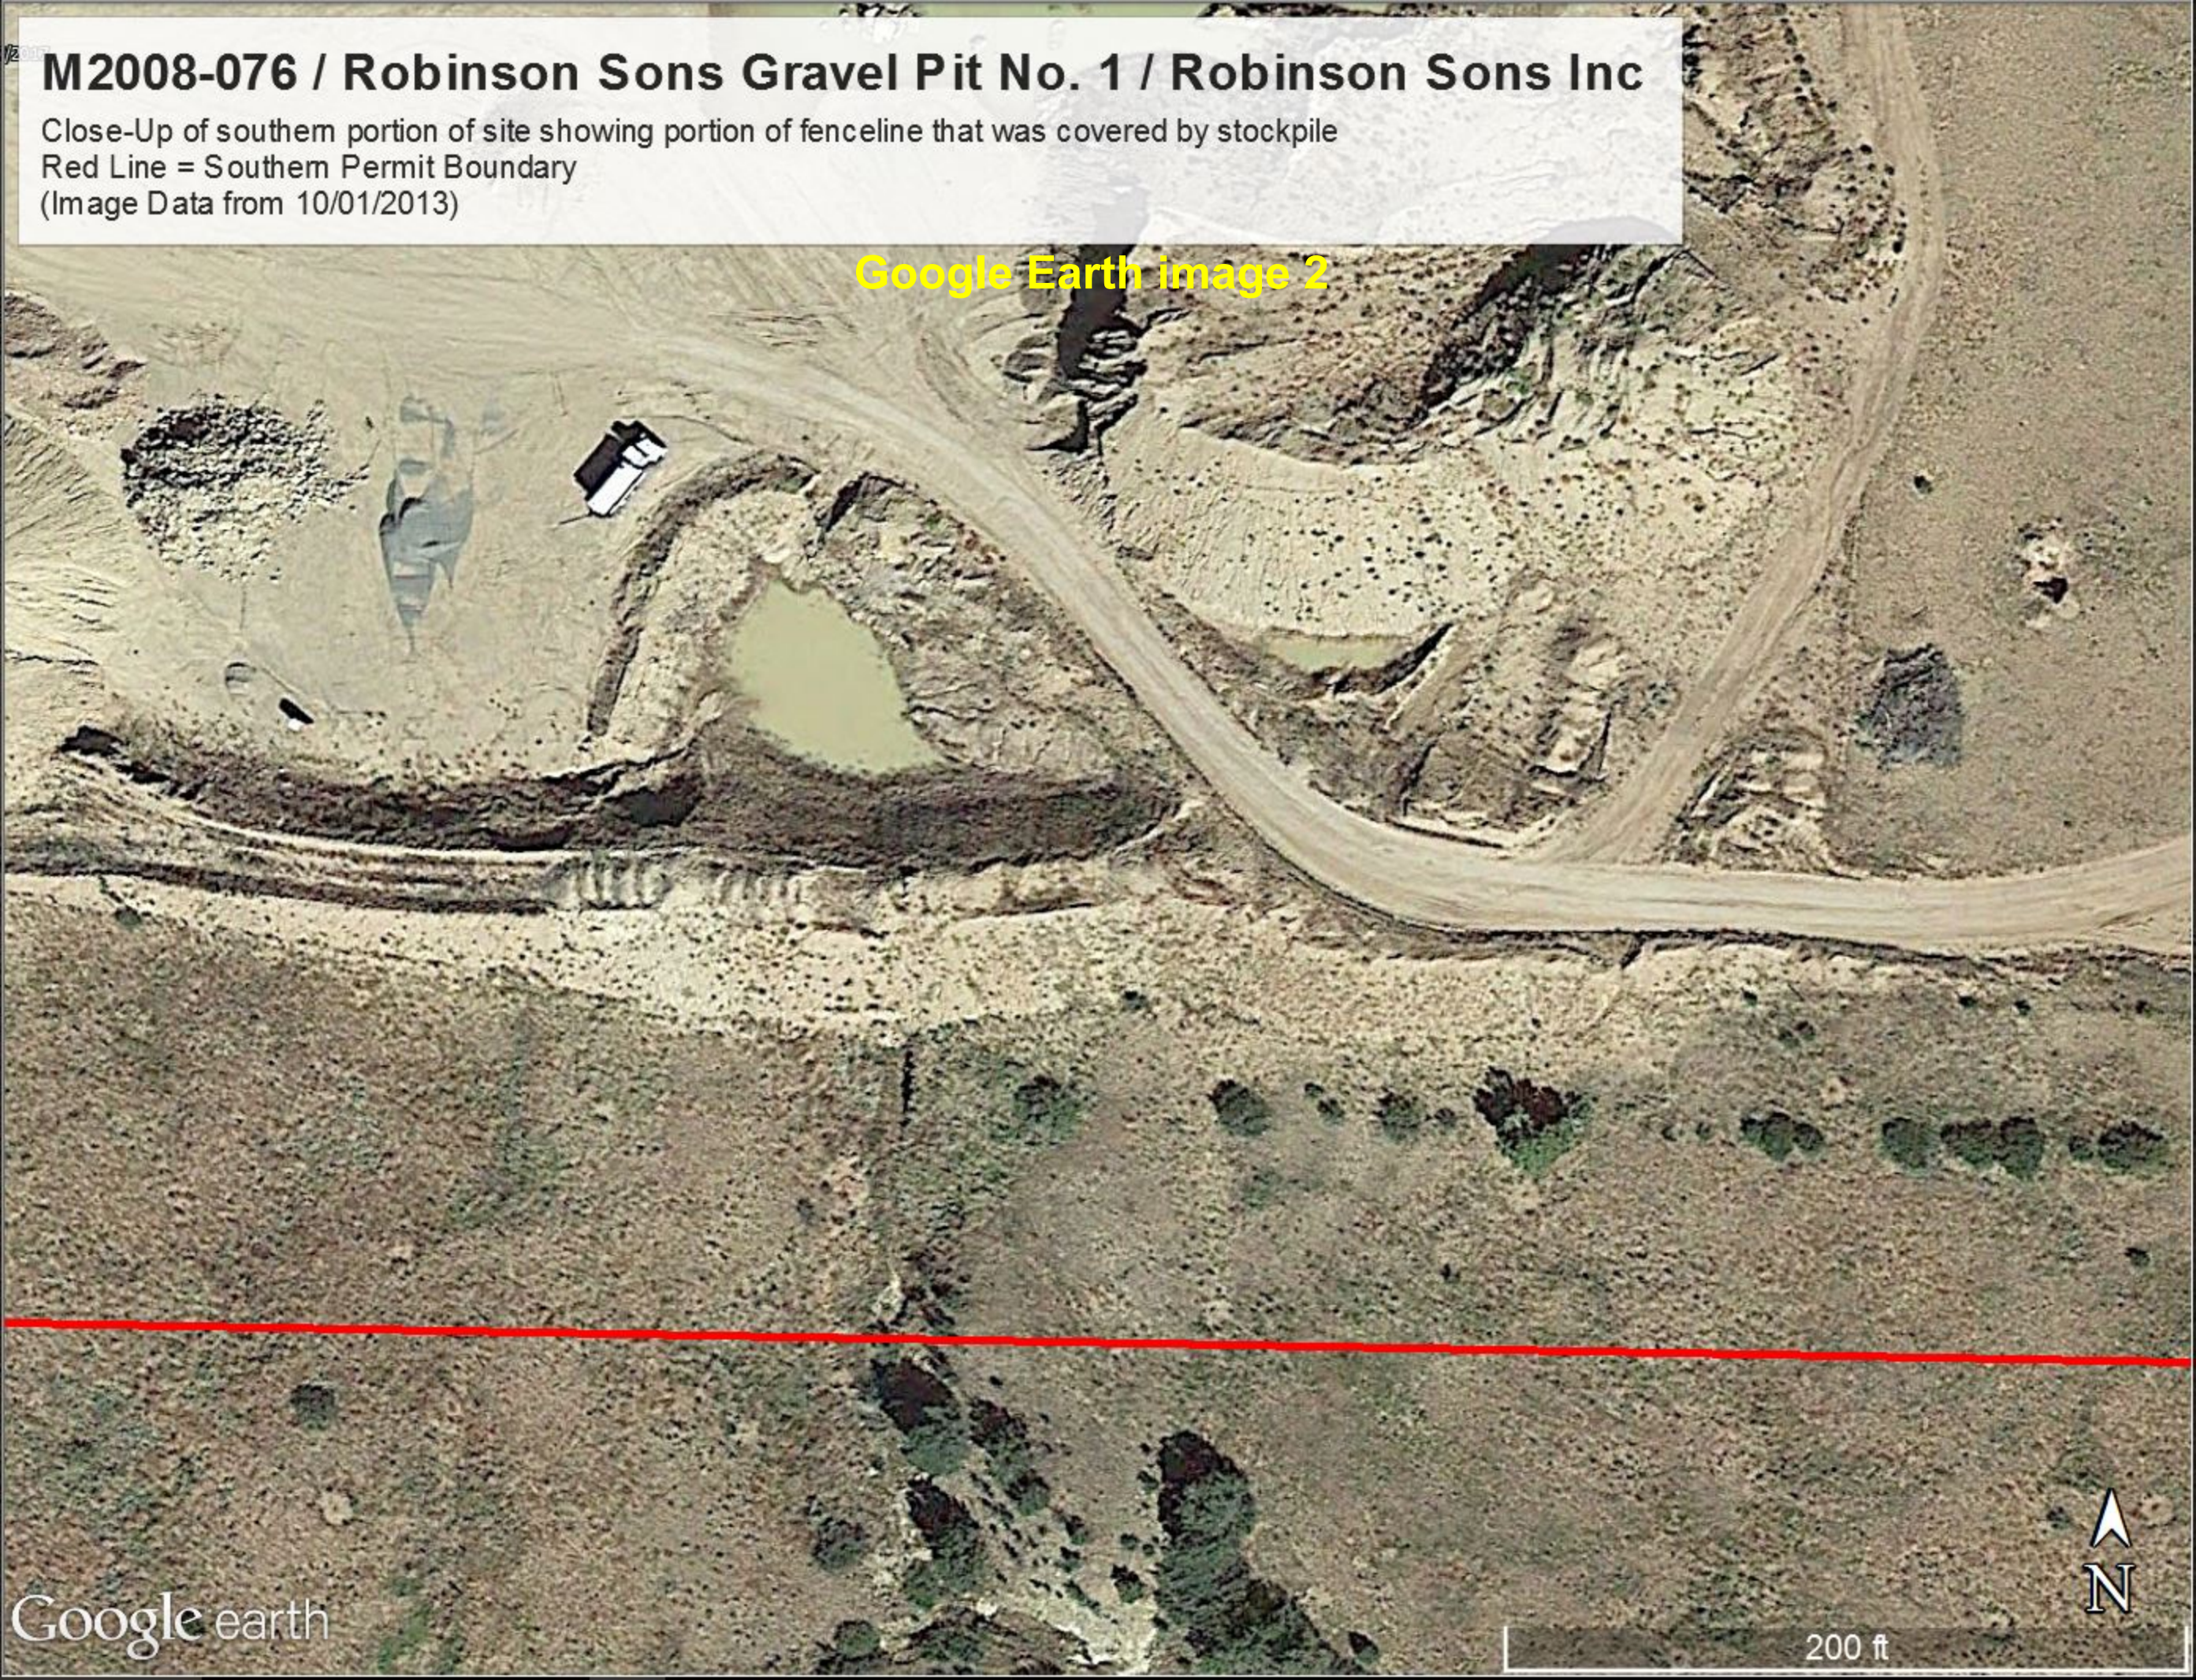
Close-Up of southern portion of site showing portion of fenceline that was covered by stockpile

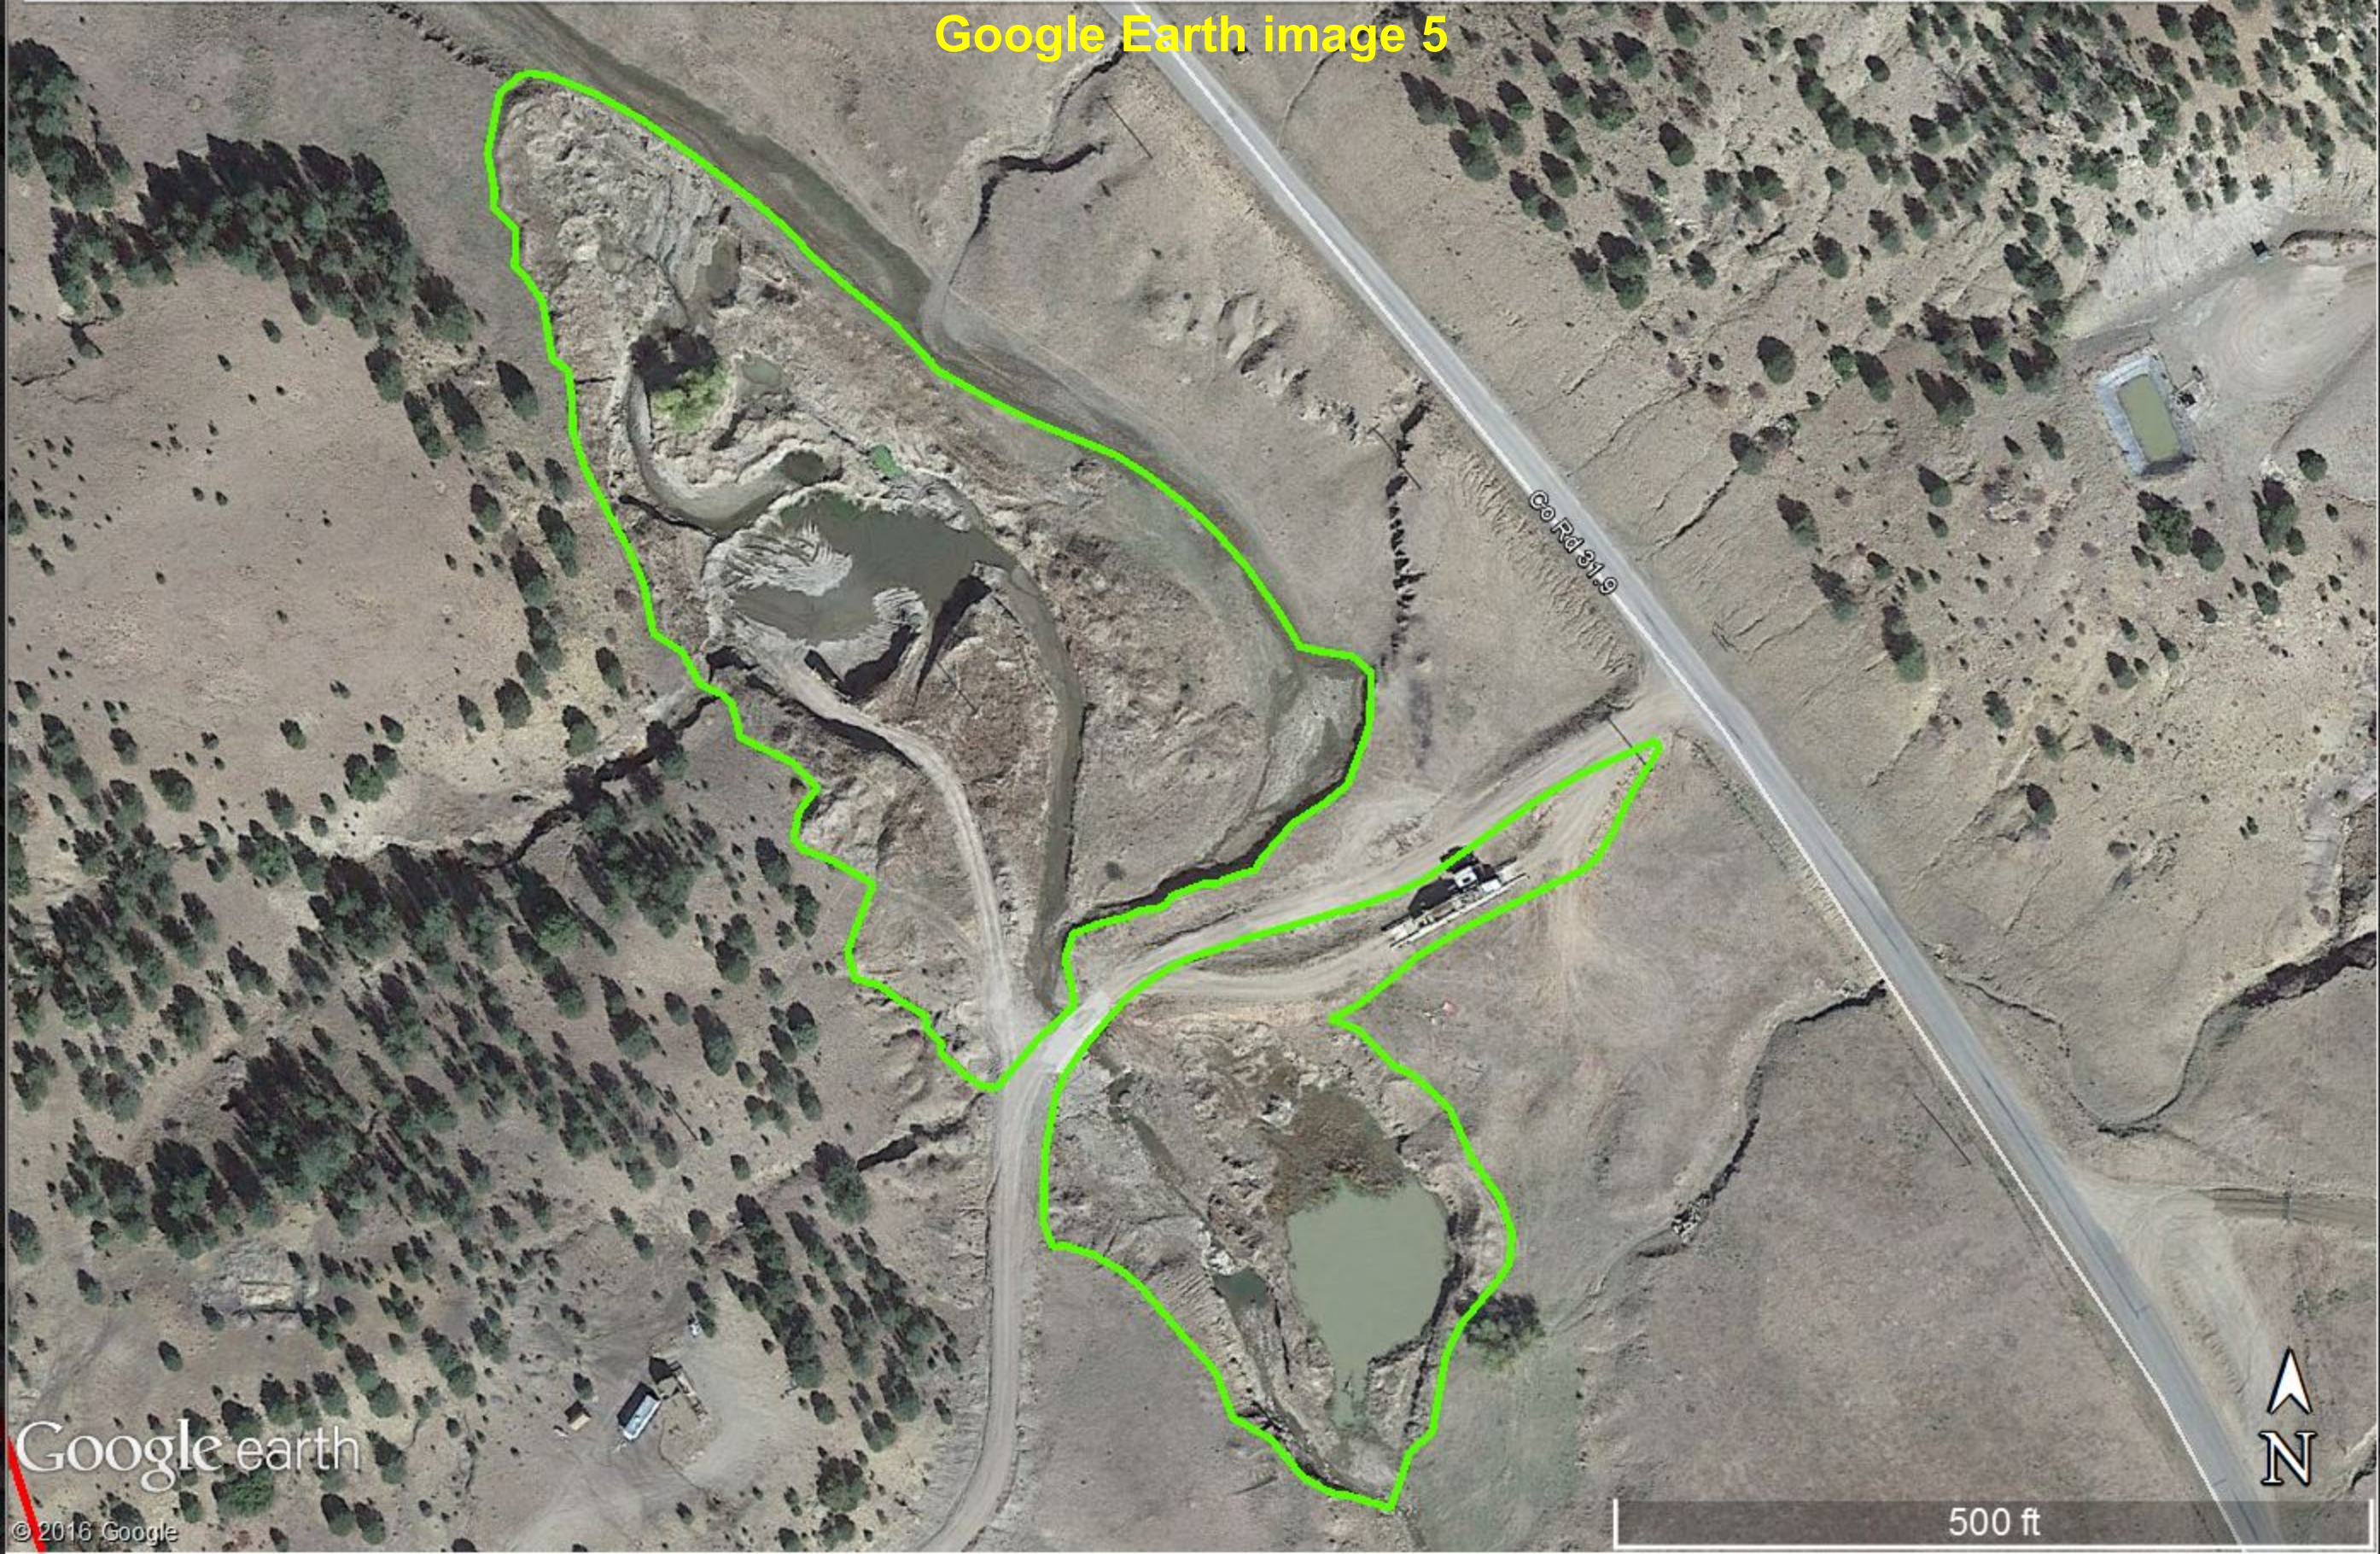
Google Earth image 5

The illegal mining activity located upstream (north) of the mine access road (Photos 34-41) has captured the creek flow, diverting and retaining the creek flow, and has exposed alluvial groundwater. The diverted surface flow and exposed groundwater are routed back to the natural channel through a pair of culverts installed beneath the access road (Photo 42). The affected lands located beyond the affected land boundary and upstream (north) of the mine access road were estimated at 3.95 acres (see enclosed Google Earth image 5).

The illegal mining activity located downstream (south) of the mine access road was nearby and/or within the floodplain of the same unnamed creek (Photos 43-45). The Division's preliminary investigation indicates the excavation activity has exposed alluvial groundwater, as evidenced by the pond resulting from material extraction from the floodplain. The Division observed a truck scale and associated scale house and scale access ramps nearby (Photo 1). The truck scales and associated structures are defined as affected lands under Rule 1.1(3), but were

located beyond the affected land boundary as delineated on the approved mining plan map. The affected lands located beyond the permit boundary and downstream (south) of the mine access road were estimated at 1.89 acres (see enclosed Google Earth image 5).

Green Outline = 5.84 acres = Disturbed Land Outside of Permit Area Near Main Site Entrance (3.95 acres north of rd + 1.89 acres south of rd)
(Image Data from 10/18/2016)

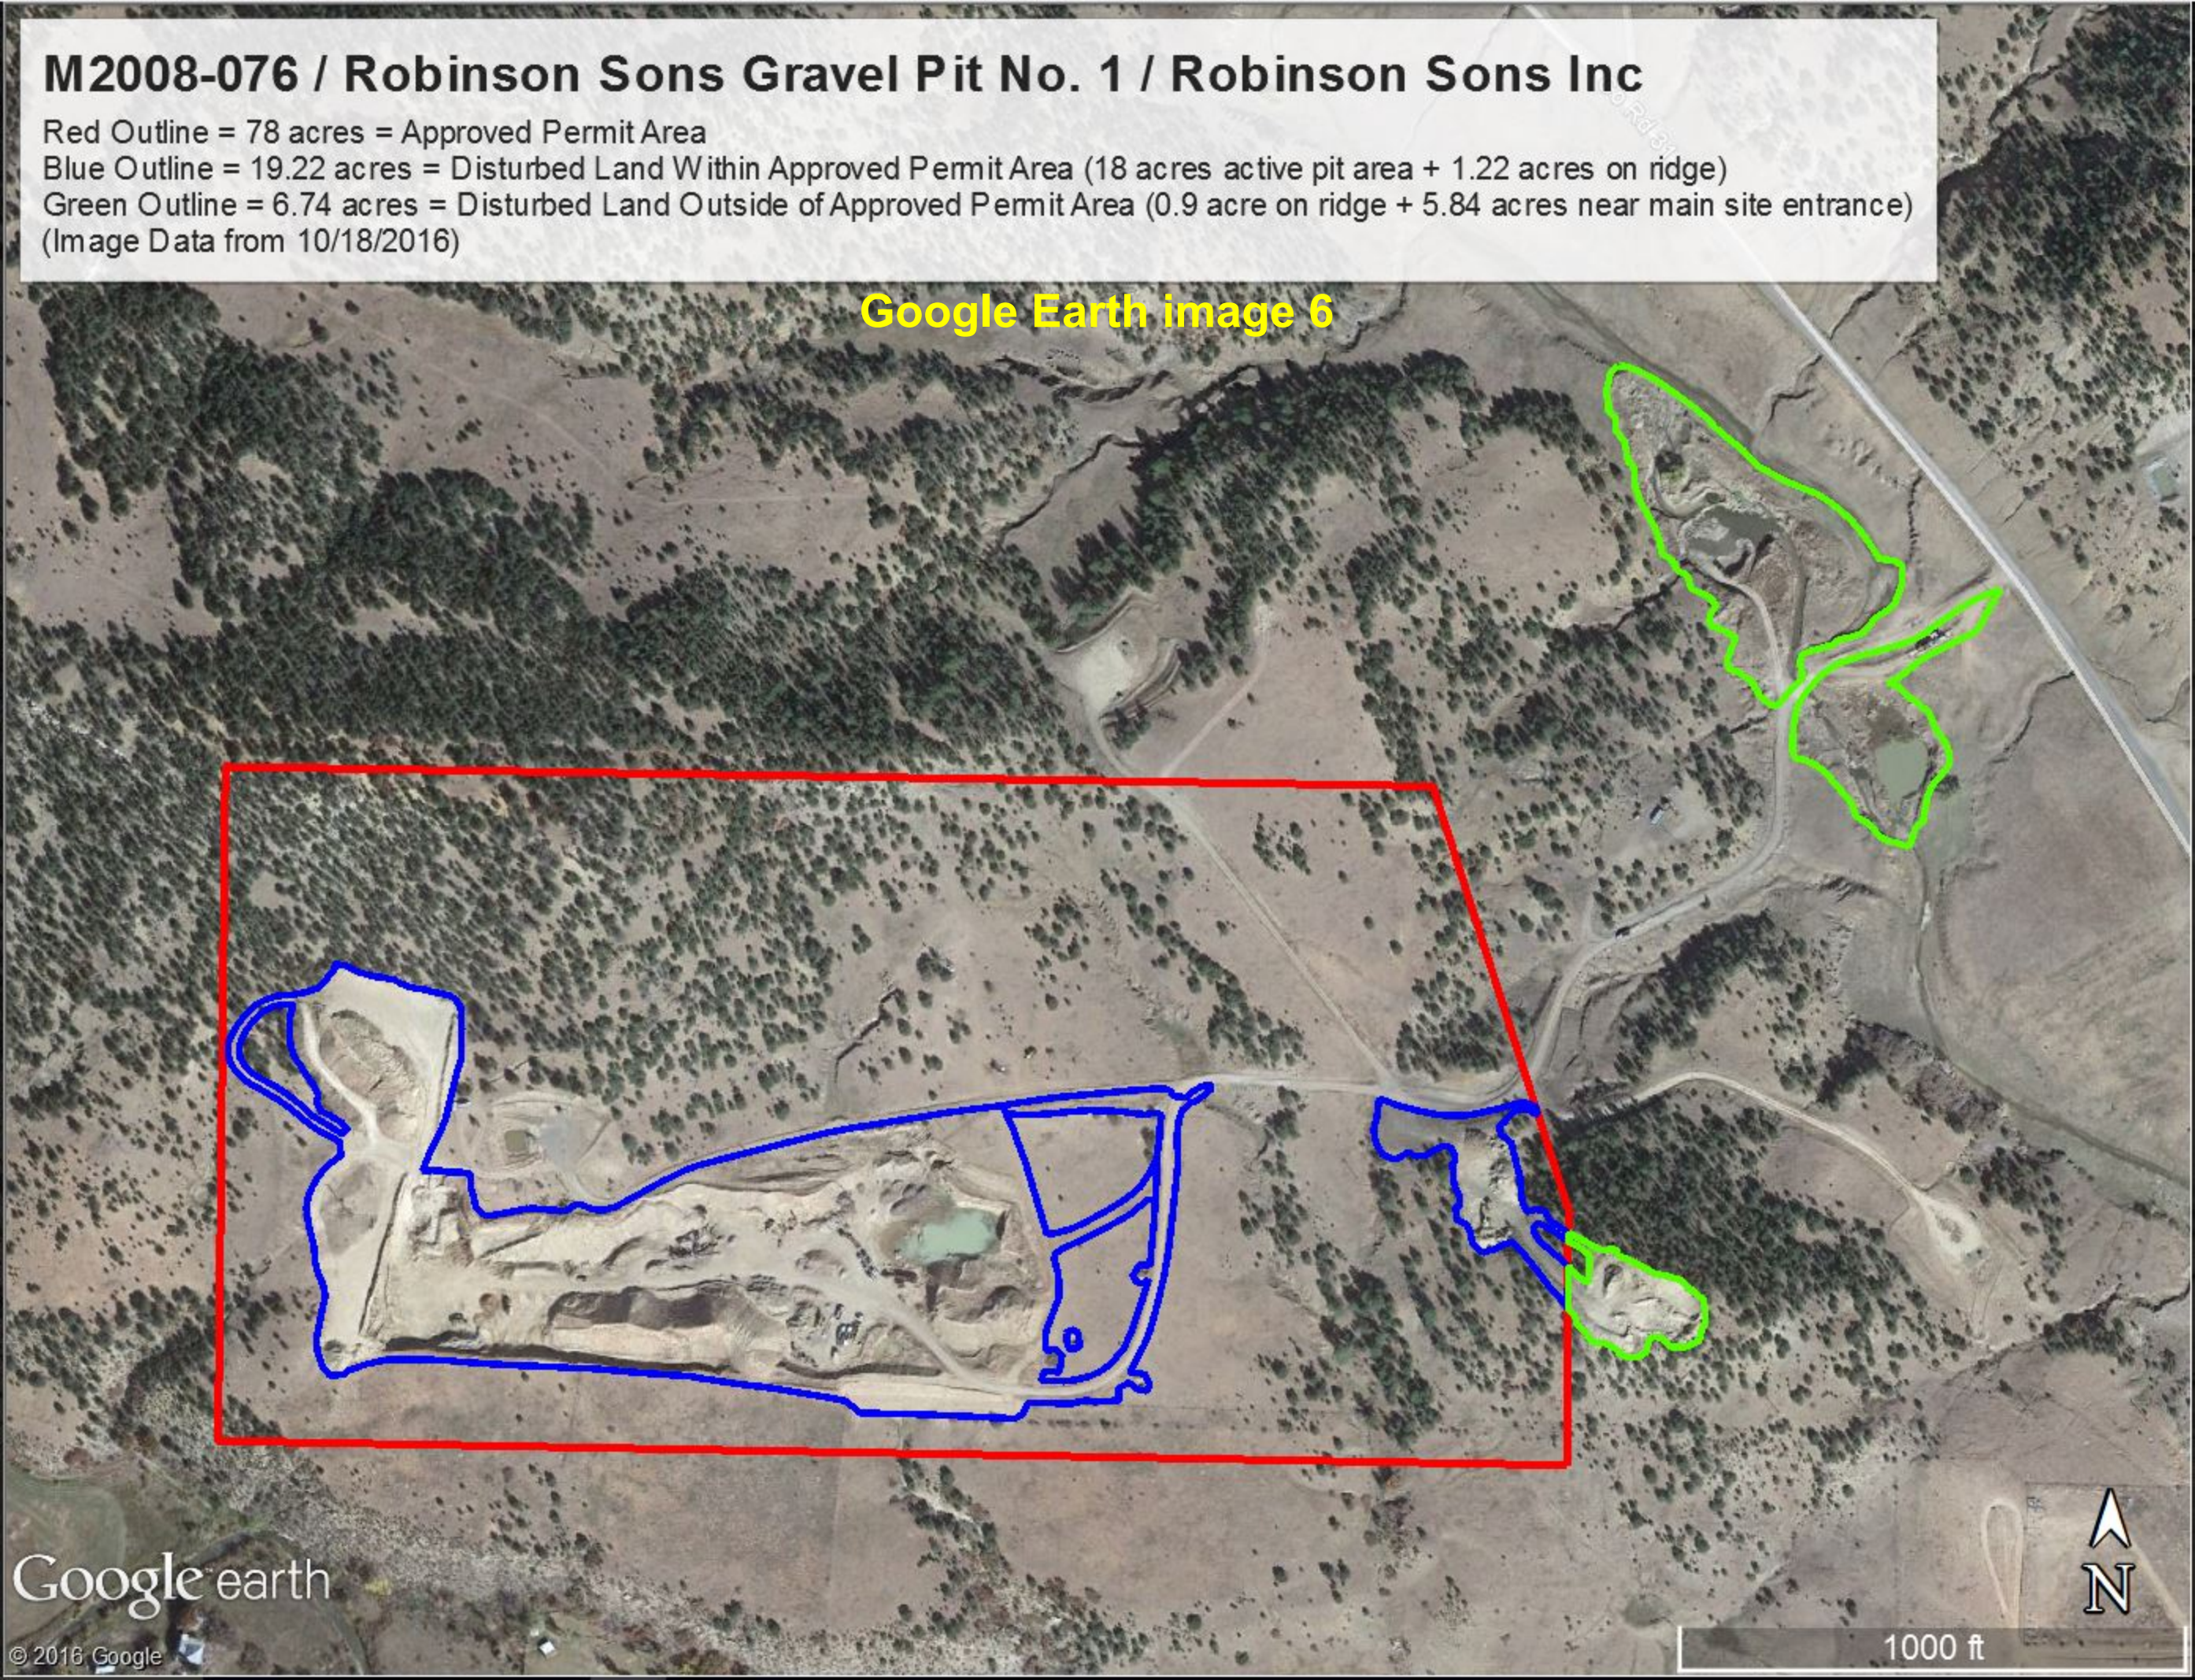
Google Earth image 6

Observations made during the inspection and recorded in this report indicate the Operator has affected a total of 6.74 acres beyond the approved affected area boundary (see enclosed Google Earth image 6). The 6.74 acres are clarified as follows:
