COLORADO DIVISION OF RECLAMATION, MINING AND SAFETY MINERALS PROGRAM INSPECTION REPORT

MINE NAME:	MINE/PROSPECTING ID#:	MINERAL:	COUNTY:
Rocky Ford East Pit	M-1977-560	Sand and gravel	Otero
INSPECTION TYPE:	INSPECTOR(S):	INSP. DATE:	INSP. TIME:
Partial Release Inspection	Amy Eschberger, Wally Erickson	May 13, 2016	10:00
OPERATOR:	OPERATOR REPRESENTATIVE:	TYPE OF OPERATION:	
VALCO, INC.	Tom Brubaker and Steve O'Brian	112c - Construction Regular Operation

This inspection of the Rocky Ford East Pit (Permit No. M-1977-560) was conducted by Amy Eschberger and Wally Erickson of the Division of Reclamation, Mining and Safety (Division) in response to an Acreage Reduction request (Revision No. AR-01) submitted by the operator on April 29, 2016. Mr. Tom Brubaker represented the operator, Valco, Inc. during the inspection. Mr. Steven O'Brian of Environment, Inc. was also present for the inspection. The site is located approximately 1.5 miles east of Rocky Ford, Colorado, just north of and adjacent to Hwy 50. The permit area is divided into two parcels by Co Rd 22, giving a western parcel comprised of 71.83 acres where mining activities first occurred on site, and a larger eastern parcel co

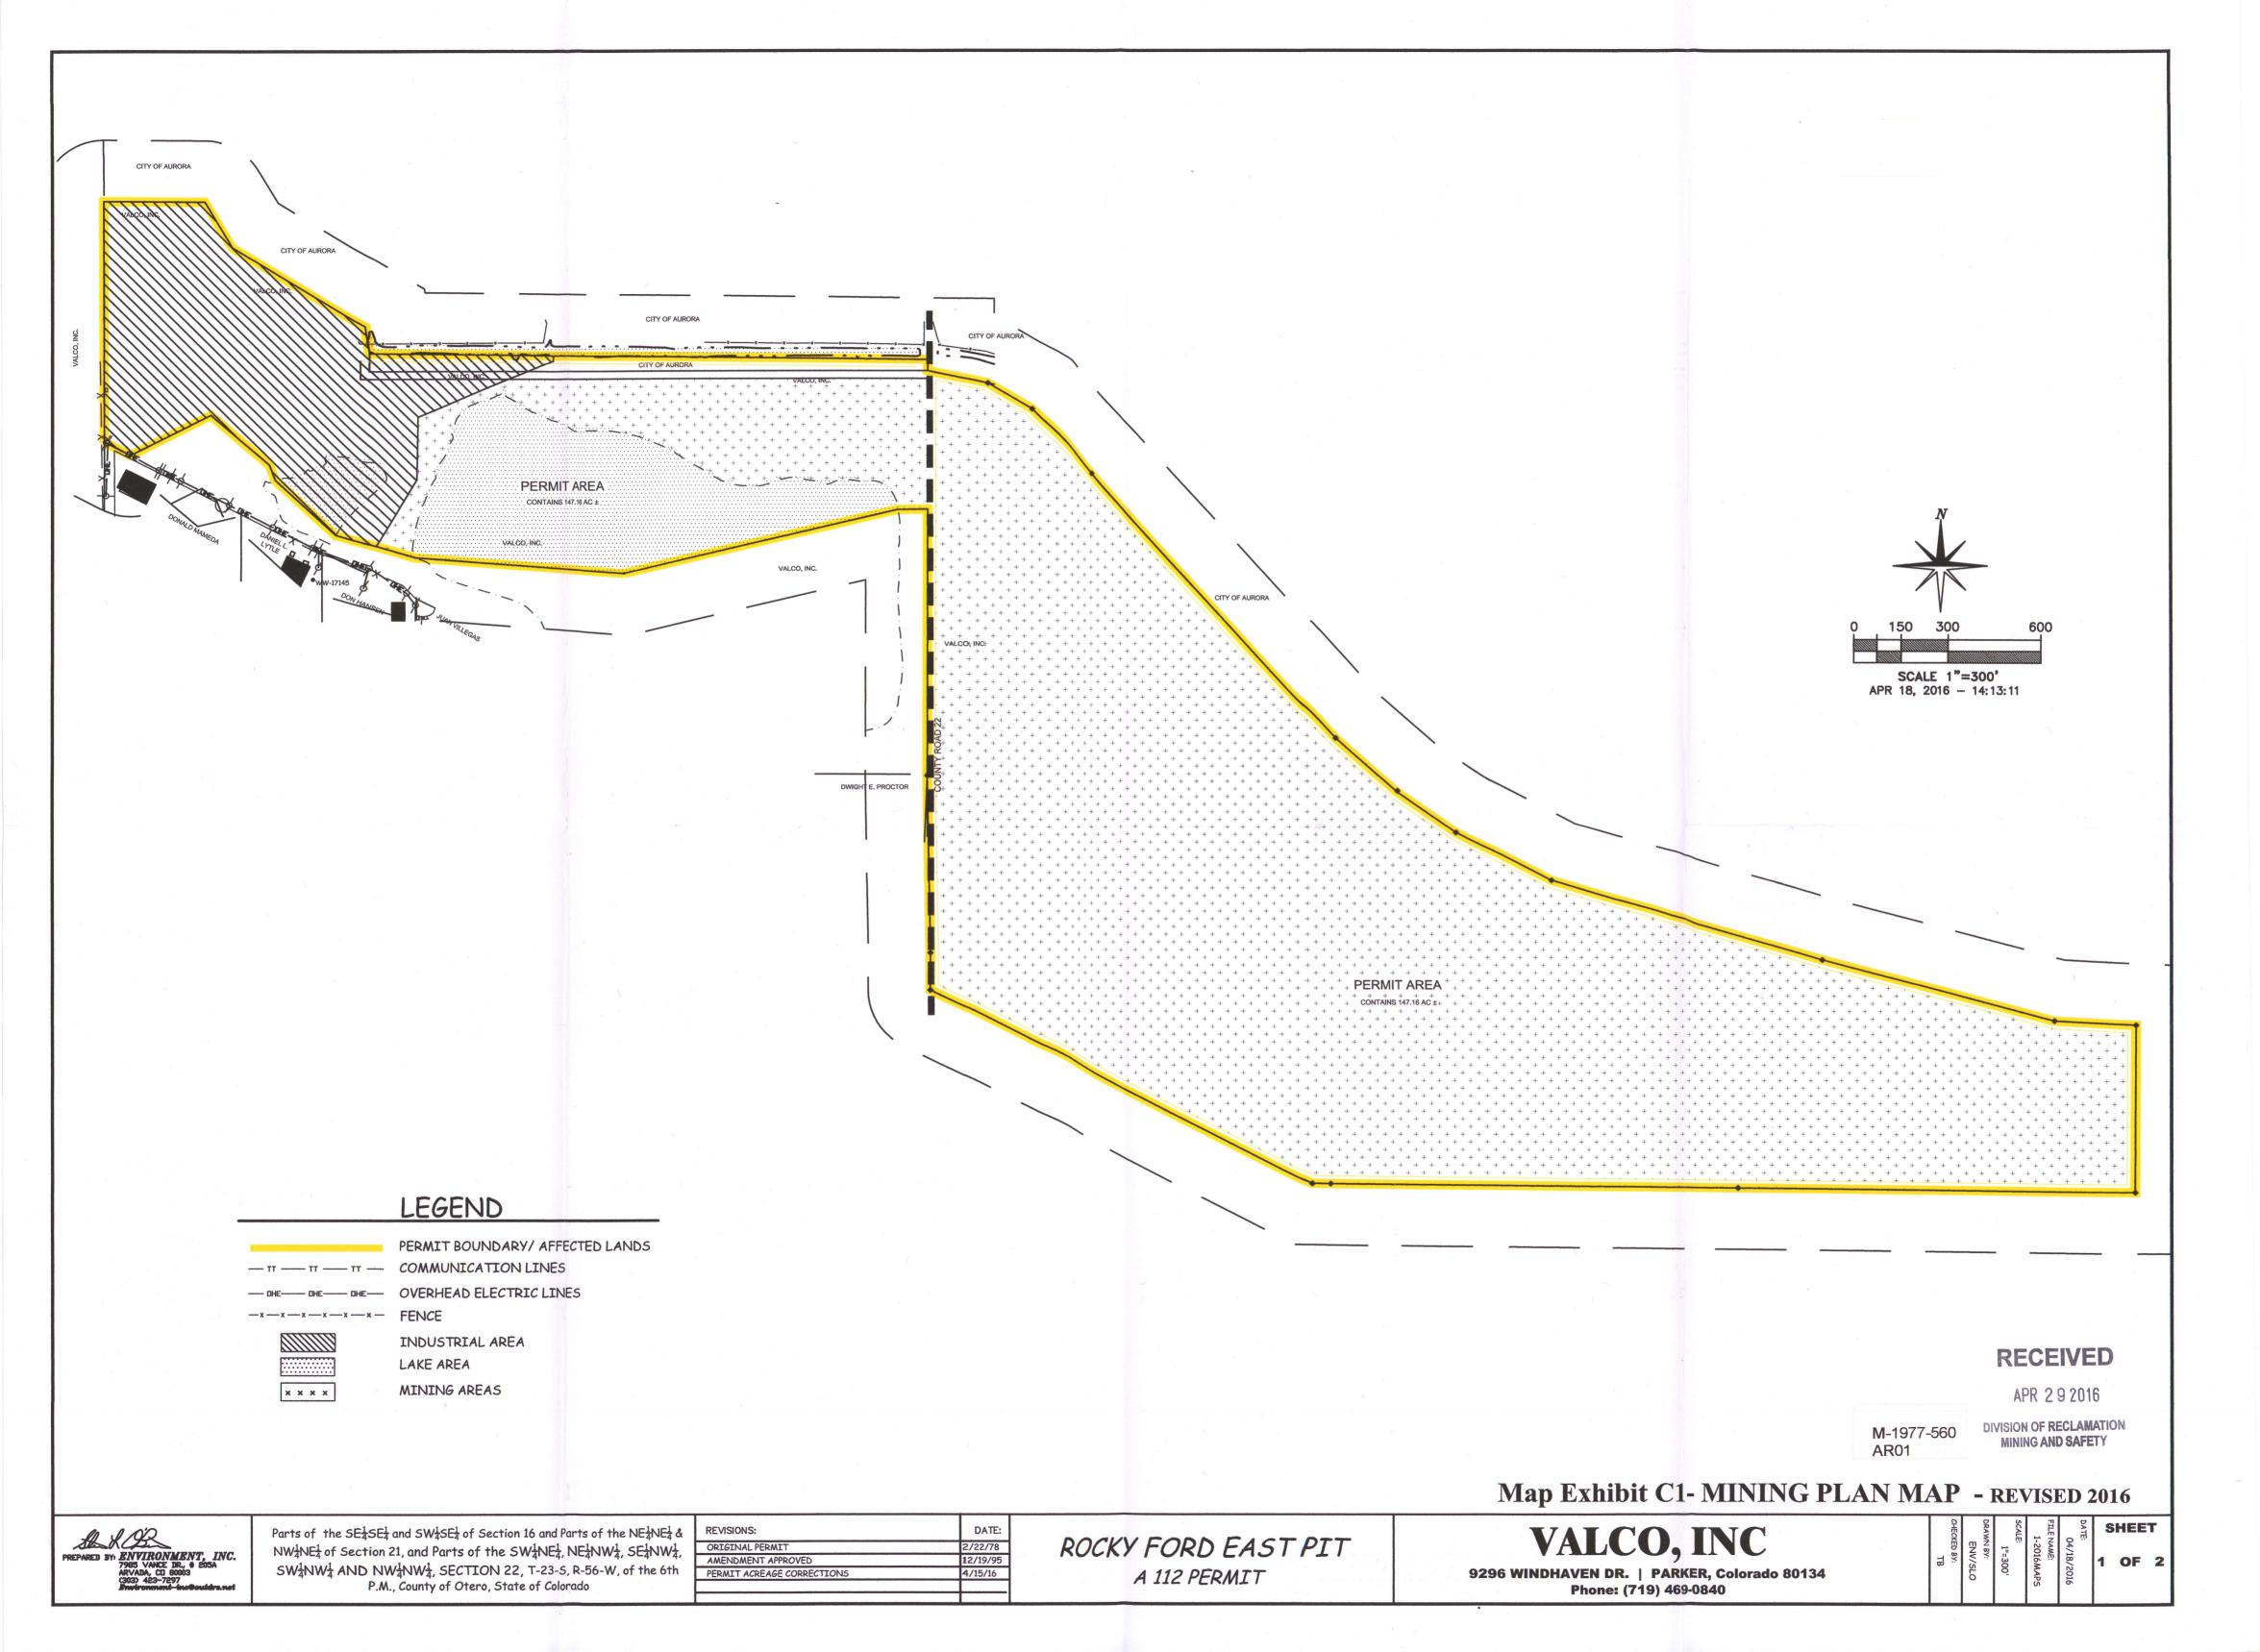
M-1977-560 / Rocky Ford East Pit / Valco, Inc. Purple Outline = 71.83 acres = Old permit area in western parcel Red Outline = 147.30 acres - New permit area with AR-01 approval (39.97 acres western parcel + 107.33 acres eastern parcel) Blue Outline = 45.15 acres = Total exposed groundwater on site; 27.75 acres within permit area after AR-01 approval (17.4 acres released) (Image data from 3/19/2016) M1977-560 Google earth © 2016 Google
