**MINERALS PROGRAM INSPECTION REPORT**  
**PHONE: (303) 866-3567**

<b>MINE NAME:</b> The Orr Pit	<b>MINE/PROSPECTING ID#:</b> M-2009-074	<b>MINERAL:</b> Sand/gravel/borrow	<b>COUNTY:</b> Pueblo
<b>INSPECTION TYPE:</b> Monitoring	<b>INSPECTOR(S):</b> Elliott R. Russell	<b>INSP. DATE:</b> March 1, 2017	<b>INSP. TIME:</b> 08:00
<b>OPERATOR:</b> Colorado Backhoe Service	<b>OPERATOR REPRESENTATIVE:</b> Thomas Joseph	<b>TYPE OF OPERATION:</b> 110c - Construction Limited Impact

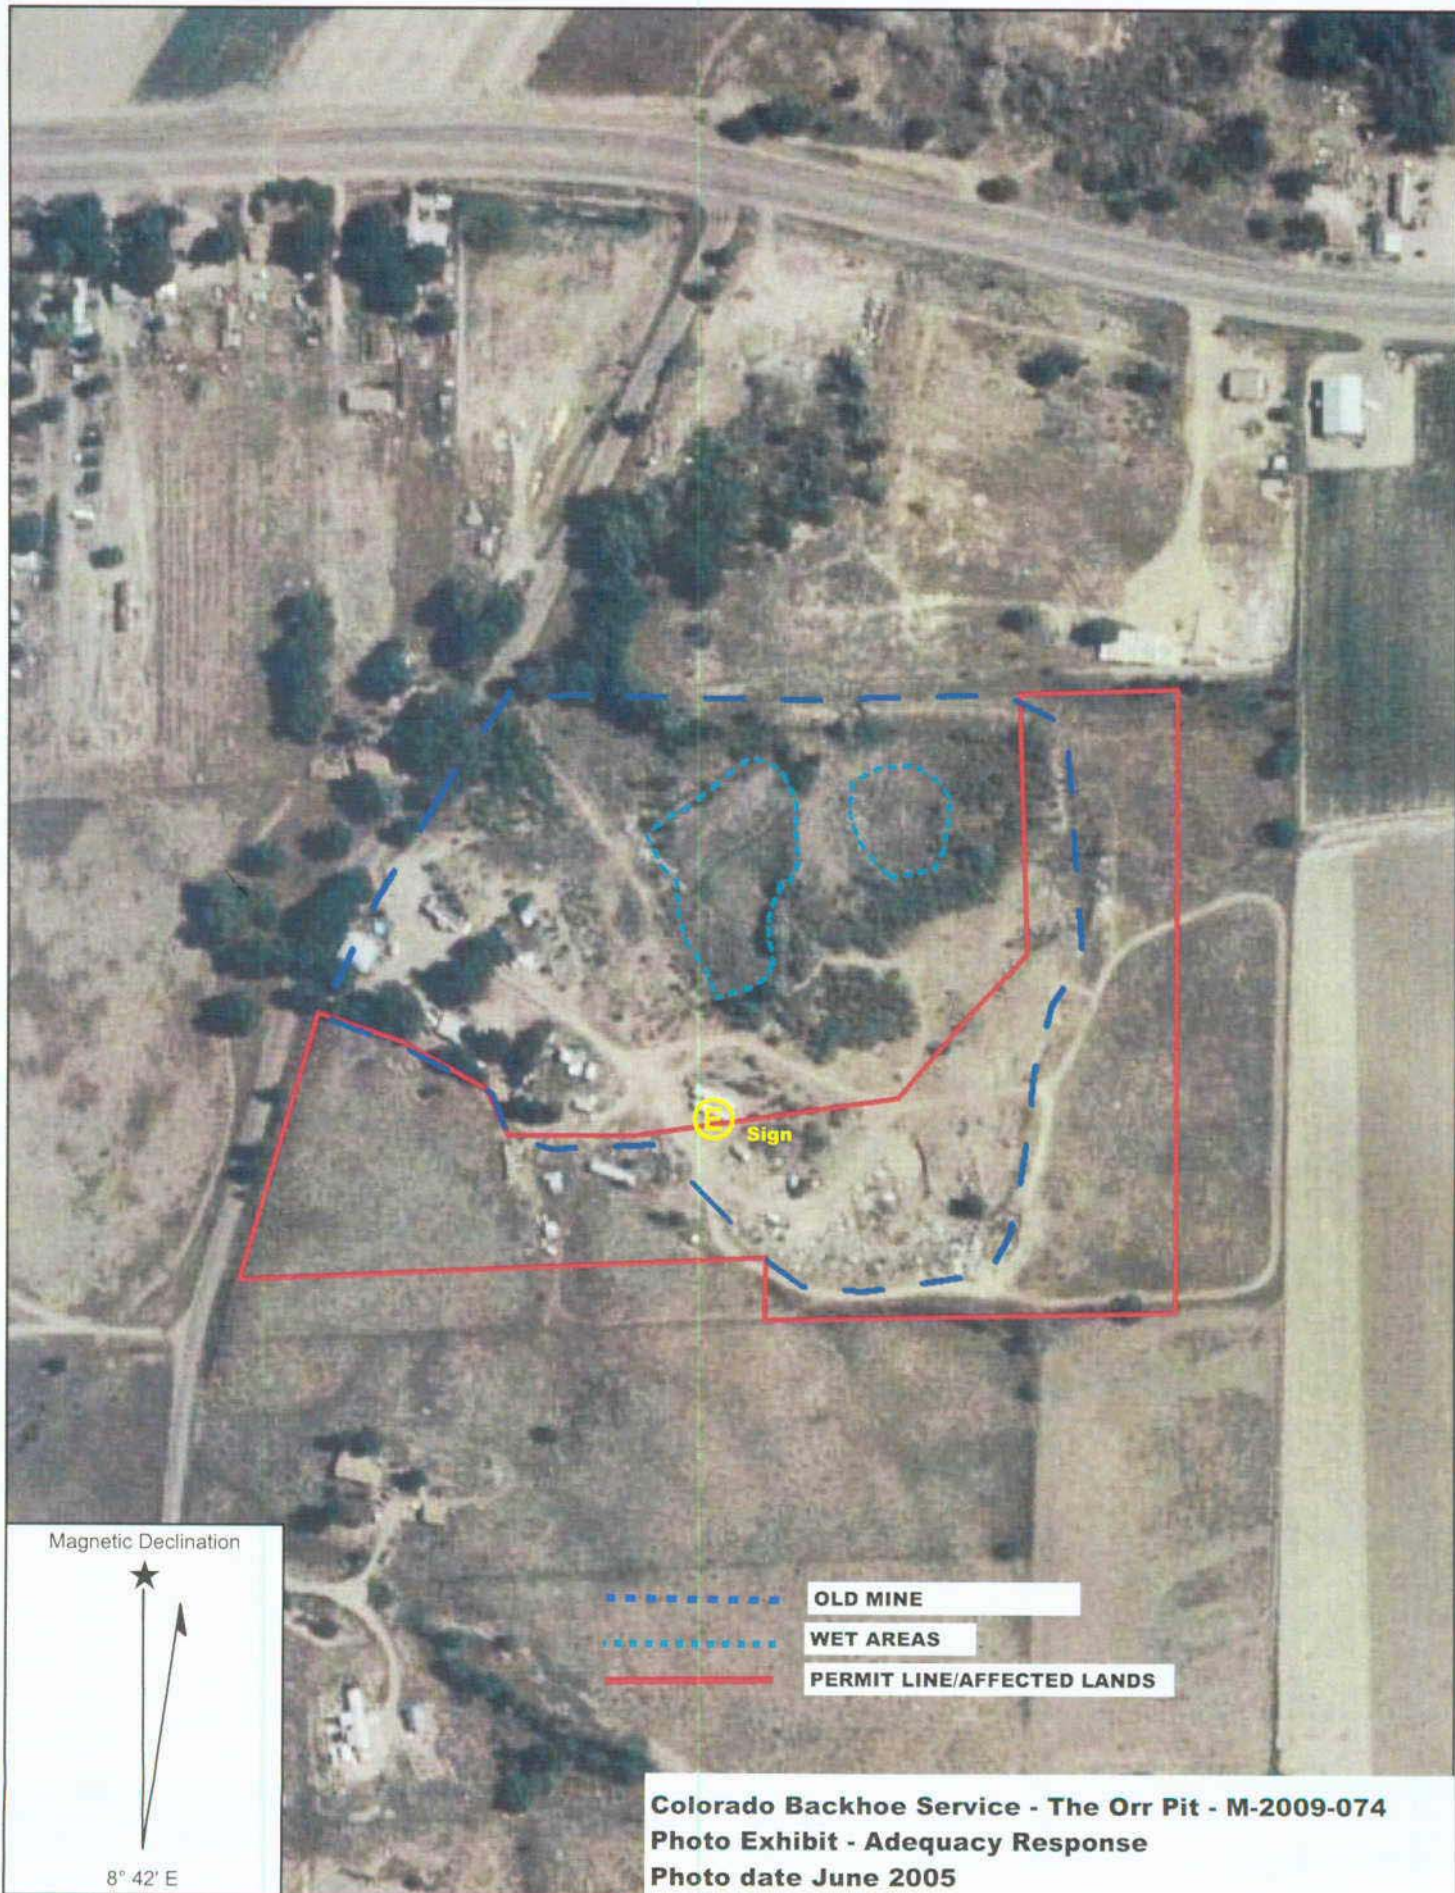
The 110c permit was issued on November 5, 2009. Pre-mine conditions are reflected in the attached aerial photo map (*10-16-2009 Photo Exhibit dated June 2005 M-2009-074*), which show portions of an old mine, trailer house junk yard, and undisturbed rangeland.
