**COLORADO**Division of Reclamation,
Mining and Safety

MINERALS PROGRAM INSPECTION REPORT**PHONE: (303) 866-3567**

MINE NAME: J & J Pit	MINE/PROSPECTING ID#: M-1985-001	MINERAL: Sand and gravel	COUNTY: La Plata
INSPECTION TYPE: Monitoring	INSPECTOR(S): Lucas J. West	INSP. DATE: April 5, 2017	INSP. TIME: 08:00
OPERATOR: Glacier Gravel Products	OPERATOR REPRESENTATIVE: Jim Helmericks, Nathan Barton	TYPE OF OPERATION: 110c - Construction Limited Impact

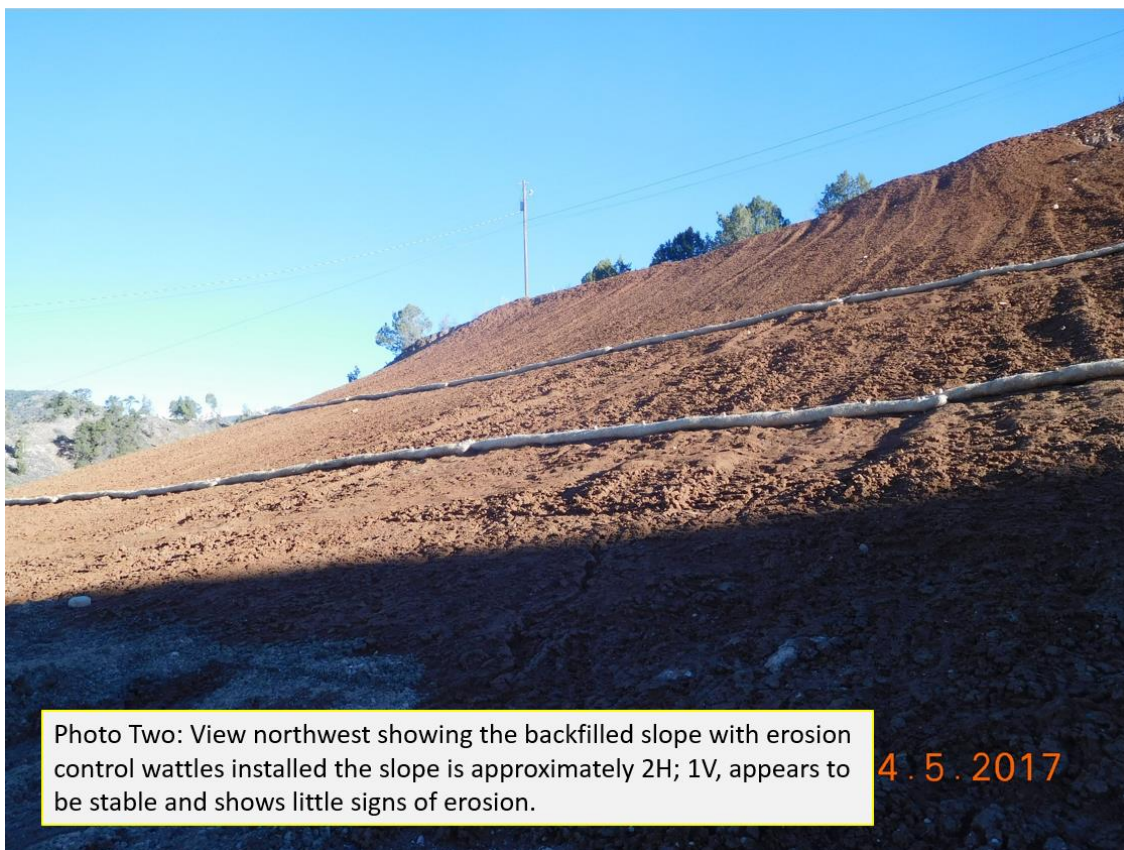
The proper Mine Identification Signage was observed at the entrance to the site. The site was not active during the inspection and the only equipment on site was a parked loader adjacent to the scale house. Several stockpiles of materials are located on the pit floor shown in Photo One, the stockpiles appear to be stable and are in good condition. A large section of the North highwall has been backfilled to approximately 2H : 1V slope with straw wattles installed for erosion control. Photo Two shows the backfilled slope which was hydro seeded shortly after the inspection concluded. The remaining highwall to be backfilled, shown in Photo Three, consists of 430 foot long section that is a mix of vertical face and 1.5H: 1V slopes. A stockpile of material is located approximately 300 feet from the highwall, which will need to be moved via Wheeled Loader to backfill the slope. The slope of the remaining highwalls can be reduced by utilizing the cut and fill method of dozing. The remaining highwalls are approximately 80 feet tall, 500 linear feet, and are a mix of vertical face and 1H :1V slopes.
