**MINERALS PROGRAM INSPECTION REPORT****PHONE: (303) 866-3567**

<b>MINE NAME:</b> Garrett Pit	<b>MINE/PROSPECTING ID#:</b> M-1978-271	<b>MINERAL:</b> Gravel	<b>COUNTY:</b> Conejos
<b>INSPECTION TYPE:</b> Monitoring	<b>INSPECTOR(S):</b> Dustin M. Czapla	<b>INSP. DATE:</b> May 15, 2017	<b>INSP. TIME:</b> 13:00
<b>OPERATOR:</b> Asphalt Gravel Products, Inc.	<b>OPERATOR REPRESENTATIVE:</b> Alonzo Salazar	<b>TYPE OF OPERATION:</b> 112c - Construction Regular Operation

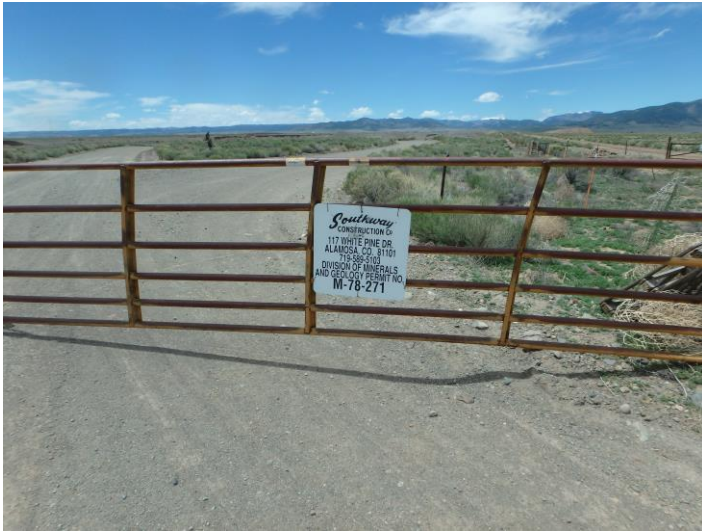
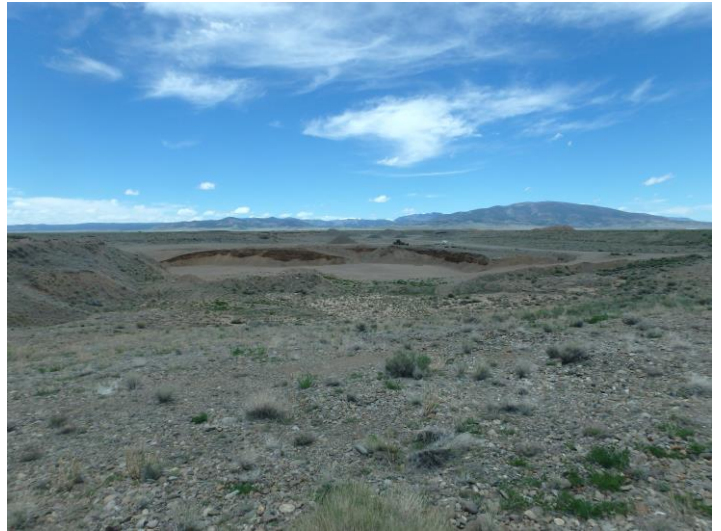
**PROBLEM/POSSIBLE VIOLATION:** Problem: An erosion gully was observed on the east side of the pit. The gully is head-cutting toward the permit boundary. This is a problem at this time for failure to protect the affected land from erosion.

An erosion feature has formed on the east pit wall. The gully is headcutting toward the permit boundary and needs to be repaired. This has been noted as a problem on page one of this report.

Erosion feature on east side

**CORRECTIVE ACTIONS:** Provide photo documentation to the Division verifying the erosion gully has been repaired, and that the site has been reconstructed and stabilized to prevent erosion damage by the corrective action due date.
