Permit Number: C-1996-084 Mine Name: Lorencito Canyon Mine Operator: New Elk Coal Company, LLC Operator Address: Mr. Louis Head 12250 Highway 12 Weston, CO 81091 **County:** Las Animas **Operation Type:** Surface **Permit Status:** Permanent Cessation **Ownership:** Private

INSPECTION INFORMATION

Inspection Start Date: June 8, 2017 Inspection Start Time: 09:00 Inspection End Date: June 9, 2017 Inspection End Time: 10:30			Inspection Type: Coal Complete Inspection Inspection Reason: Normal I&E Program Weather: Clear		
Joint Inspection Agency:		Joint Inspection Contacts:			
None					
Post Inspection Agency:		Post Inspection Contacts:			
None					
Inspector(s):	Inspecto	r's Sig	nature: Signature Date:		
Robert D. Zuber, P.E.	Phot	D.	24		
			6/20/2017

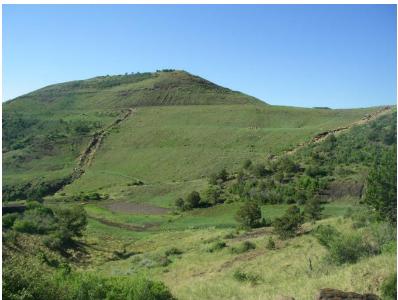
Fill 8

Fills 7, 8, and 9 were inspected. All were generally in good condition, but the following should be addressed. Rills on Fill 7 (as noted in past inspections) may require repair; this remains a judgement call, and NECC should balance the pros and cons of this work. The gully near the bottom of Fill 7 does require repair. Riprap work is needed in down drains for Fill 9.
