**COLORADO**Division of Reclamation,
Mining and Safety

MINERALS PROGRAM INSPECTION REPORT**PHONE: (303) 866-3567**

MINE NAME: Pitch Project	MINE/PROSPECTING ID#: M-1977-004	MINERAL: Uranium	COUNTY: Saguache
INSPECTION TYPE: Monitoring	INSPECTOR(S): Dustin M. Czapla	INSP. DATE: June 14, 2017	INSP. TIME: 08:30
OPERATOR: Homestake Mining Company	OPERATOR REPRESENTATIVE: Dale Davis	TYPE OF OPERATION: 112d-1 - Designated Mining Operation	
REASON FOR INSPECTION: Normal I&E Program	BOND CALCULATION TYPE: None	BOND AMOUNT: \$2,263,000.00	
DATE OF COMPLAINT: NA	POST INSP. CONTACTS: None	JOINT INSP. AGENCY: None	
WEATHER: Clear	INSPECTOR'S SIGNATURE:

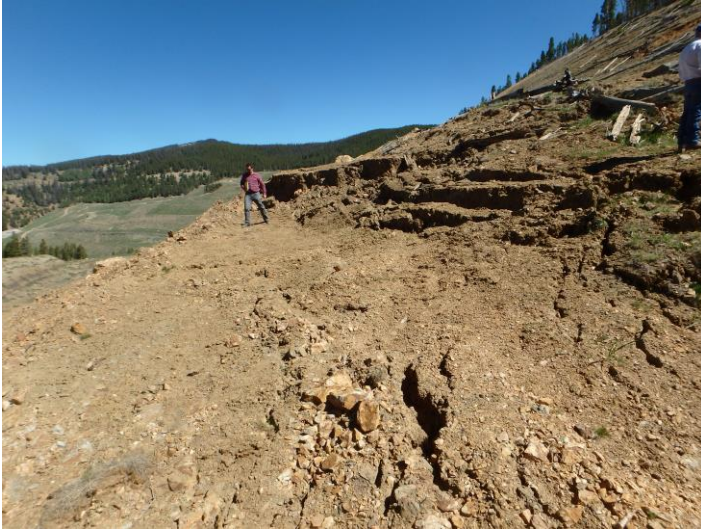
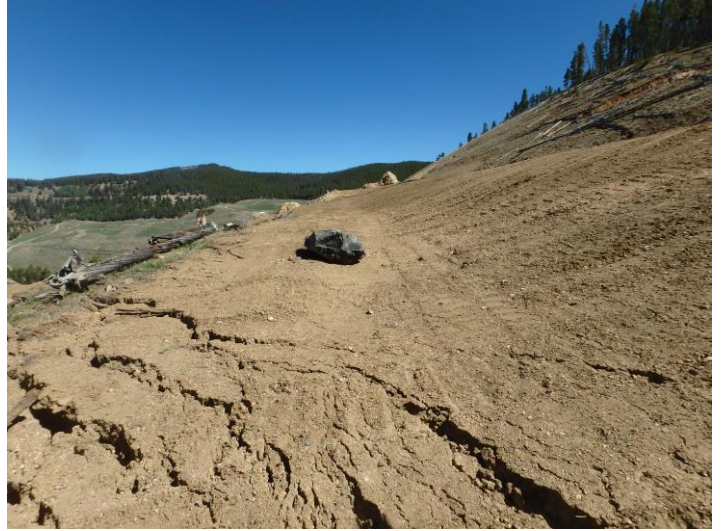
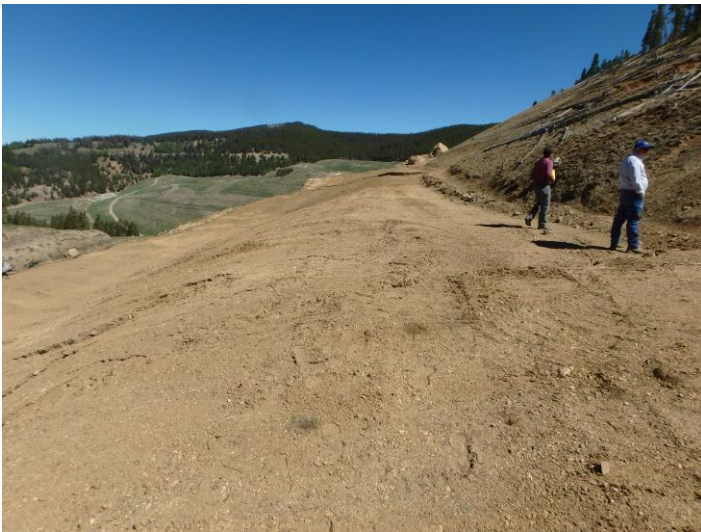
South Pit: The phosphate injection program continues in this area. Several more boreholes, as approved through TR-8, are to be drilled this season in this area. There has been some slope failure in the upper part of the south pit area. The failure affects approximately 0.75 acres. This is an area of recurring failure, so the operator plans to drill a borehole in the slope this season in order to better understand the failure so that a more permanent fix can be developed. The failure poses no risk to public safety.

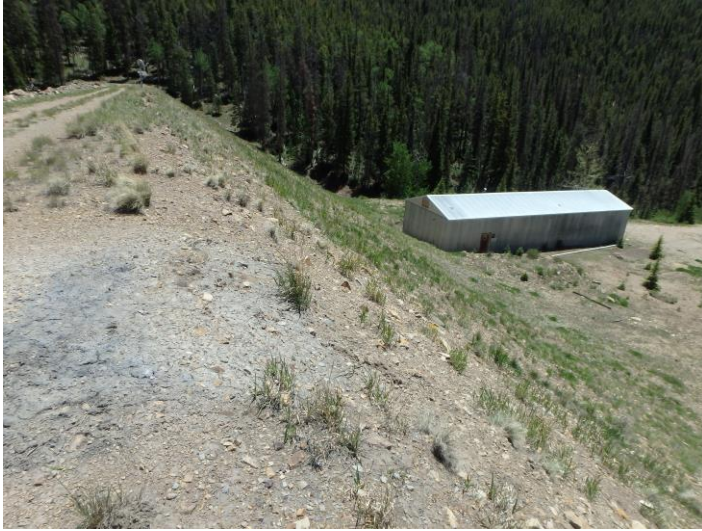
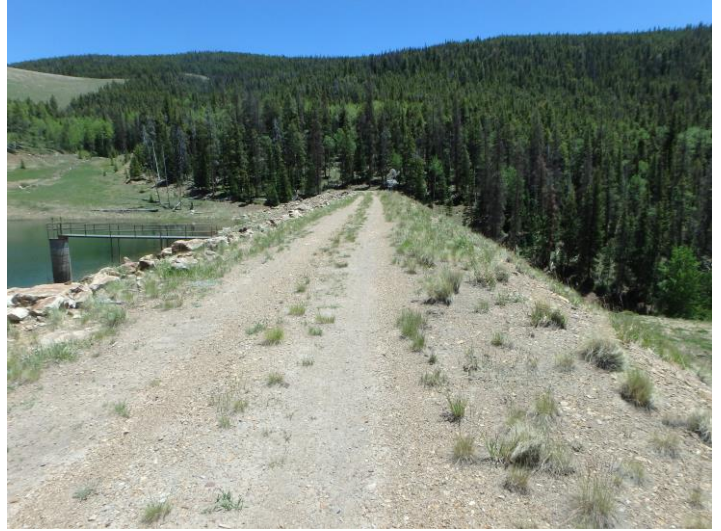
Sediment Pond: The sediment pond appears functional and the pond slopes appear stable. A surface filter boom placed at the upper end of the pond is maintained and still in place. No seepage or stability concerns were noted around the dam.
