**MINERALS PROGRAM INSPECTION REPORT**  
**PHONE: (303) 866-3567**

<b>MINE NAME:</b> Cresson Project	<b>MINE/PROSPECTING ID#:</b> M-1980-244	<b>MINERAL:</b> Gold	<b>COUNTY:</b> Teller
<b>INSPECTION TYPE:</b> Monitoring	<b>INSPECTOR(S):</b> Timothy A. Cazier	<b>INSP. DATE:</b> May 30, 2017	<b>INSP. TIME:</b> 10:00
<b>OPERATOR:</b> Cripple Creek & Victor Gold Mining Company	<b>OPERATOR REPRESENTATIVE:</b> Clara Steward, Erik Munroe	<b>TYPE OF OPERATION:</b> 112d-3 - Designated Mining Operation	
<b>REASON FOR INSPECTION:</b> Normal I&E Program	<b>BOND CALCULATION TYPE:</b> None	<b>BOND AMOUNT:</b> \$173,934,420.00	
<b>DATE OF COMPLAINT:</b> NA	<b>POST INSP. CONTACTS:</b> None	<b>JOINT INSP. AGENCY:</b> None	
<b>WEATHER:</b> Clear	<b>INSPECTOR'S SIGNATURE:</b>

## **OBSERVATIONS**

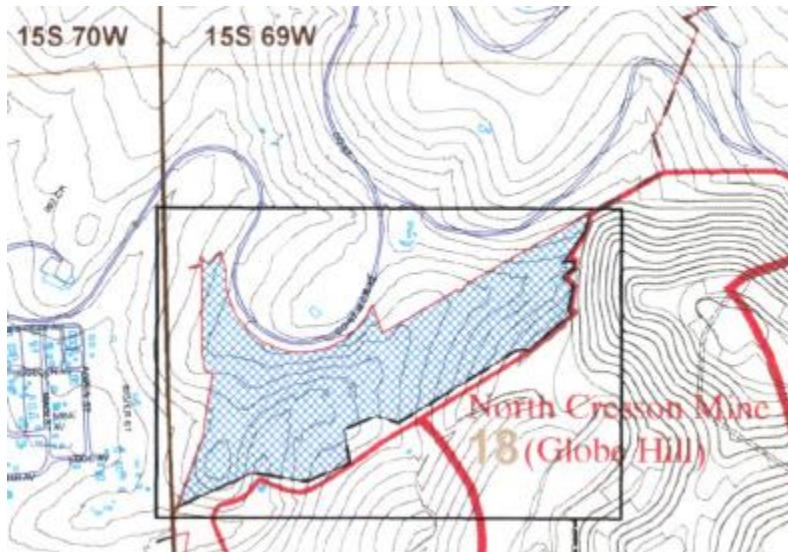
AR-04: The Division was accompanied by Ms. Steward and Mr. Munroe to inspect the area on the northwest corner of the CC&V mine permit area, essentially bounded by Poverty Gulch, Hwy 67 and Teller CR 82 (shaded area below) requested for release (AR-04).

The area has hiking trails (**Photo 7**) and numerous historic mine structures (**Photo 8**). However, no evidence of disturbance related to CC&V's mining activities was observed. The Division will recommend approval of AR-04. CC&V will be notified of the decision under separate cover.
