### MINERALS PROGRAM INSPECTION REPORT

<b>MINE NAME:</b> Incas Mine	<b>MINE/PROSPECTING ID#:</b> M-1986-076	<b>MINERAL:</b> Gold and silver	<b>COUNTY:</b> La Plata
<b>INSPECTION TYPE:</b> Multi Person Inspection	<b>INSPECTOR(S):</b> Lucas J. West	<b>INSP. DATE:</b> July 18, 2017	<b>INSP. TIME:</b> 09:30
<b>OPERATOR:</b> Michael McClure	<b>OPERATOR REPRESENTATIVE:</b> None	<b>TYPE OF OPERATION:</b> 110d - Designated Limited Impact	
<b>REASON FOR INSPECTION:</b> Normal I&E Program	<b>BOND CALCULATION TYPE:</b> None	<b>BOND AMOUNT:</b> \$29,902.68	
<b>DATE OF COMPLAINT:</b> NA	<b>POST INSP. CONTACTS:</b> None	<b>JOINT INSP. AGENCY:</b> None	
<b>WEATHER:</b> Clear	<b>INSPECTOR'S SIGNATURE:</b>

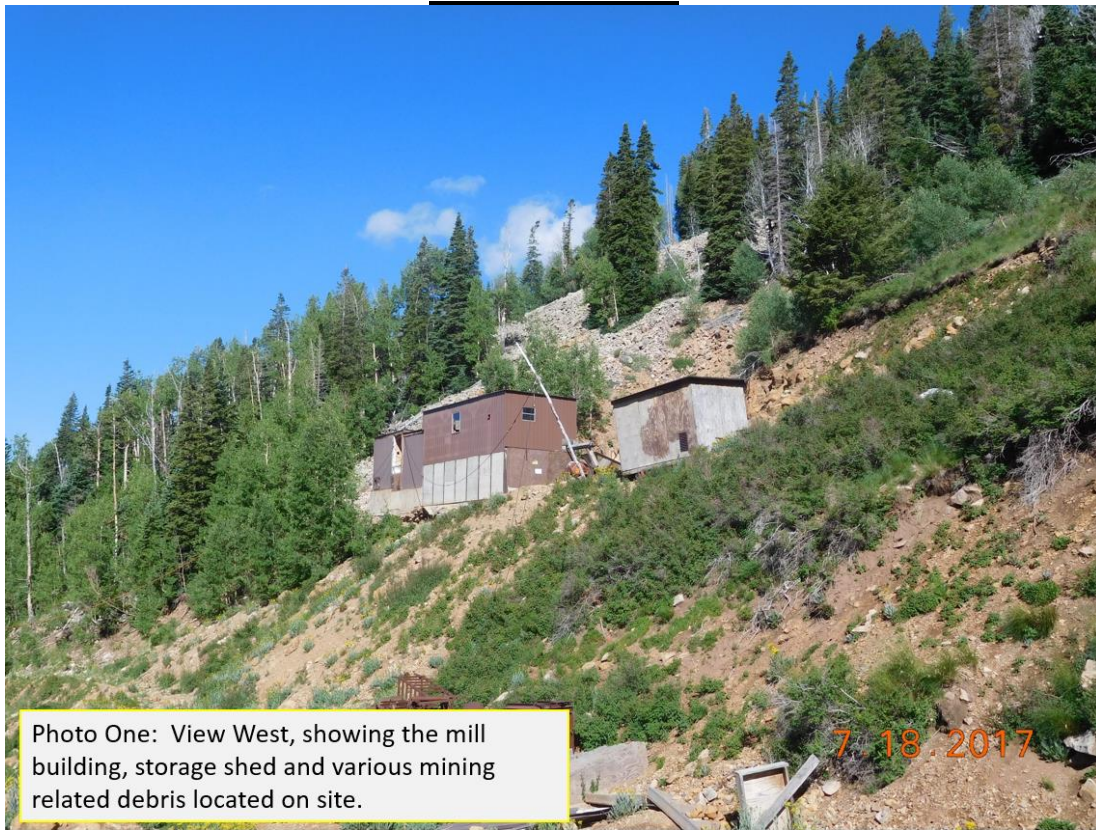
The site was not active during this inspection and has not been in recent years. The First 5 year period of Temporary Cessation will expire on April 15, 2019 at which time the Operator will need to resume active operations, enter final reclamation or appear before the Mined Land Reclamation Board to request a second period of Temporary Cessation. The site is in similar condition to the previous inspection conducted on June 30, 2016. The proper mine identification sign was not posted at the entrance to the site. Given the recent Succession of Operator, the new operator should post a new sign, complete with permit number, site number and operator contact information at the entrance to the site. All buildings and storage sheds located on site were in good condition and showed no signs of vandalism. Various pieces of equipment, scrap metal and other items were noted throughout the site. Photos One and Two shows examples of the various items and buildings located on site. Items that are being stored on site for future use should be stored in a neat and orderly fashion. All other items should be removed from the site.
