**MINERALS PROGRAM INSPECTION REPORT****PHONE: (303) 866-3567**

<b>MINE NAME:</b> Perkins Sandstone	<b>MINE/PROSPECTING ID#:</b> M-2006-016	<b>MINERAL:</b> Sandstone (silica, stone quartzite)	<b>COUNTY:</b> Dolores
<b>INSPECTION TYPE:</b> Monitoring	<b>INSPECTOR(S):</b> Lucas J. West	<b>INSP. DATE:</b> August 23, 2017	<b>INSP. TIME:</b> 12:09
<b>OPERATOR:</b> McStone Aggregates, LLC	<b>OPERATOR REPRESENTATIVE:</b> None	<b>TYPE OF OPERATION:</b> 112c - Construction Regular Operation

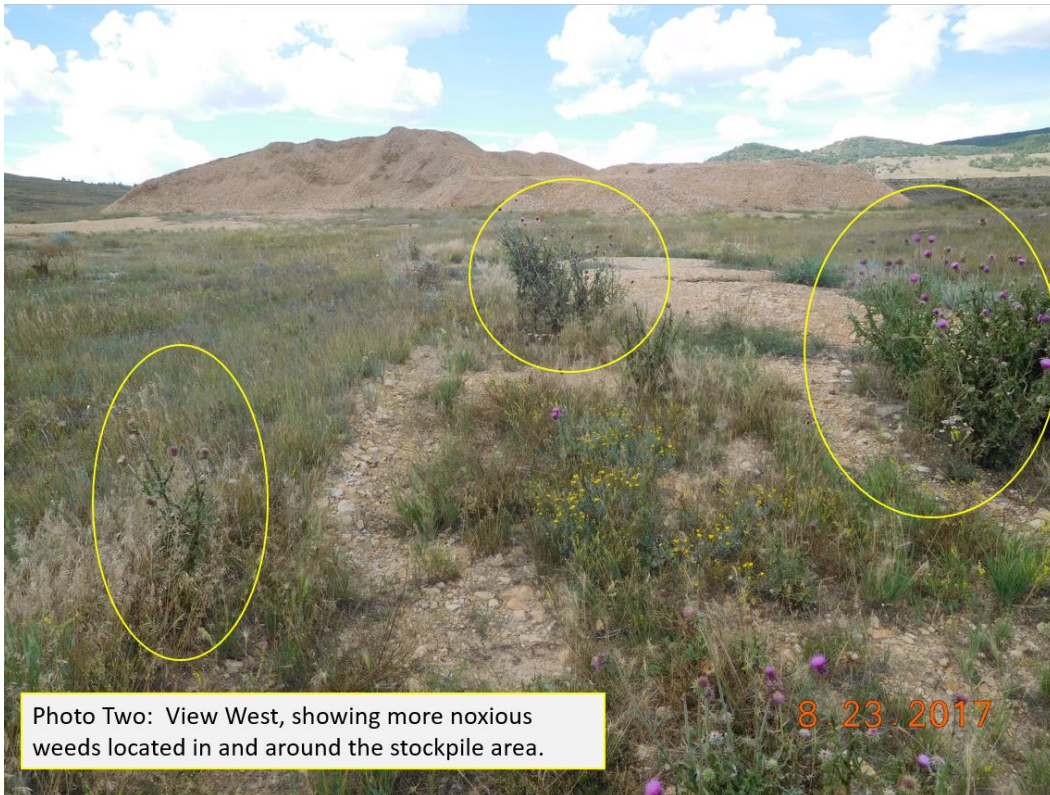
**PROBLEM/POSSIBLE VIOLATION:** Problem: There are state-listed noxious weeds present on site including large populations of Musk thistle, a B List species. This is a problem for failure to employ weed control methods for state listed noxious weed species within the permitted area, and to reduce the spread of weeds to nearby areas as required by Section 3.1.10 (6) of the rule.

Photo One: View South, showing several large Musk thistle plants along the access road to the site.

**CORRECTIVE ACTION DUE DATE:** 10/31/17
