MINERALS PROGRAM INSPECTION REPORT
PHONE: (303) 866-3567

MINE NAME: Wallace Pit	MINE/PROSPECTING ID#: M-1983-028	MINERAL: Sand and gravel	COUNTY: Montezuma
INSPECTION TYPE: Monitoring	INSPECTOR(S): Lucas J. West	INSP. DATE: August 23, 2017	INSP. TIME: 14:08
OPERATOR: Stone Sand & Gravel, LLC	OPERATOR REPRESENTATIVE: Daren Stone	TYPE OF OPERATION: 112c - Construction Regular Operation	
REASON FOR INSPECTION: Normal I&E Program	BOND CALCULATION TYPE: Complete Bond	BOND AMOUNT: \$45,081.66	
DATE OF COMPLAINT: NA	POST INSP. CONTACTS: None	JOINT INSP. AGENCY: None	
WEATHER: Clear	INSPECTOR'S SIGNATURE:

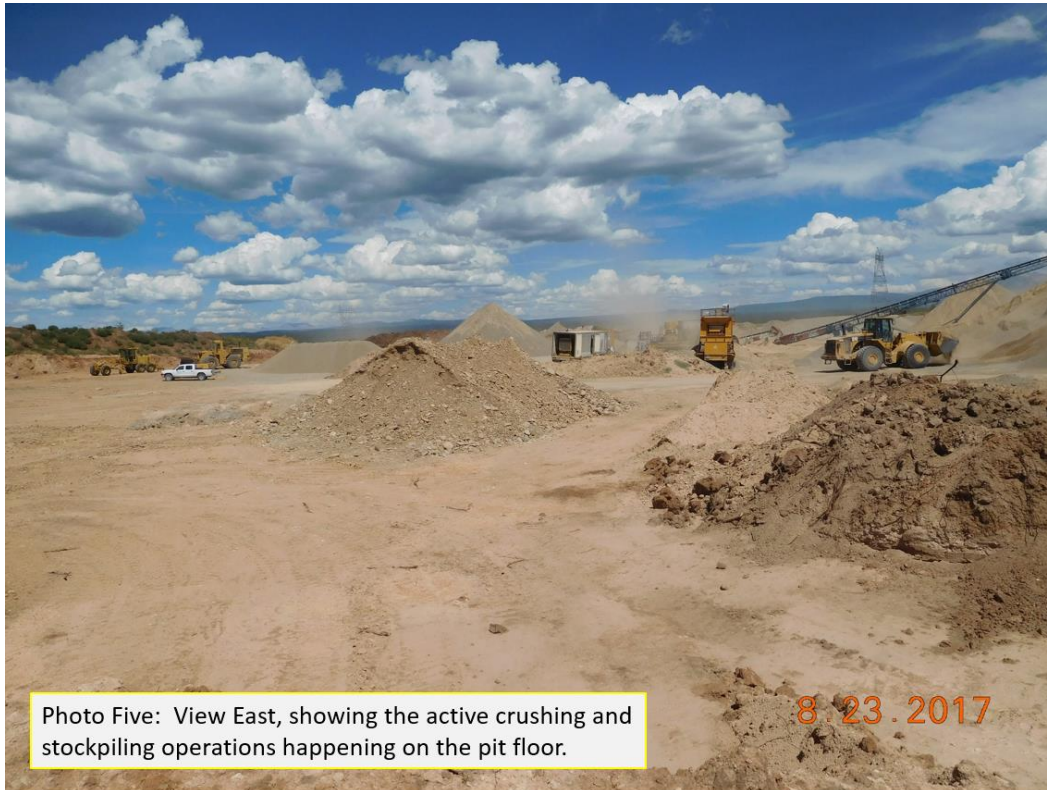
The active mining area can be seen in Photos Three and Four. Several short highwalls are present in the mining area, all of which are no more than 20 feet tall. All exposed highwalls are in good condition and appear to be stable. The site was actively crushing and stockpiling materials during the inspection. Photo Five shows the activities taking place. All stockpiles appeared to be stable as well, and showed no signs of settling slumping or erosion. The Next area to be mined has been stripped, and the vegetation has been cleared. The area can be seen in Photo Six.
