MINERALS PROGRAM INSPECTION REPORT
PHONE: (303) 866-3567

MINE NAME: Amzak Pit	MINE/PROSPECTING ID#: M-2003-003	MINERAL: Gravel and sand	COUNTY: La Plata
INSPECTION TYPE: Monitoring	INSPECTOR(S): Lucas J. West	INSP. DATE: August 24, 2017	INSP. TIME: 08:57
OPERATOR: Consolidated Constructors, Inc.	OPERATOR REPRESENTATIVE: None	TYPE OF OPERATION: 112c - Construction Regular Operation	
REASON FOR INSPECTION: Normal I&E Program	BOND CALCULATION TYPE: Complete Bond	BOND AMOUNT: \$133,165.00	
DATE OF COMPLAINT: NA	POST INSP. CONTACTS: None	JOINT INSP. AGENCY: None	
WEATHER: Clear	INSPECTOR'S SIGNATURE:

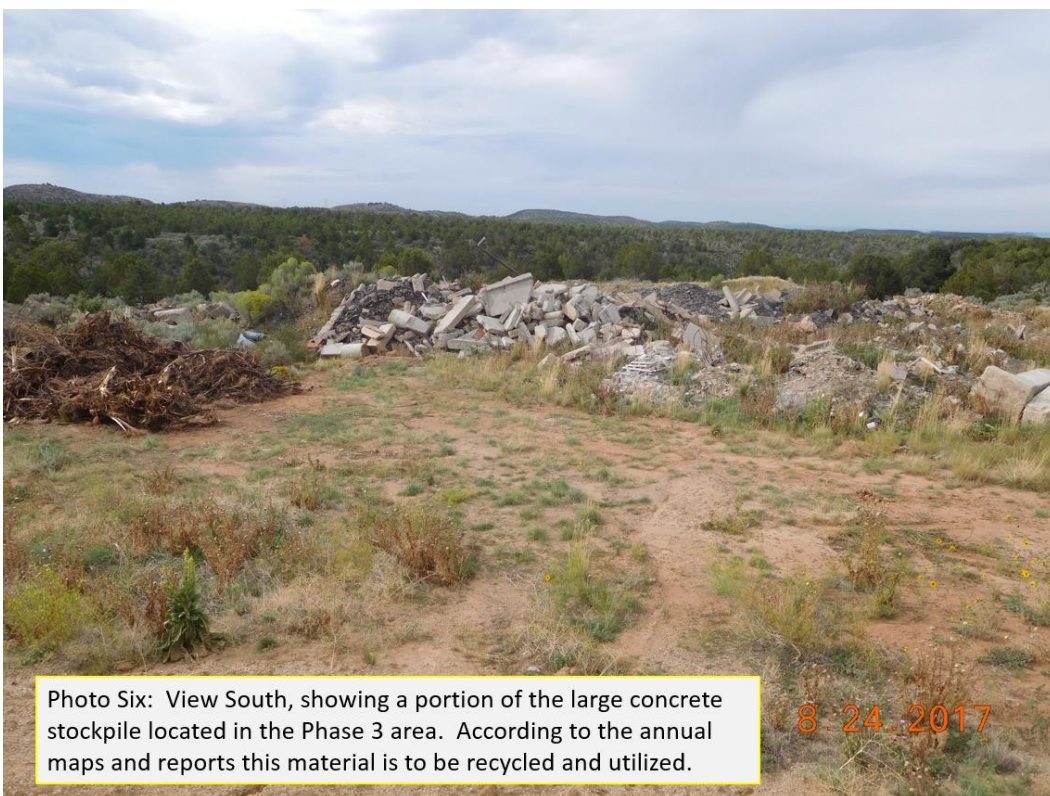
Mining activities have yet to commence in Phases 2 or 3, however the areas are being utilized for stockpiling of materials. Phase 2 contains several stockpiles as well as some equipment being stored as well as shown in Photo Five. Phase 3 contains a large stockpile of concrete, rip rap and rubble that is to be recycled and utilized. The piles can be seen in Photo Six. All stockpiles that were observed in both phases 1 and 2 appear to be stable and show no signs of settling, slumping or erosion. Throughout the site, in both the disturbed and undisturbed areas, excessive amounts of noxious weeds exist. The predominant species on site is Musk thistle that can be seen in several of the above listed photographs. Other species including Halogeton and Russian thistle are also present. Some evidence of chemical treatment was observed, however observations made during this inspection indicate that follow up treatments did not take place. The Division recommends that the Operator continue to treat the noxious weeds on site, and do so several times during the year to avoid future problems with reclamation success. This is not being cited a problem at this time, however future neglect of the noxious weeds could result in possible enforcement action.
