**COLORADO**Division of Reclamation,
Mining and Safety

MINERALS PROGRAM INSPECTION REPORT**PHONE: (303) 866-3567**

MINE NAME: Zellitti Pit	MINE/PROSPECTING ID#: M-1980-246	MINERAL: Gravel	COUNTY: La Plata
INSPECTION TYPE: Monitoring	INSPECTOR(S): Lucas J. West	INSP. DATE: August 24, 2017	INSP. TIME: 10:31
OPERATOR: Anthony Zellitti	OPERATOR REPRESENTATIVE: None	TYPE OF OPERATION: 112c - Construction Regular Operation

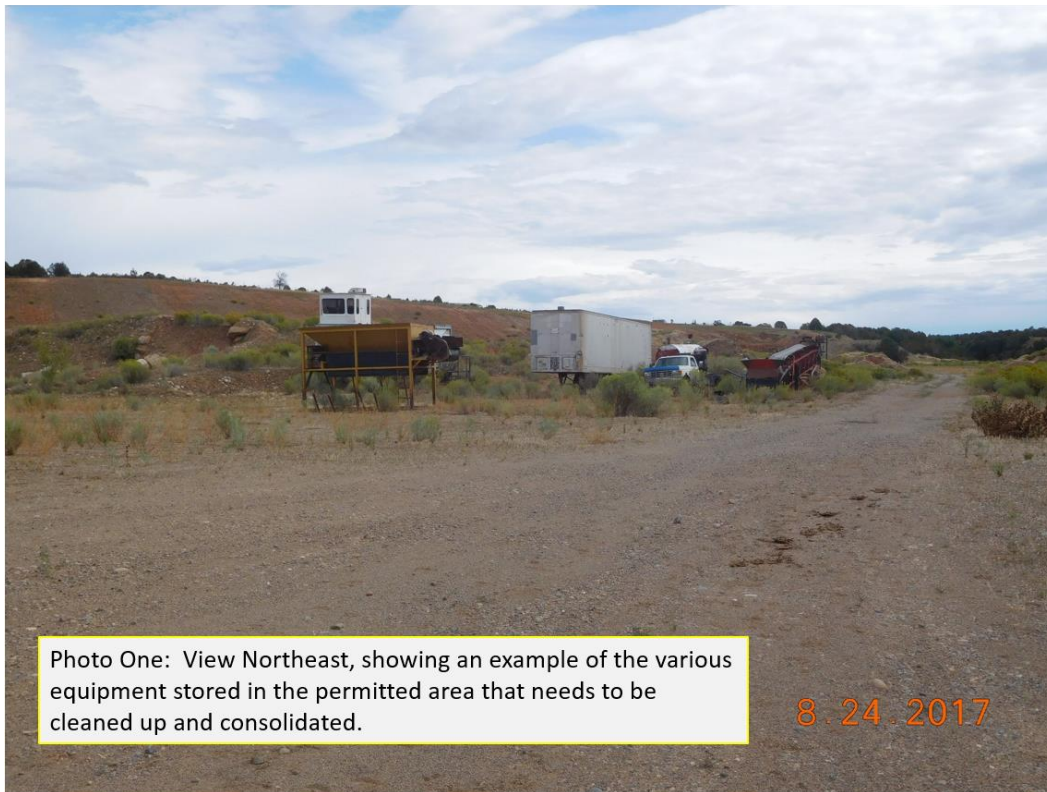
The active mining area consists of sloping highwall that can be seen in Photo Two. The highwall appears to be stable and at this time is showing no signs of settling, slumping or erosion. The adjacent slope which was previously mined can be seen in Photo Three is the location of the new access road. The road is in construction and will be used to access the pit floor once completed. The Pit floor is in good condition and has begun to revegetate itself with volunteer species. Several conveyors and stockpiles of materials are on the pit floor including overburden and salable materials and can also be seen in Photo One. Several other stockpiles exist throughout the site including various overburden and topsoil stockpiles that have been spread across the site for ease of reclamation. An example of the various stockpiles can be seen in Photo Four. All stockpiles on site appear to be stable and in good condition. A majority of the site has begun to revegetate itself with volunteer species. There are several large populations of Canada thistle onsite that show signs of treatment earlier in the summer. There was however a significant amount of new growth, and the Operator should consider completing a fall treatment and possibly removal effort in the coming weeks.
