MINERALS PROGRAM INSPECTION REPORT
PHONE: (303) 866-3567

MINE NAME: Ellison Mine	MINE/PROSPECTING ID#: M-1978-342	MINERAL: Uranium and vanadium	COUNTY: San Miguel
INSPECTION TYPE: Monitoring	INSPECTOR(S): Lucas J. West	INSP. DATE: September 13, 2017	INSP. TIME: 13:10
OPERATOR: Gold Eagle Mining, Inc.	OPERATOR REPRESENTATIVE: DOE, Navarro	TYPE OF OPERATION: 110d - Designated Limited Impact	
REASON FOR INSPECTION: Normal I&E Program	BOND CALCULATION TYPE: None	BOND AMOUNT: \$100.00	
DATE OF COMPLAINT: NA	POST INSP. CONTACTS: None	JOINT INSP. AGENCY: None	
WEATHER: Clear	INSPECTOR'S SIGNATURE:

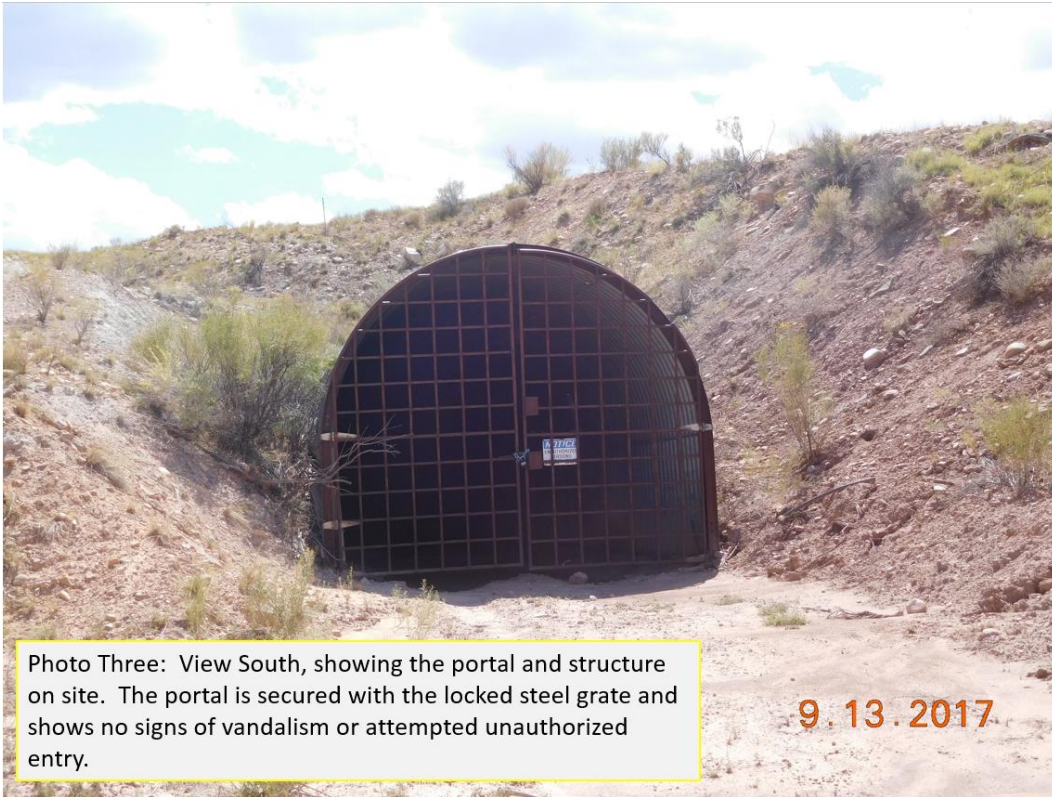
Photo One shows the Quonset hut style structure located on site. The structure was secure and in good condition at the time of this inspection. Also located on is a shipping container used for storage that was also secured and in good condition. The main pad and work area that the structure, containers and portal are located on was in good condition and well vegetated with native grasses and shrubs. The pad and work area can be seen in Photo Two. The portal, shown in Photo Three, is enforced with a Quonset style structure leading underground, and secured with a locked, welded steel grate. All components associated with the portal are in good condition and show no signs of attempted unauthorized entry.
