**RE:** Enforcement Hearing  
Colorado Milling Company, LLC; Permit No. M-1994-117; Gold Hill Mill

**MINERALS PROGRAM INSPECTION REPORT****PHONE: (303) 866-3567**

<b>MINE NAME:</b> Gold Hill Mill	<b>MINE/PROSPECTING ID#:</b> M-1994-117	<b>MINERAL:</b> Gold and silver	<b>COUNTY:</b> Boulder
<b>INSPECTION TYPE:</b> Monitoring	<b>INSPECTOR(S):</b> Amy Eschberger, Wally Erickson	<b>INSP. DATE:</b> August 1, 2017	<b>INSP. TIME:</b> 10:25
<b>OPERATOR:</b> Colorado Milling Company, LLC	<b>OPERATOR REPRESENTATIVE:</b> Mark Steen	<b>TYPE OF OPERATION:</b> 110(2) - Hard Rock Limited Impact

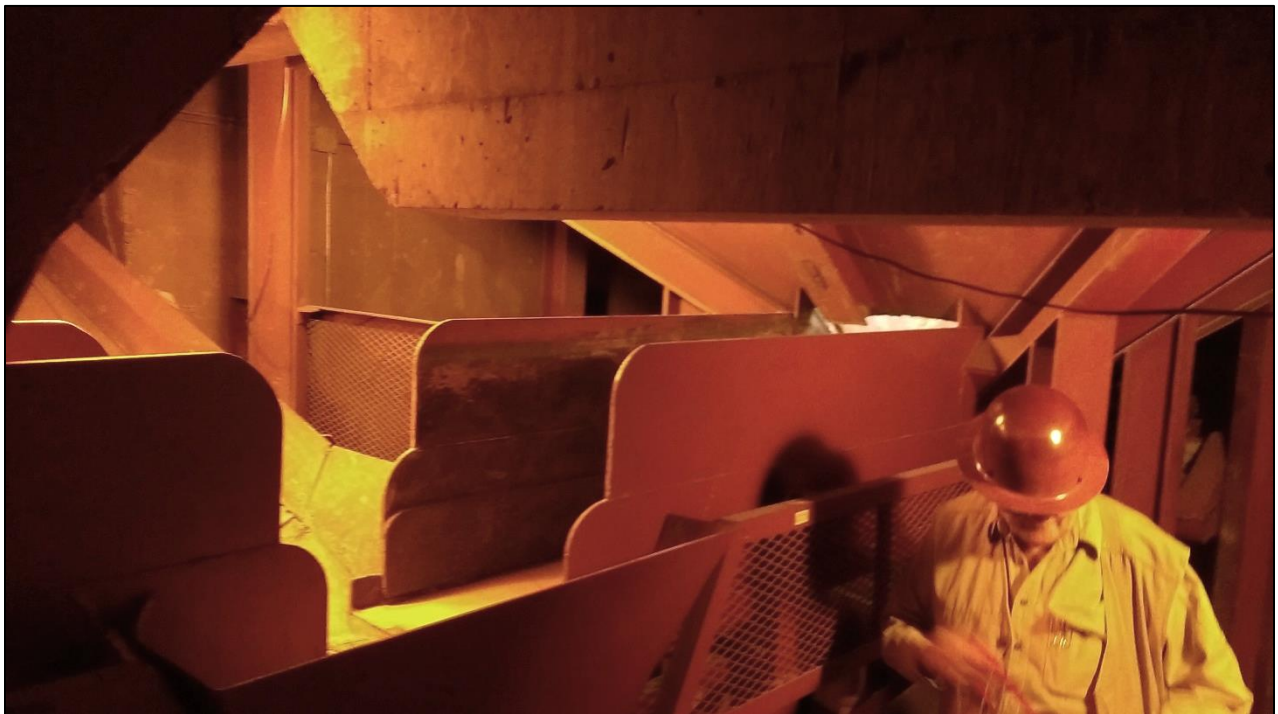
**Photo 12.** View inside mill showing shoot from two outside coarse ore bins.

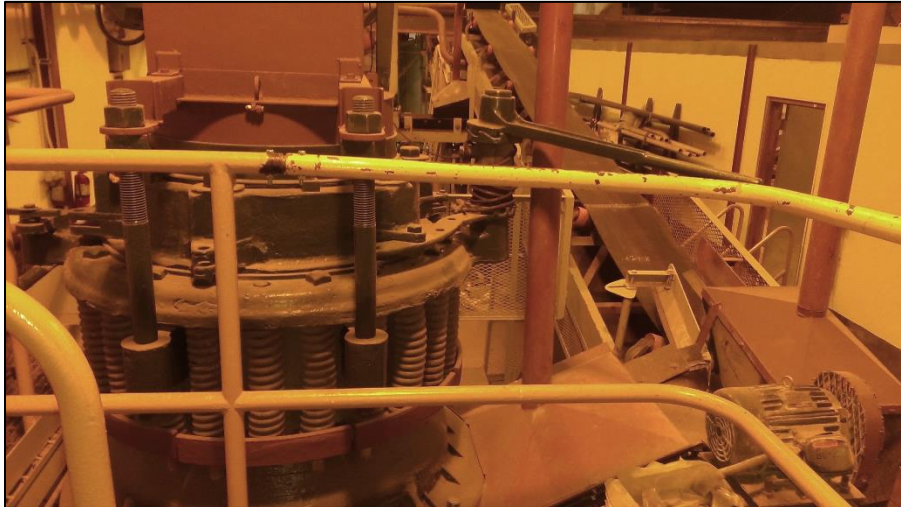
**Photo 13.** View inside mill showing closed-circuit crushing plant. No water is added in this circuit. A dust-collection system is in place.

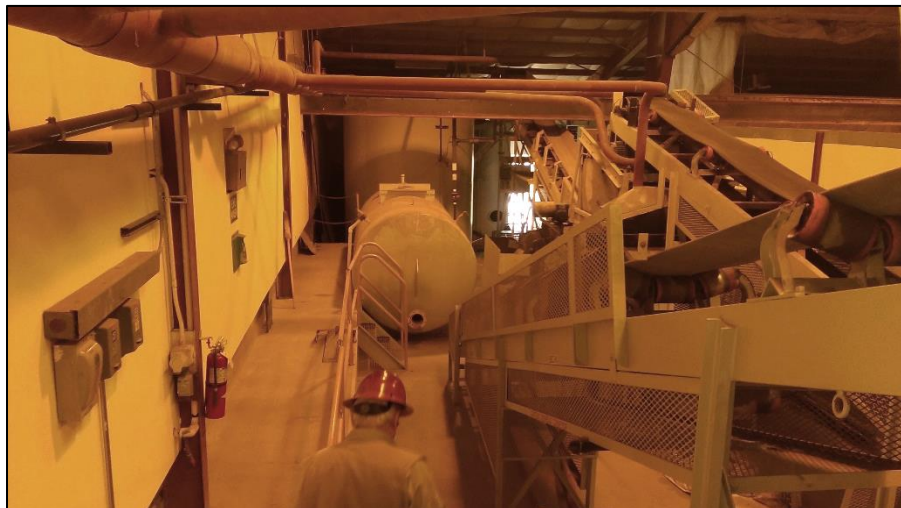
**Photo 14.** View inside mill showing closed-circuit crushing plant. No water is added in this circuit. A dust-collection system is in place (including red pipeline shown at top of photo).

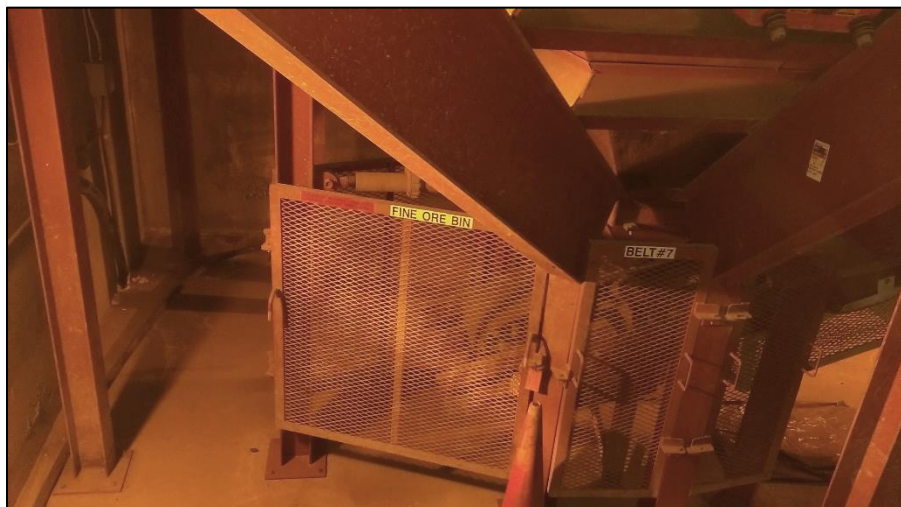
**Photo 15.** View inside mill showing fine ore bin where crushed ore is stored until conveyed to grinding circuit to complete comminution process.

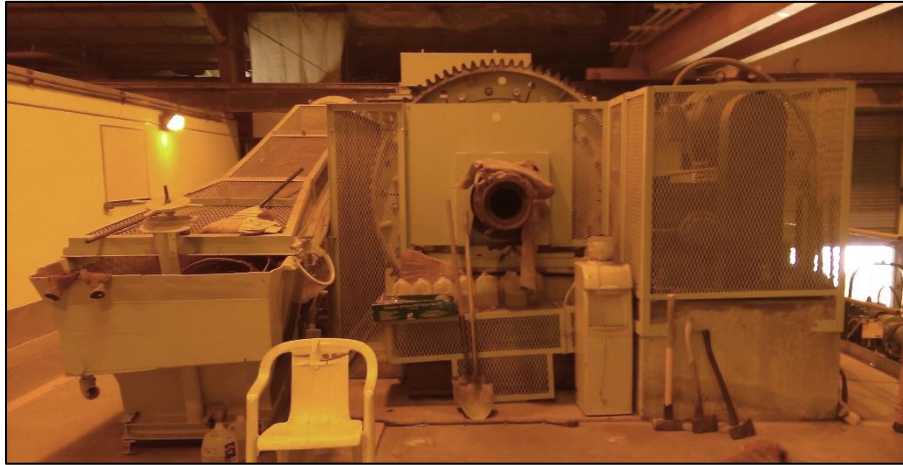
**Photo 16.** View inside mill showing closed-circuit grinding plant, which includes a ball mill and a spiral classifier. Fresh water is added to ore at this phase for wet grinding. Soda ash is added to control pH levels.

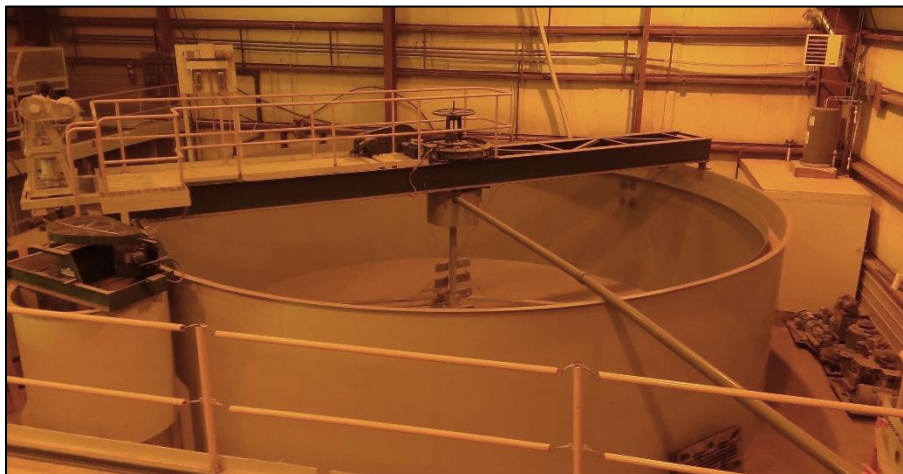
**Photo 17.** View inside mill showing large thickener tank where overflow from shaking table carries suspended, finely divided fraction of pulverized ore. This tank clarifies mill water which is returned to ball mill for recycling, and increases concentration of suspended solids prior to flotation.

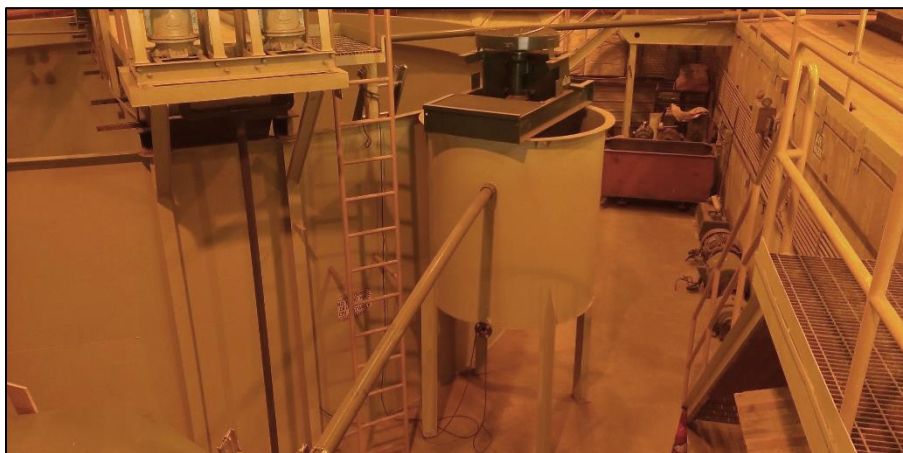
**Photo 18.** View inside mill showing conditioner tank (adjacent to thickener tank) where reagents are added to pulp before entering flotation circuit. Most likely, reagents will include a readily soluble frothing oil (i.e., pine oil, cresol) and quick-acting promoting reagent (i.e., xanthate).

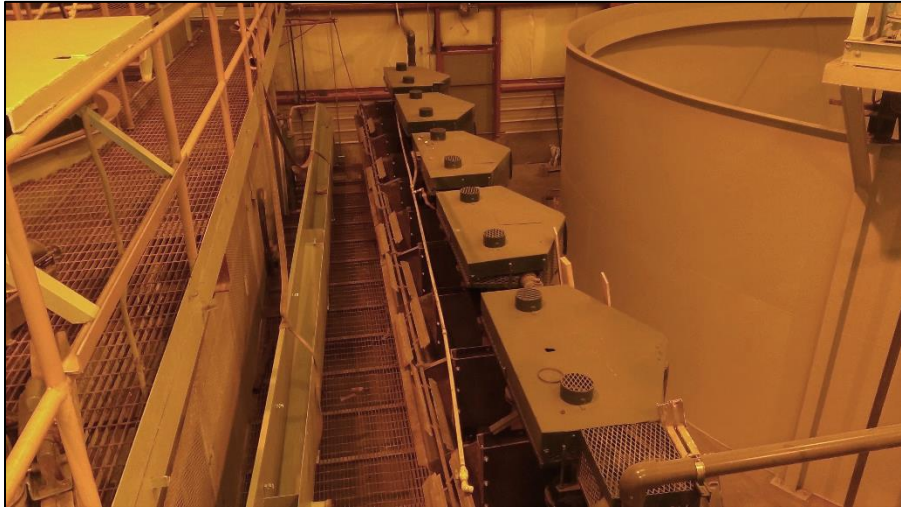
**Photo 19.** View inside mill showing flotation circuit composed of 8 cells where conditioned pulp enters for final concentration. Final concentrate pulp is collected for filtration, while tailings are pumped to tailings impoundment.

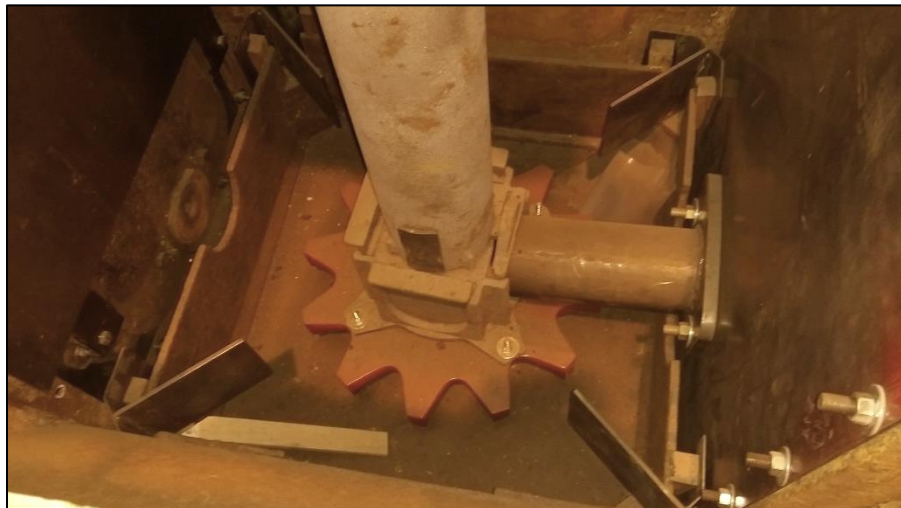
**Photo 20.** View inside one of eight cells in the flotation circuit showing agitator at center.

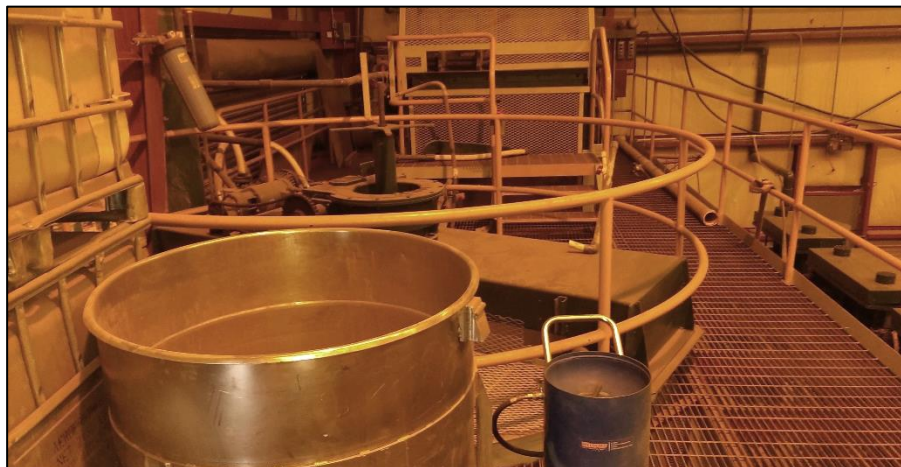
**Photo 21.** View inside mill showing deck where concentrated pump enters a disc vacuum filter (in background) to dewater the concentrate in preparation for shipment.

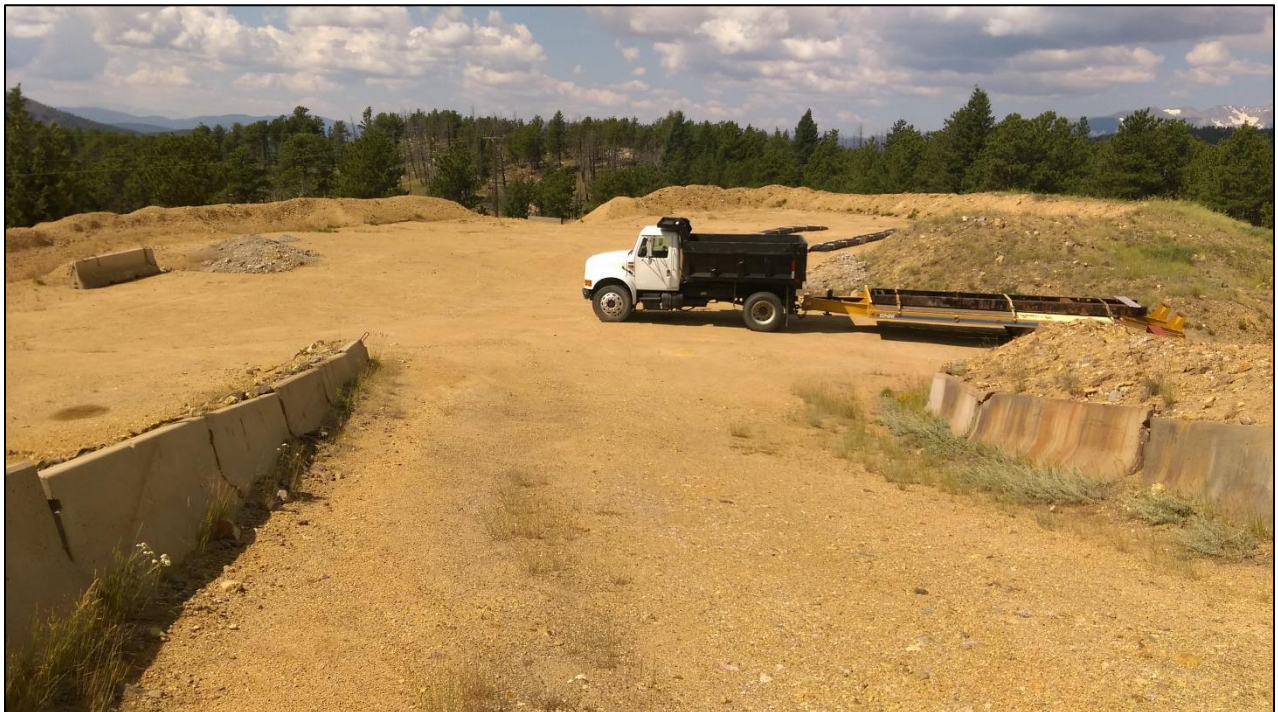
The Division observed the ore stockpile area located southwest of the mill building (**Photos 31-33**). According to the permit file, the material came from the permitted Cash Mine (located approximately 0.4 mile downhill from the mill). Mr. Steen estimates the stockpile to contain approximately 35,000-40,000 tons of material. A ramp connects the top of the stockpile to the two coarse ore bins located at the southwestern edge of the mill building. The stockpile appeared to be stable. No signs of acid rock drainage from the stockpile were observed.

**Photo 31.** View looking southwest from top of ramp at edge of mill building (near coarse ore bins), showing top of large ore stockpile.

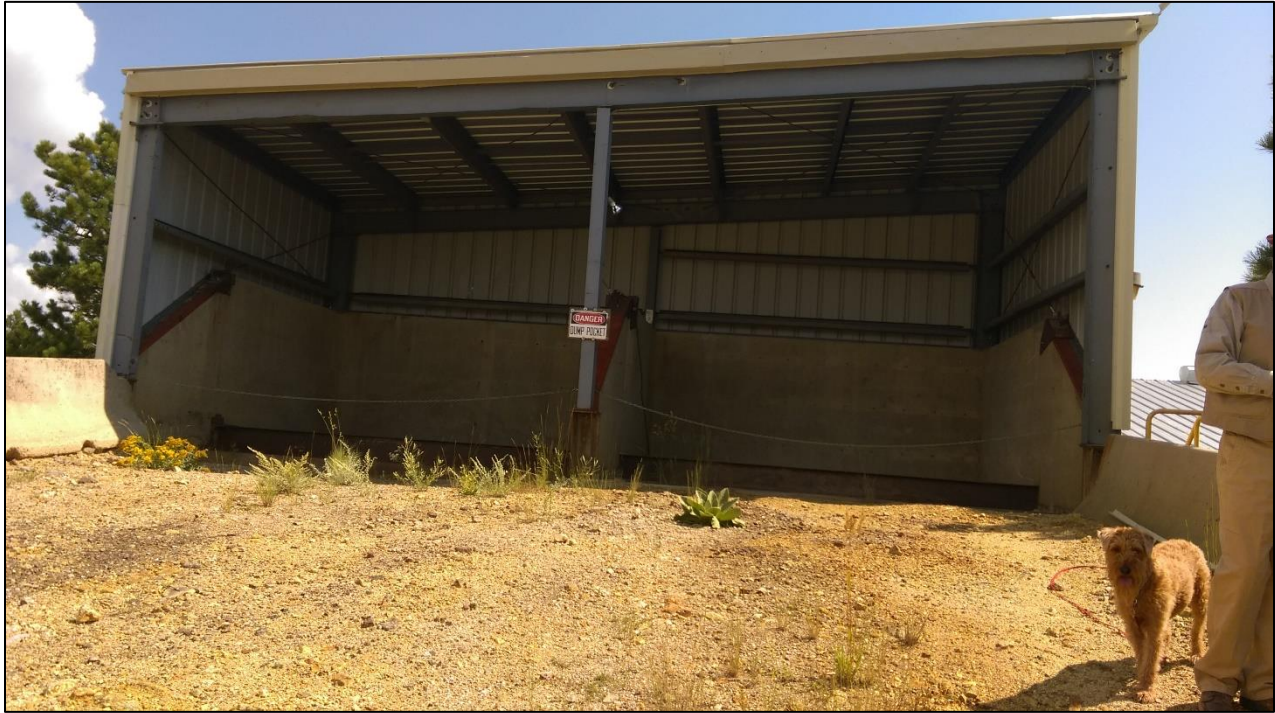
**Photo 32.** View of two coarse ore bins located at top of ramp on southwestern edge of mill building.
