MINERALS PROGRAM INSPECTION REPORT
PHONE: (303) 866-3567

| MINE NAME: Sunnyside Gold Mine | MINE/PROSPECTING ID#: M-1977-378 | MINERAL: Lead, zinc, copper, iron | COUNTY: San Juan |
| INSPECTION TYPE: Multi Person Inspection | INSPECTOR(S): Lucas J. West | INSP. DATE: September 19, 2017 | INSP. TIME: 11:54 |

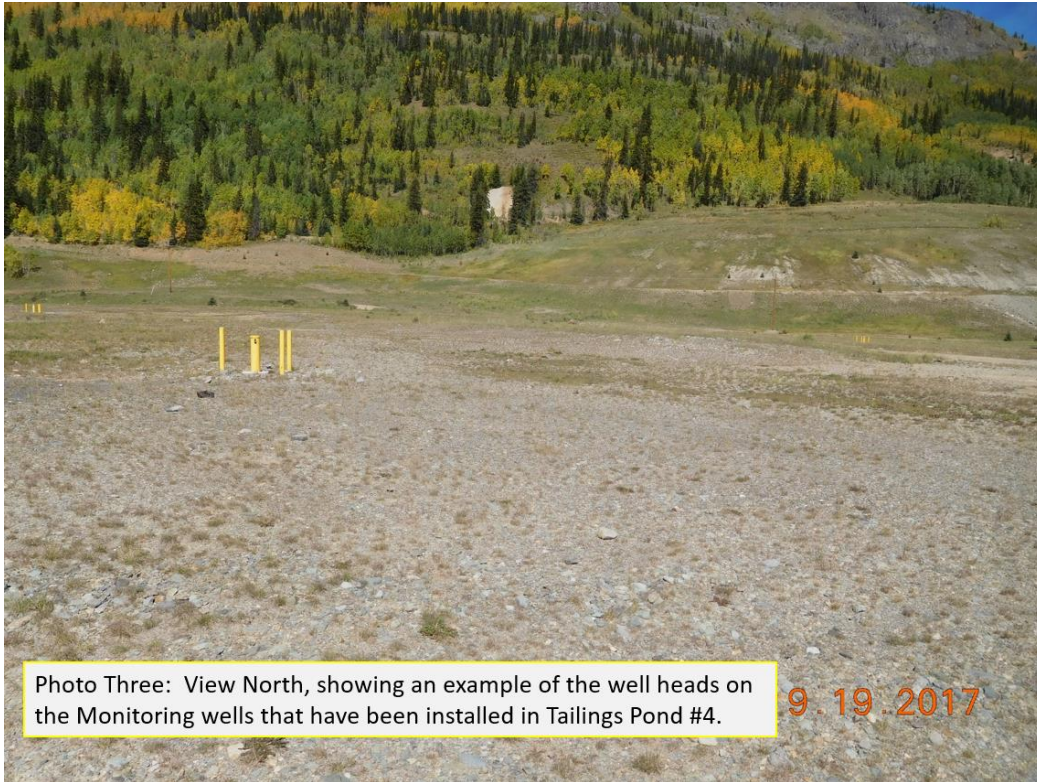
The side slopes and top of the constructed repository appear to be stable and are in good condition. Photos One and Two show the top of the repository which is well vegetated and showing signs of self-sustainment with previous years biomass observed. The operator expressed that vegetation management is ongoing and continuous, and evidence of chemical weed treatment was observed on site. 8 monitoring wells were observed on the top of the repository, all of which were properly collared and secured. Photo Three shows an example of the covers on the wells. The repository exhibits positive drainage and no impounded storm water or erosional issues were noted. The upland diversion ditch was inspected and appeared to be functioning as designed.

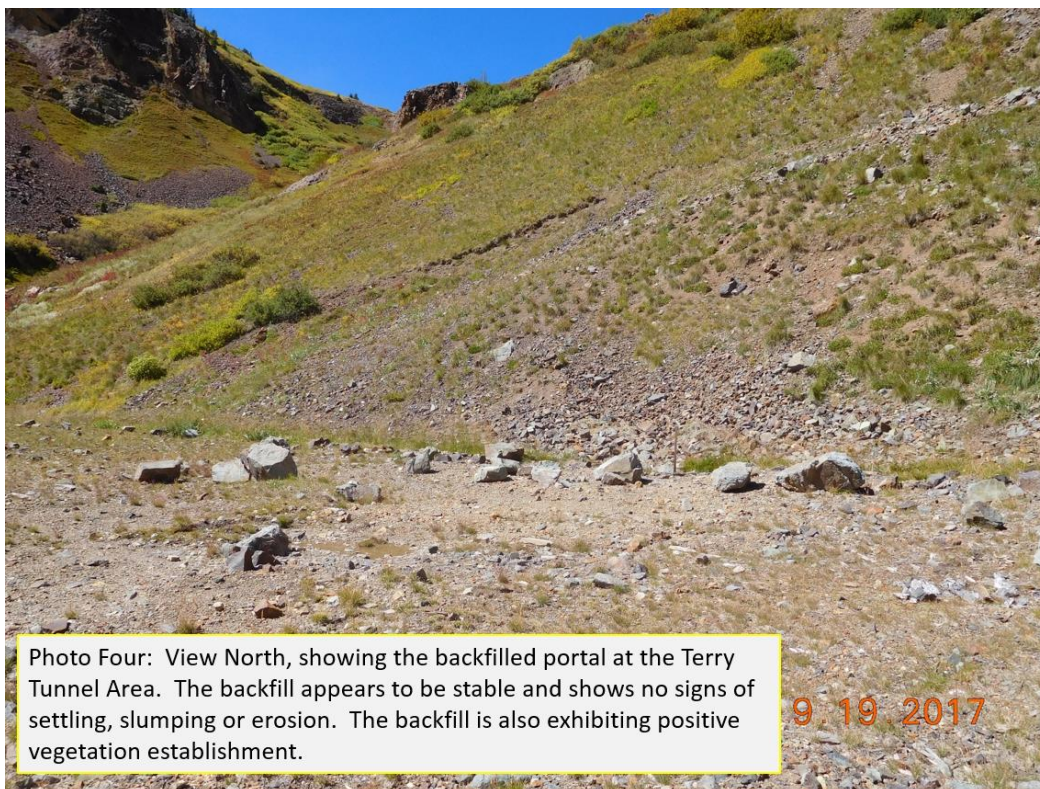
Terry Tunnel Area: The permit area at Terry Tunnel includes approximately 7 acres of affected lands in final reclamation. The permit area is located adjacent to Eureka Creek at 11,600 feet in elevation. The portal and portal pad pre-date the permit and connect with the workings from the American Tunnel. Topsoil was not salvaged during the pre-law mining activities and was not available for reclamation purposes. The portal was closed with two bulkheads and backfilled in accordance with the approved reclamation plan and the conditions of the Consent Decree. The reclamation of the portal was completed in 1996 and the portal can be seen in Photo Four. The mine bench was graded to provide positive drainage, stabilize slopes, and blend with the surrounding topography. The operator imported and distributed earthen materials to support revegetation efforts. Affected lands have been reseeded several times but due to an extremely short growing season and grazing by sheep in the area, revegetation has been difficult to establish. The portal pad with limited vegetative cover can be seen in Photo Five. Although the vegetation is sparse, it has improved since the previous inspection conducted by the Division.

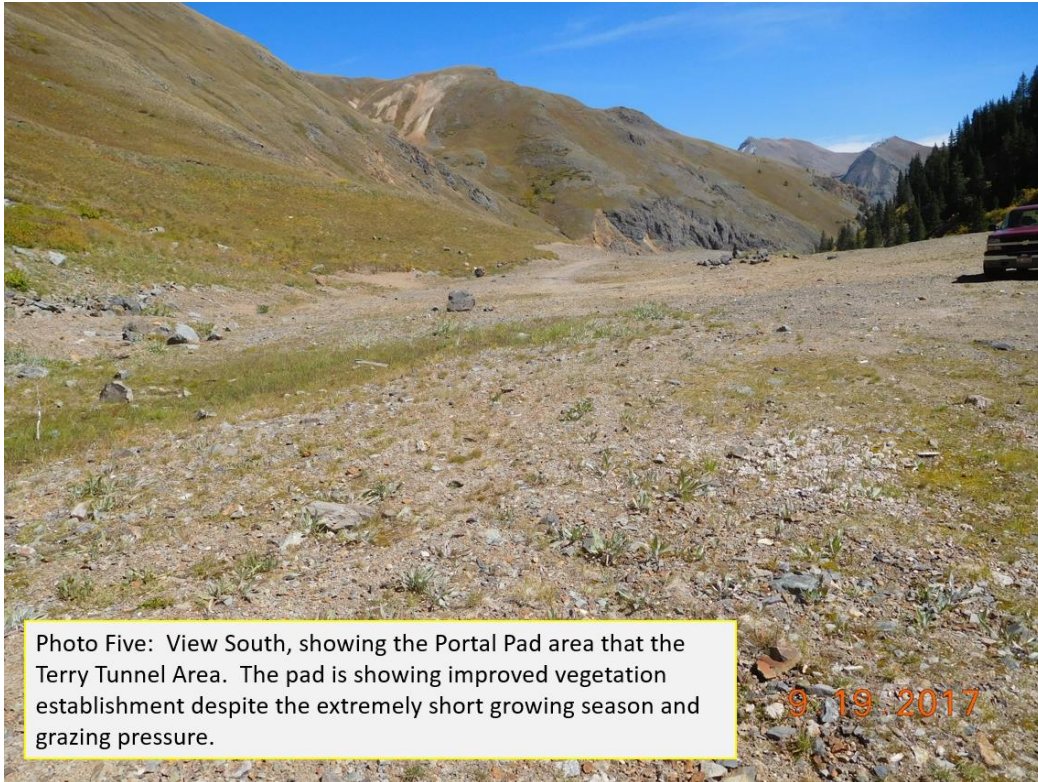
noted during the inspection. Despite the extremely short growing season, grazing from sheep in the area and unrestricted tourist traffic the vegetative cover of the affected area is very well established. The vegetation appears to be adequate in both density and diversity, and shows signs of multiple year's biomass indicating that the populations are self-sufficient. No erosional issues or noxious weeds were observed in this area. The reclaimed areas can be seen in Photos Six.
