**MINERALS PROGRAM INSPECTION REPORT**  
**PHONE: (303) 866-3567**

<b>MINE NAME:</b> Caliche School Pit	<b>MINE/PROSPECTING ID#:</b> M-1989-023	<b>MINERAL:</b> Sand and gravel	<b>COUNTY:</b> Logan
<b>INSPECTION TYPE:</b> Monitoring	<b>INSPECTOR(S):</b> Jared L. Ebert	<b>INSP. DATE:</b> October 12, 2017	<b>INSP. TIME:</b> 11:15
<b>OPERATOR:</b> Kristine M Couch	<b>OPERATOR REPRESENTATIVE:</b> Kristine Couch	<b>TYPE OF OPERATION:</b> 110c - Construction Limited Impact	
<b>REASON FOR INSPECTION:</b> Normal I&E Program	<b>BOND CALCULATION TYPE:</b> Complete Bond	<b>BOND AMOUNT:</b> \$43,000.00	
<b>DATE OF COMPLAINT:</b> NA	<b>POST INSP. CONTACTS:</b> None	<b>JOINT INSP. AGENCY:</b> None	
<b>WEATHER:</b> Clear	<b>INSPECTOR'S SIGNATURE:</b>

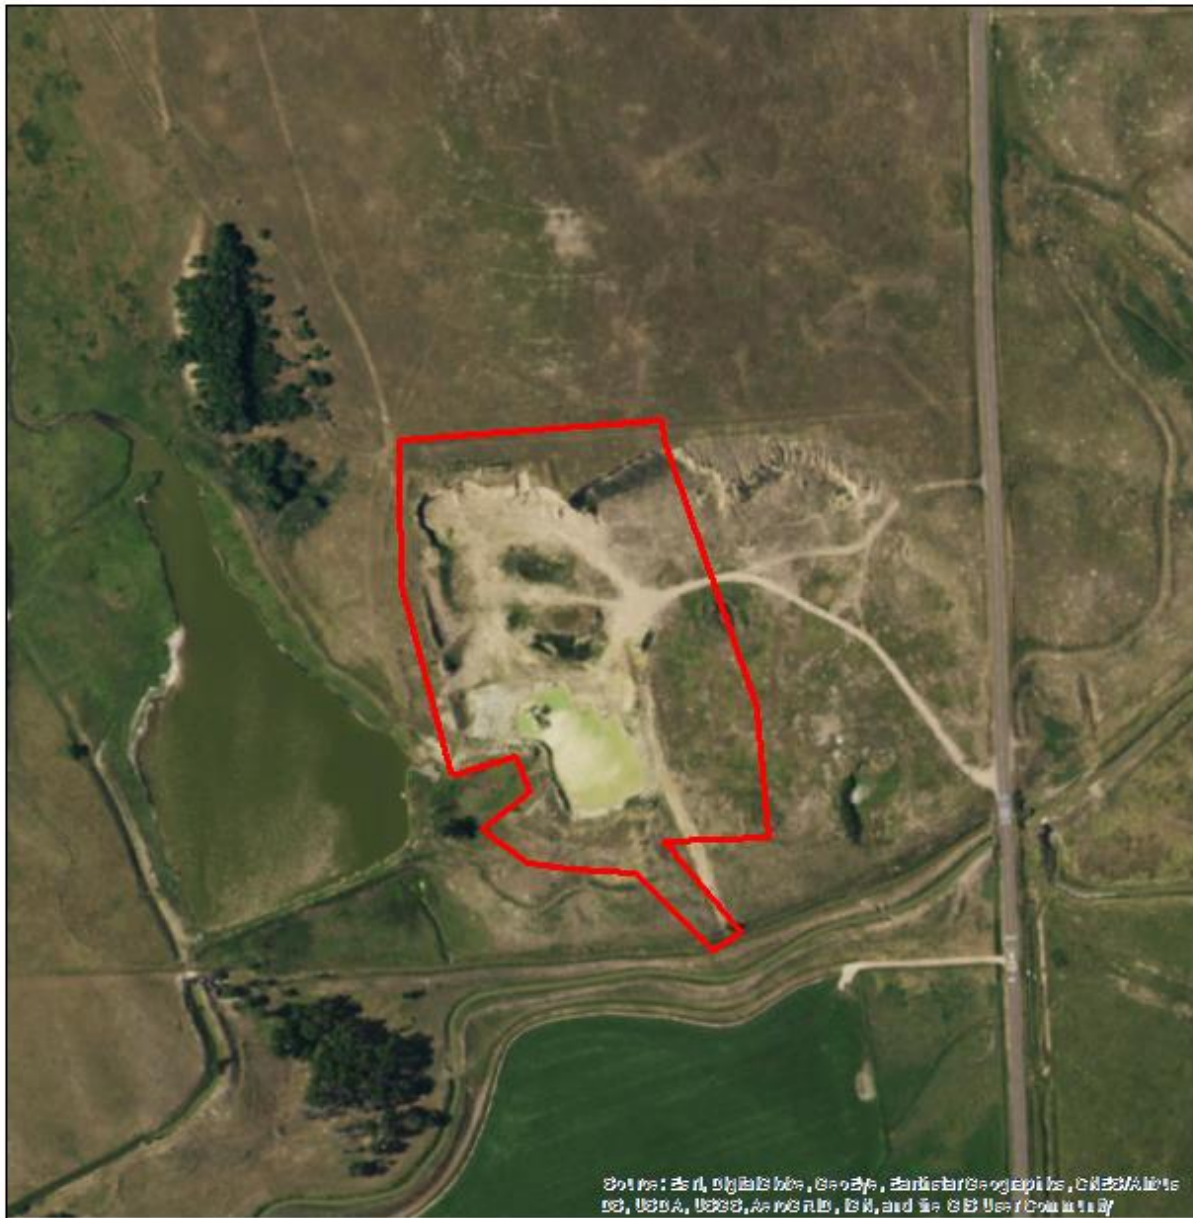
Mrs. Couch owns an augmentation pond that is adjacent to the permit area. Given the hydrologic conditions of the site it appears water from her pond has seeped into the pit area. It appears a small trench has been created on the south end of the site to help drain the pond to the adjacent ditch. However the inlet to the trench is above the pooled water in the pit. Mrs. Couch indicated that they intend to excavate the trench deeper to help drain the water collected in the bottom of the pit.

Figure 5. Trench from bottom of the pit, view from the south end looking north.
