MINERALS PROGRAM INSPECTION REPORT

MINE NAME: Lamar West Pit	MINE/PROSPECTING ID#: M-1981-132	MINERAL: Sand and gravel	COUNTY: Prowers
INSPECTION TYPE: Monitoring	INSPECTOR(S): Amy Eschberger	INSP. DATE: November 27, 2017	INSP. TIME: 11:00
OPERATOR: Valco, Inc.	OPERATOR REPRESENTATIVE: Tom Brubaker	TYPE OF OPERATION: 112c - Construction Regular Operation

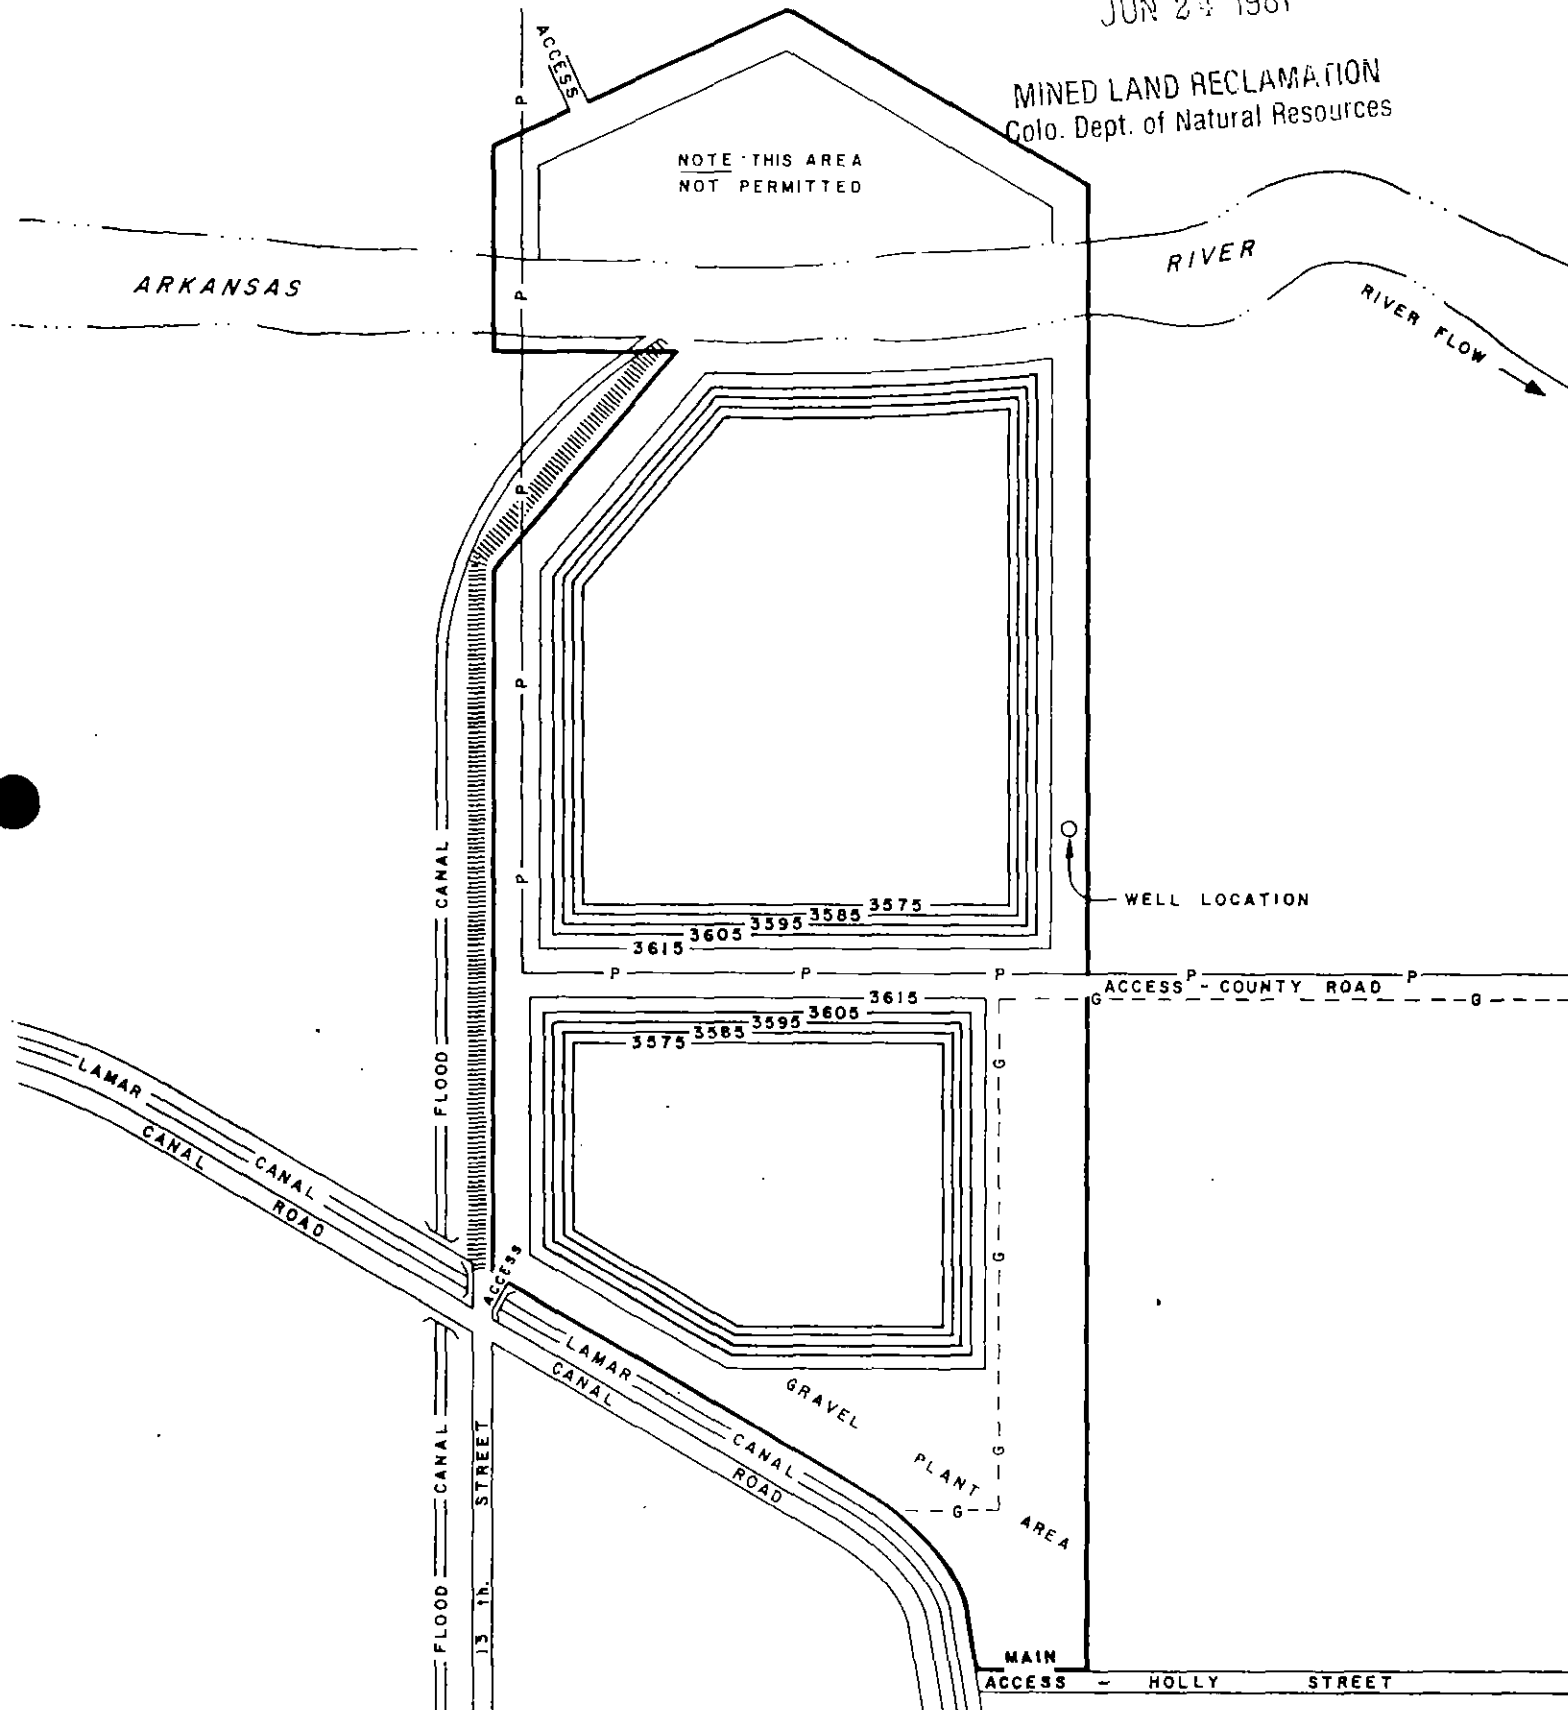
LAMAR - WEST PIT RECLAMATION MAP

The approved post-mining land use for the site is wildlife habitat. The reclamation plan calls for leaving two ponds approximately 40 feet deep (see enclosed reclamation plan maps). A pond up to 15.8 acres in size will remain in the mining phase 1 area, and a pond up to 27.6 acres in size will remain in the area of mining phases 2 and 3. Pond shorelines will be graded to 3H:1V or flatter. Excess overburden, if available, will be used to add sinuosity to the shoreline. Topsoil will be replaced on disturbed areas at a depth of 9-15 inches to the waterline. Per recommendations by the local Soil Conservation Service, revegetation of the site is divided into two separate programs, one for heavier soils present in the southern half of the site, and the other for sandy soils with limited topsoil present in the northern half of the site. Disturbance in the southern half of the site will be seeded with tall wheatgrass and switchgrass. Disturbance in the northern half of the site will be seeded with switchgrass and sideoats grama. A straw mulch or agronomy blanket will be used to protect seeded areas. Access roads will remain for use by the landowner.

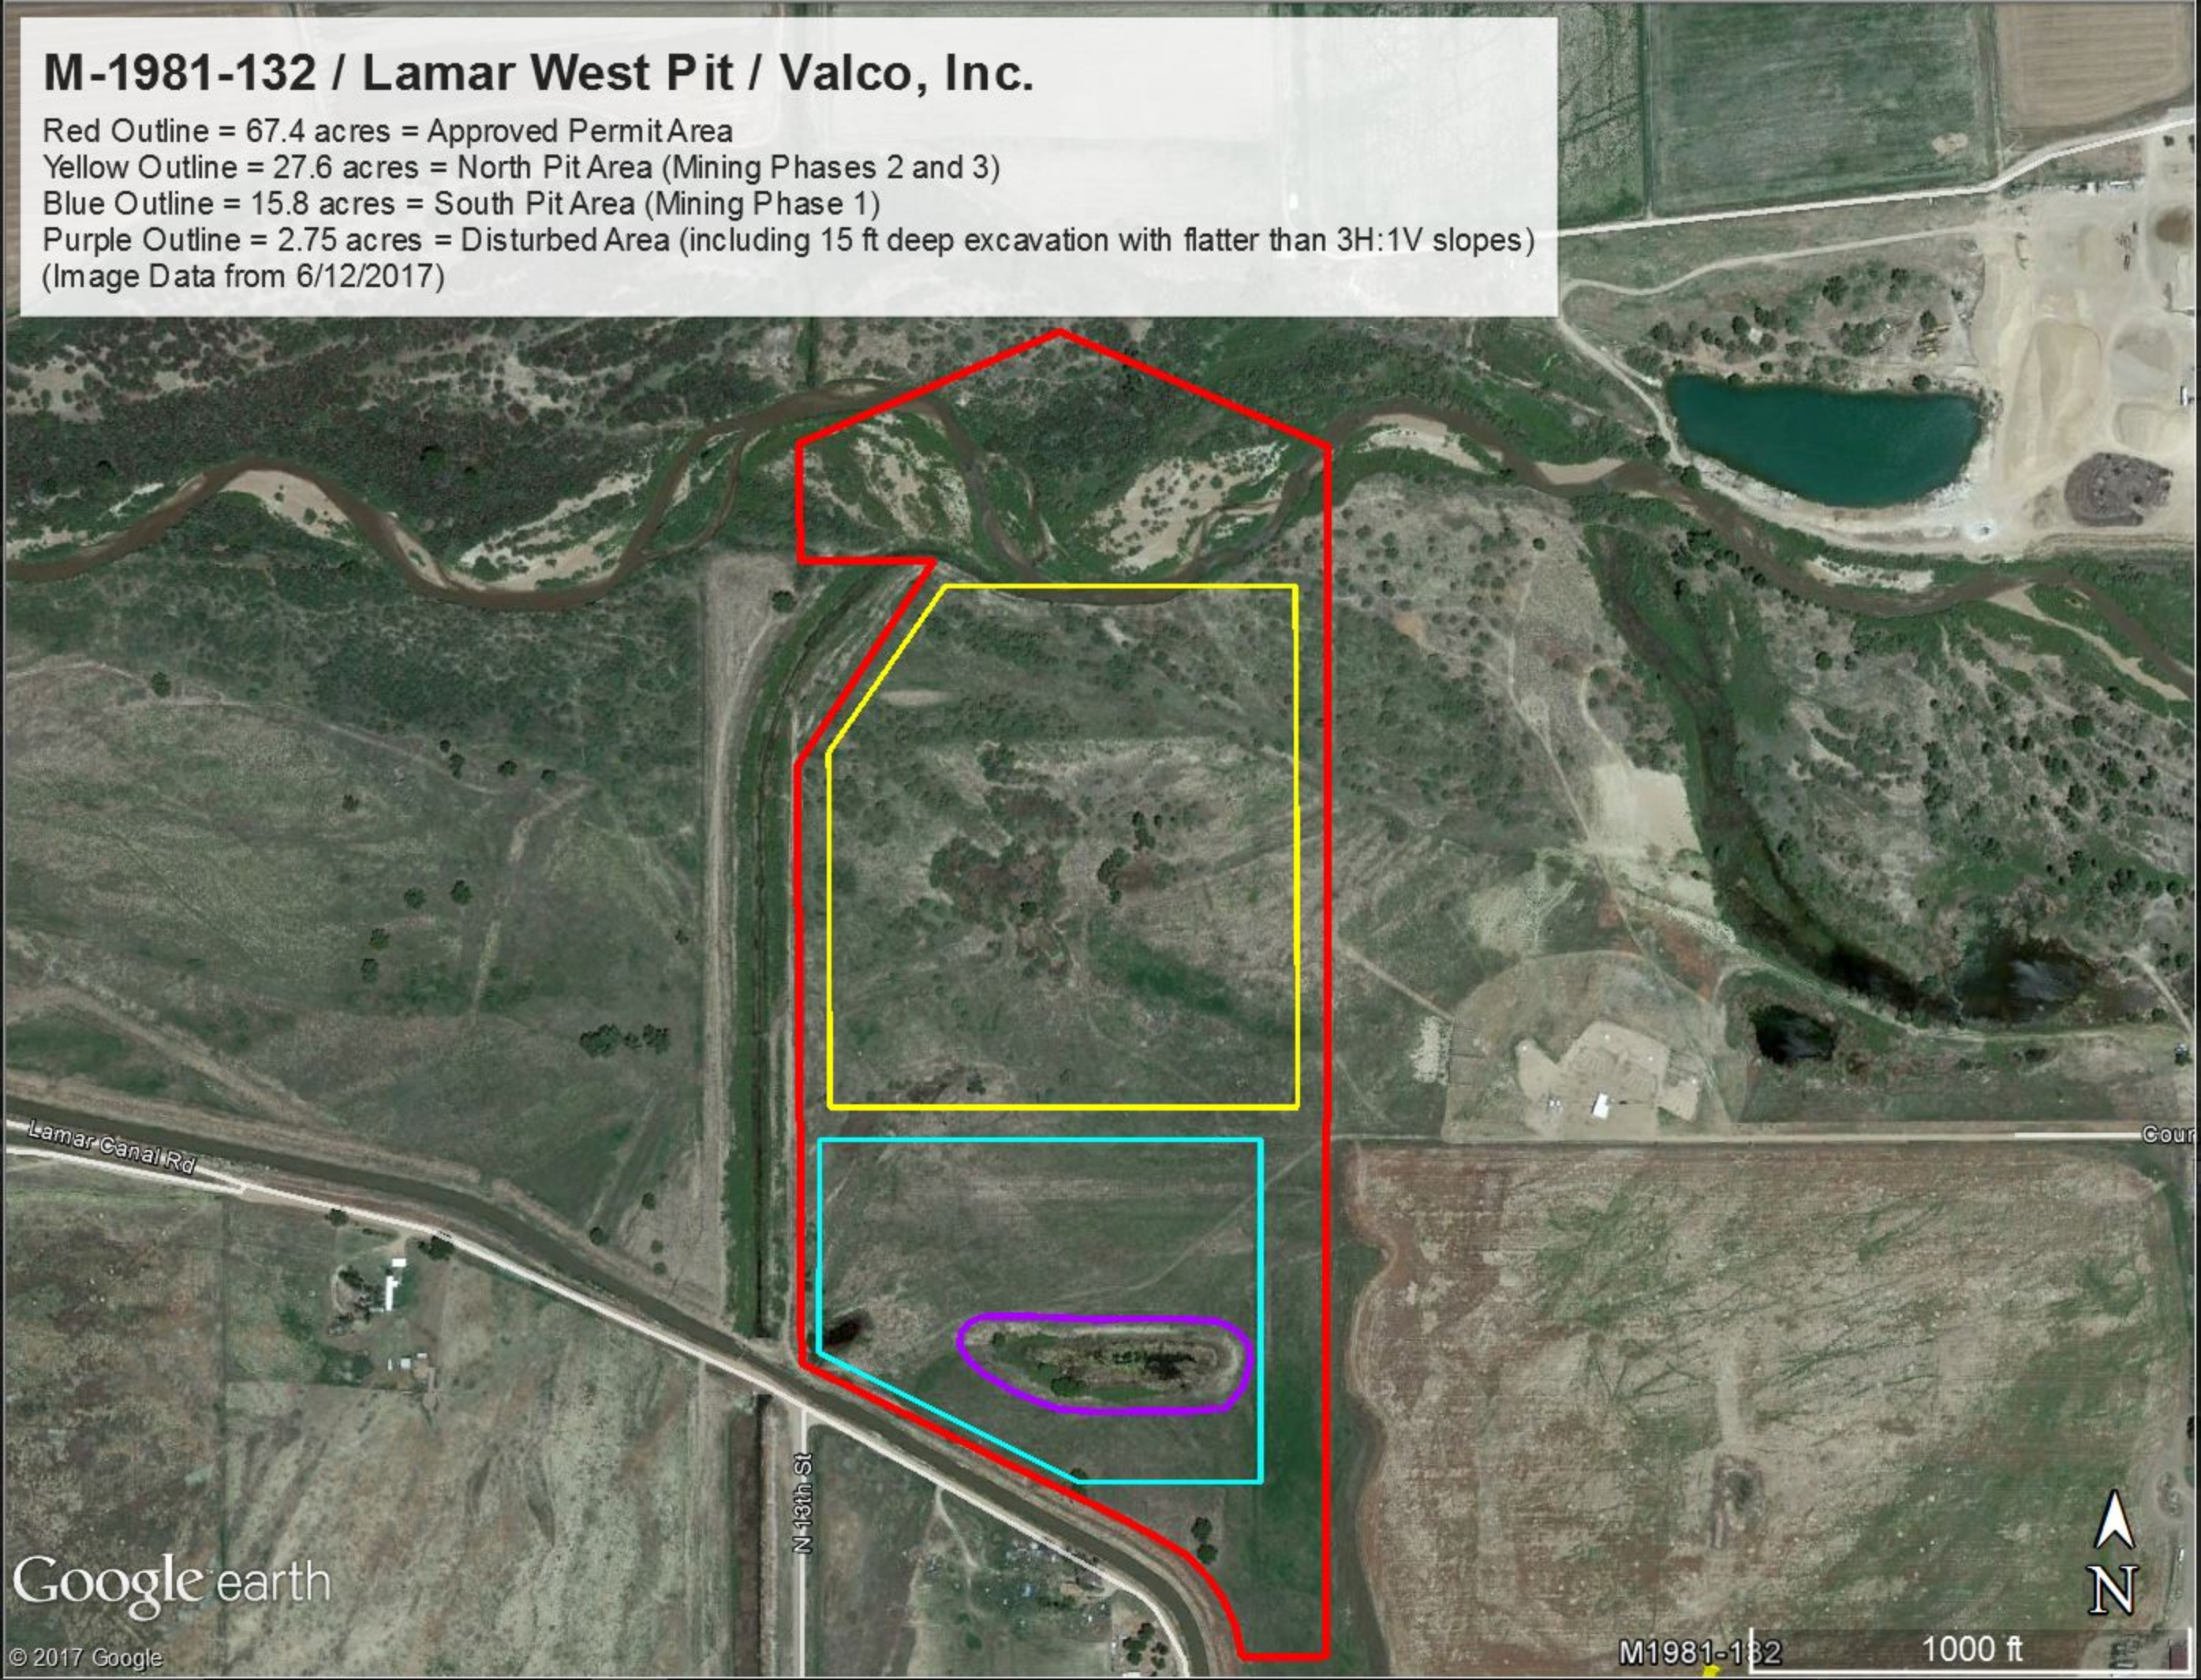
The Division would recommend the operator submit a full release request for the site, except that a problem was identified which will require corrective action before the site could be released. The Division observed the pit to be holding some water during the inspection. The Division estimated the water to be approximately one foot in depth and its surface area to be no more than one acre in size. During the past few inspections of the site, the pit

was observed to be dry. However, in review of historic imagery of the site in Google Earth, it appears the excavation has held water at times, at least as far back as 1988. Based on this information, the lack of precipitation in the region in recent weeks, and the presence of wetland vegetation on the pit floor, the Division believes the water is exposed groundwater.

Purple Outline = 2.75 acres = Disturbed Area (including 15 ft deep excavation with flatter than 3H:1V slopes)

The Division received a letter from the Office of the State Engineer (SEO) on September 24, 1981 with comments regarding the application submittal. At that time, the SEO indicated the operator would need to obtain a well permit and a water court approved plan for augmentation for the proposed unlined ponds. However, no well permit or plan for augmentation has been obtained for the site. Therefore, the Division is citing a problem in this report pursuant to Rule 3.1.6(1)(a) for failure to comply with applicable Colorado water laws and regulations governing injury to existing water rights. The operator will need to either demonstrate compliance with the SEO with regard to exposed groundwater on the site, or backfill the pit to two feet above the groundwater level.
