## MINERALS PROGRAM INSPECTION REPORT

<b>MINE NAME:</b> Midwestern Farms	<b>MINE/PROSPECTING ID#:</b> M-1993-059	<b>MINERAL:</b> Sand and gravel	<b>COUNTY:</b> Prowers
<b>INSPECTION TYPE:</b> Surety-Related Inspection	<b>INSPECTOR(S):</b> Amy Eschberger	<b>INSP. DATE:</b> October 5, 2017	<b>INSP. TIME:</b> 08:45
<b>OPERATOR:</b> Midwestern Farms	<b>OPERATOR REPRESENTATIVE:</b> David King	<b>TYPE OF OPERATION:</b> 112c - Construction Regular Operation

# M-1993-059 / Midwestern Farms / Midwestern Farms

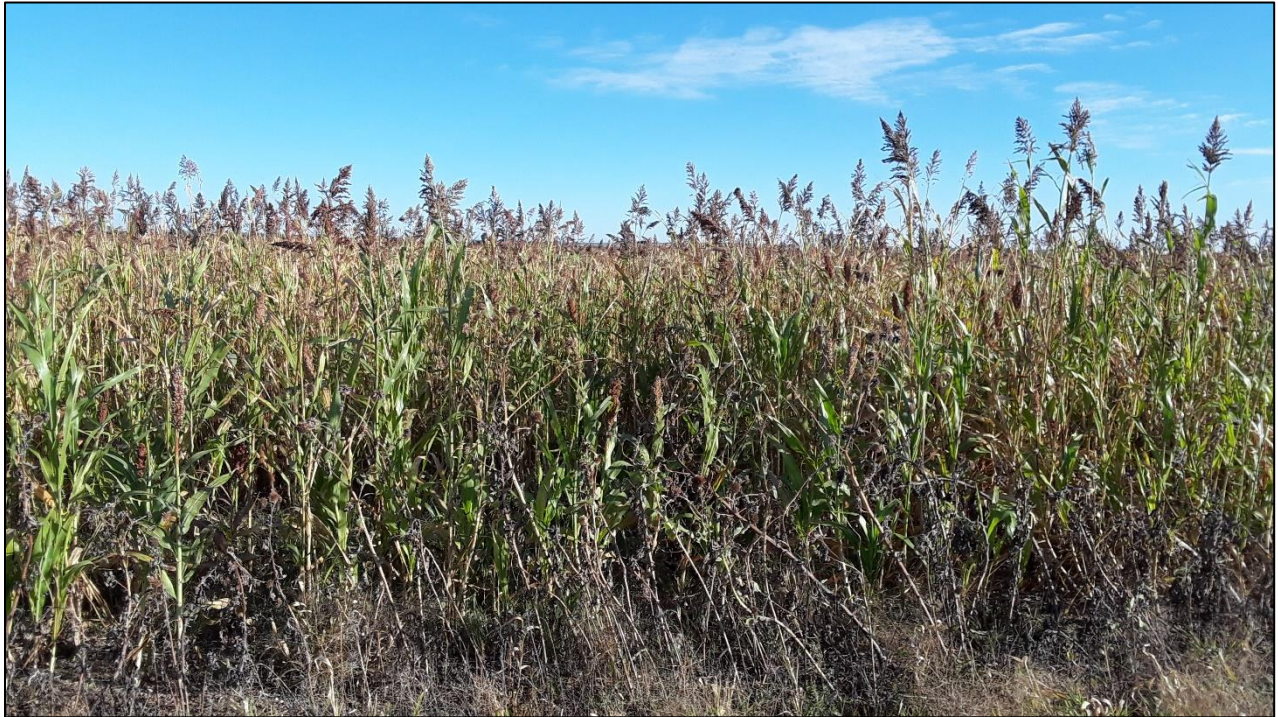
**Photo 1.** View of northwestern portion of disturbed area showing cover crop (sorghum) that was planted in early summer.

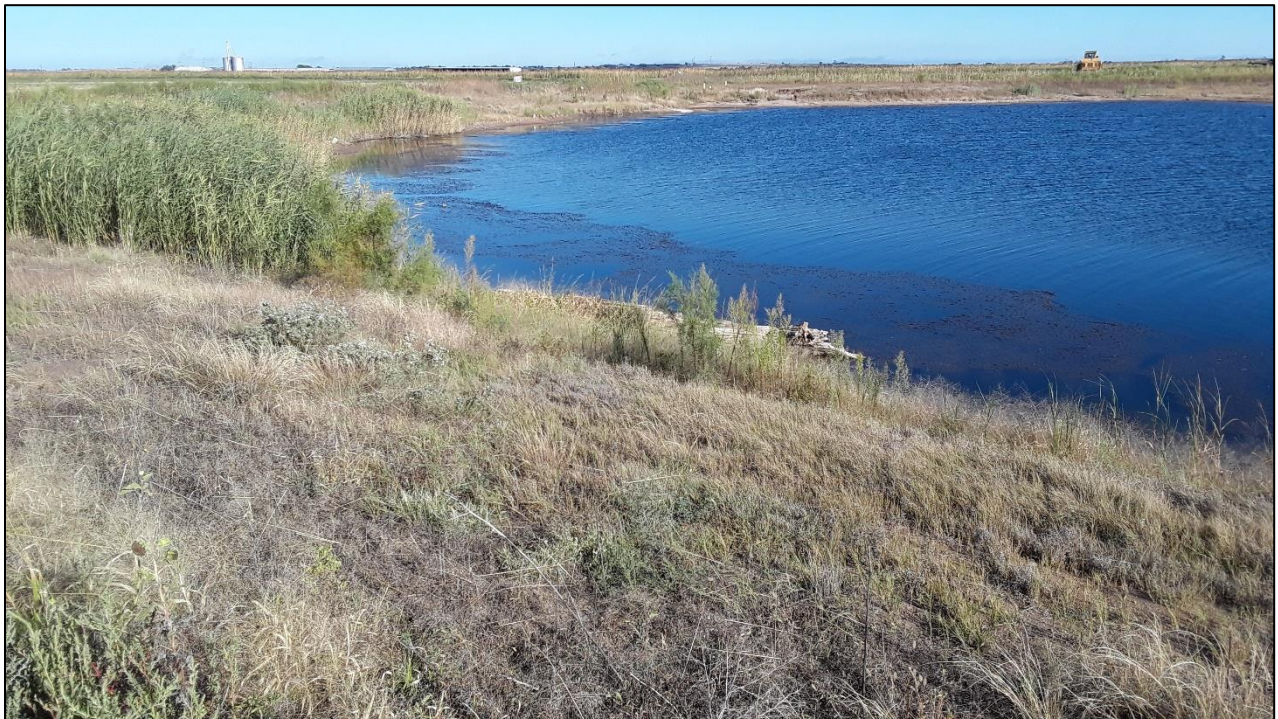
**Photo 2.** View looking north across western shoreline of western pond with slopes flatter than 3H:1V and vegetative cover consisting of native grasses, forbs, and weeds.

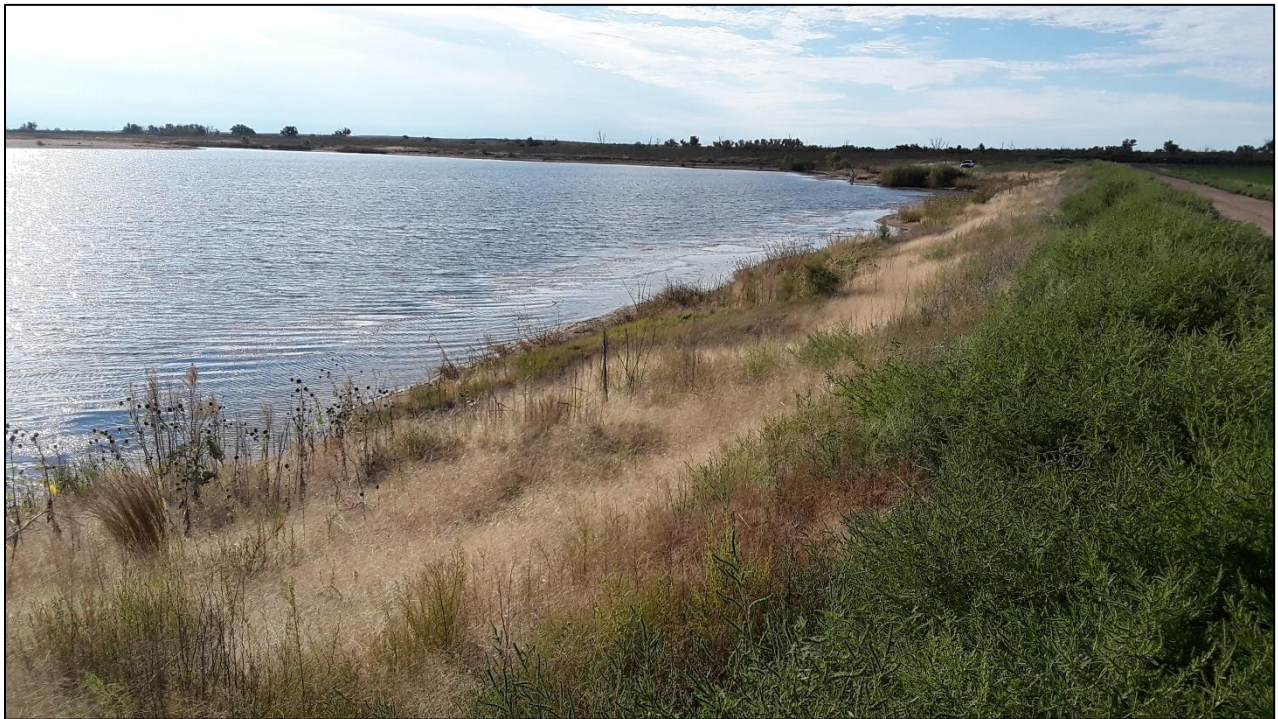
**Photo 6.** View looking south across western shoreline of western pond, showing slopes at 3H:1V or flatter with vegetative cover consisting of native grasses, forbs, and annual weeds.

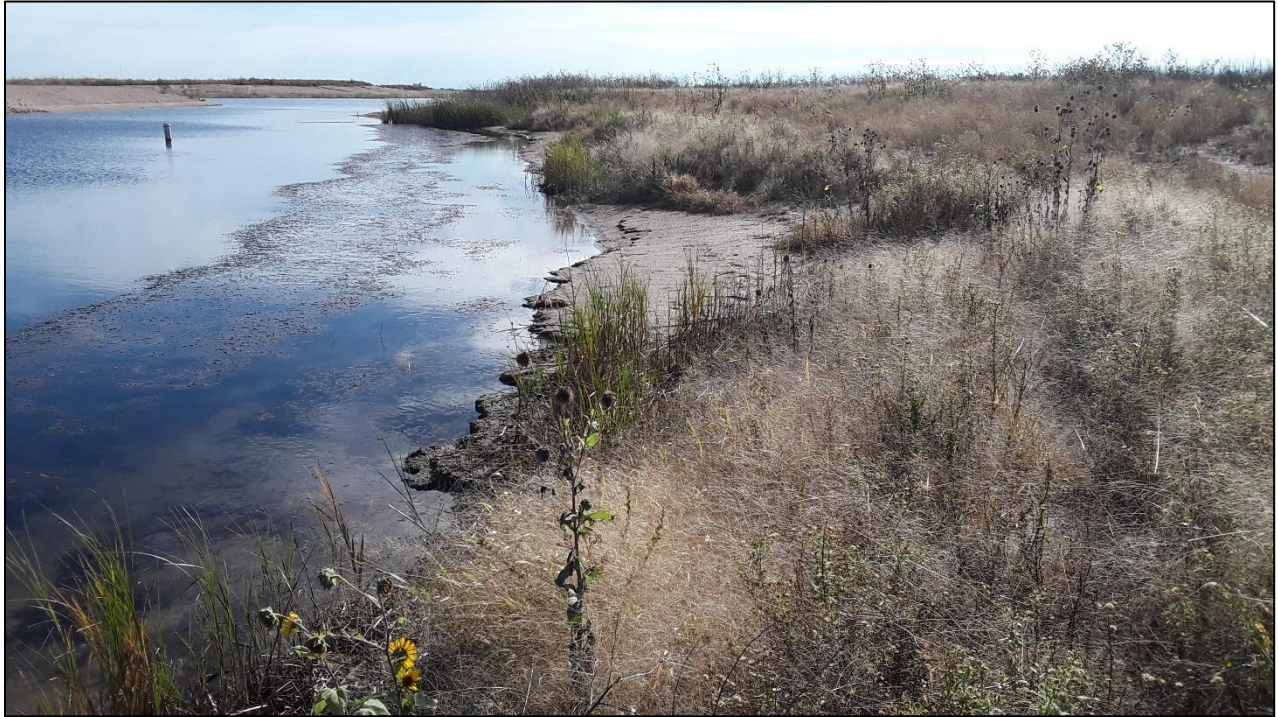
**Photo 7.** View looking east across southern shoreline of western pond, showing slopes at 3H:1V or flatter with vegetative cover consisting of native grasses, forbs, and annual weeds.

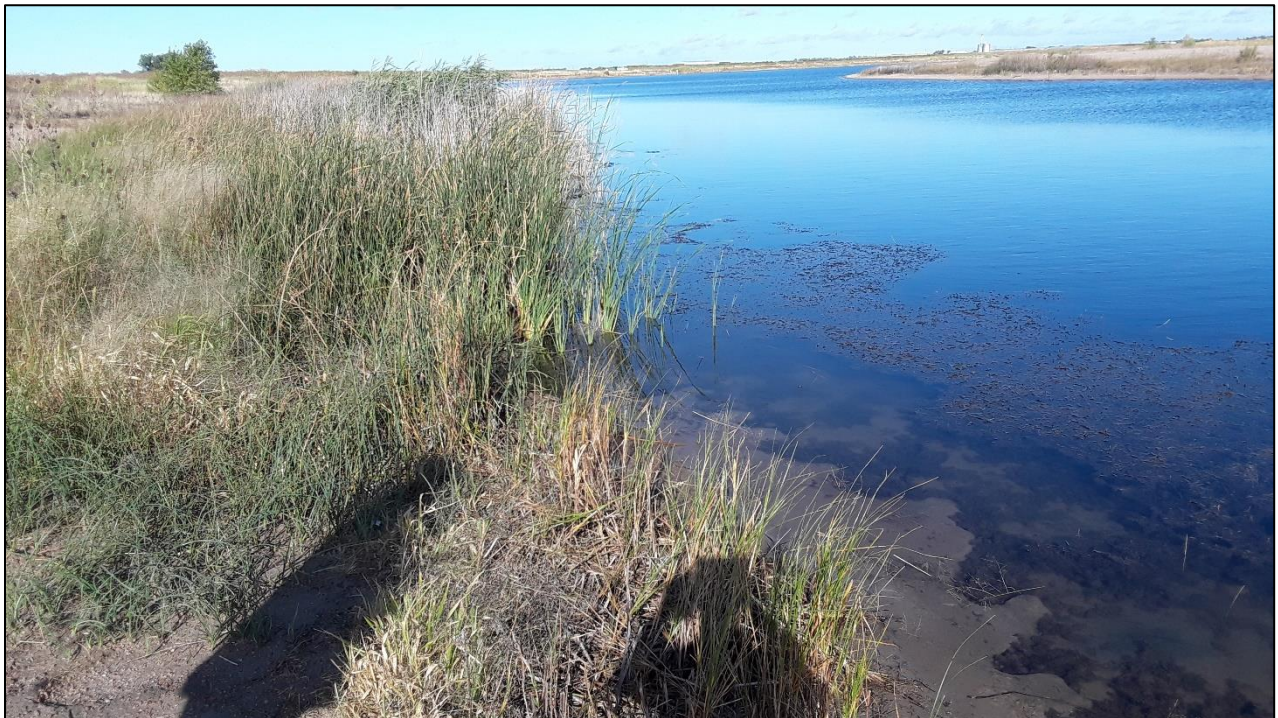
**Photo 8.** View looking west across southern shoreline of western pond, showing slopes at 3H:1V or flatter with vegetative cover consisting of native grasses, forbs, and annual weeds.

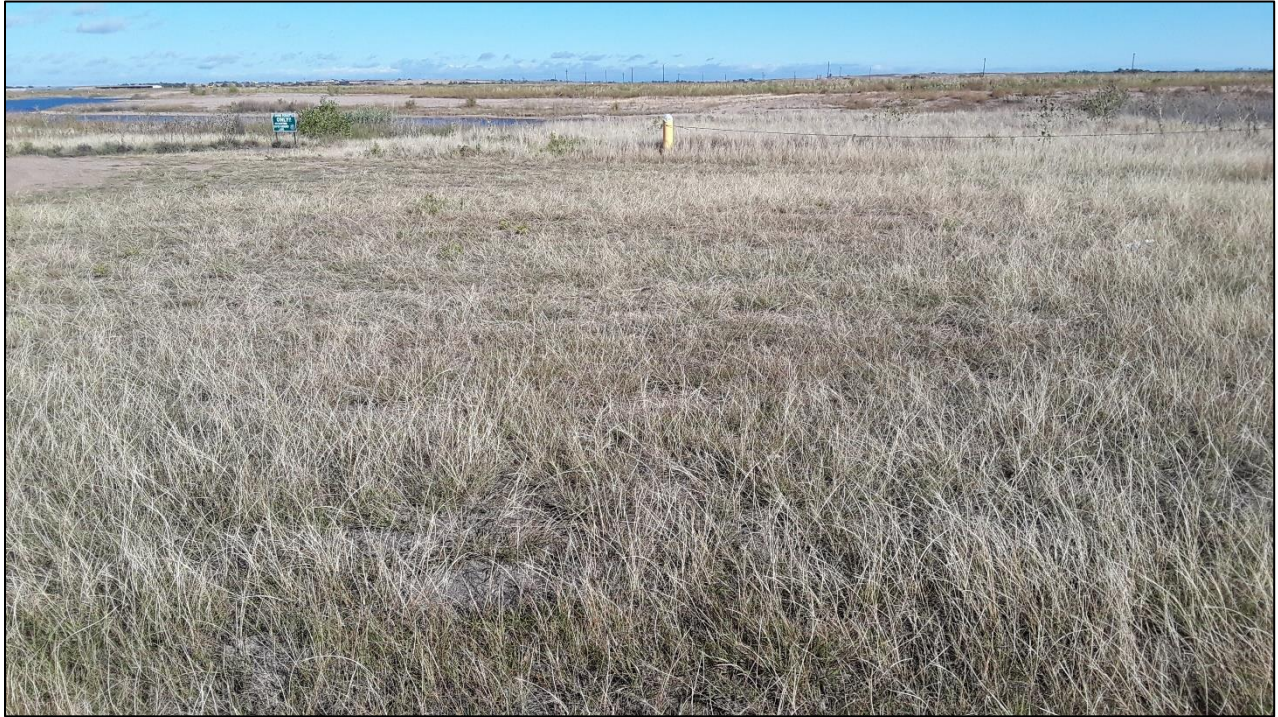
**Photo 9.** View looking north across disturbed land between pond and southern permit boundary with good establishment of native grasses.

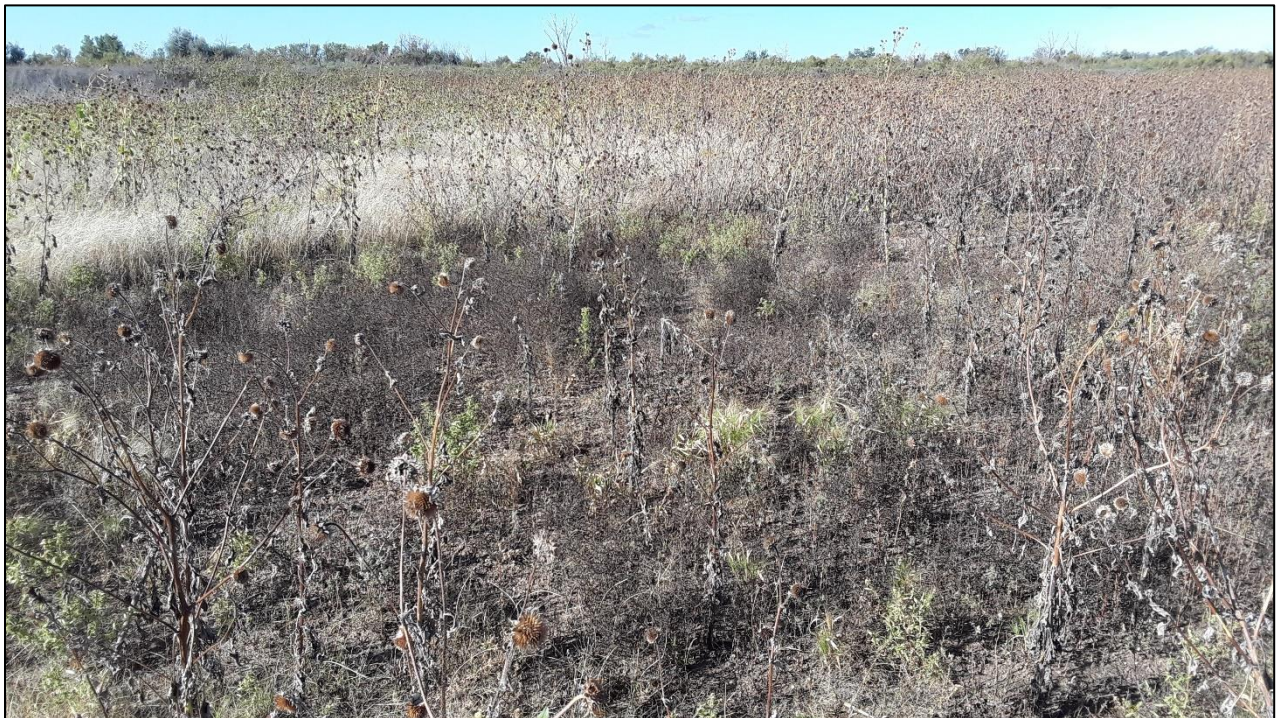
**Photo 10.** View looking west across disturbed land between pond and southern permit boundary with fewer native grasses and more annual weeds.

It should be noted the Division observed several weeds present on site, primarily annual weeds (i.e., Russian thistle, Kochia, wild sunflowers), but also a few state-listed noxious weed species (i.e., Tamarisk, Field bindweed). Some early growth Tamarisk trees were observed along the pond shoreline. Mr. King indicated the operator mechanically removed most of the Tamarisk trees that had been present on site last year. However, given the closeness of the site to the Arkansas River (a Tamarisk source) and site conditions, it will most likely require continual Tamarisk control efforts. Early growth Field bindweed was present particularly in the northeastern portion of the disturbed area. Pursuant to Rule 3.1.10(6), methods of weed control shall be employed for all prohibited noxious weed species, and whenever invasion of a reclaimed area by other weed species seriously threatens the continued development of the desired vegetation. Weed control methods shall also be used whenever the inhabitation of the reclaimed area by weeds threaten further spread of serious weed pests to nearby areas. Because the site is undergoing initial revegetation efforts, it is especially vulnerable to weed invasion. The Division recommends the operator implement the approved weed control plan at the site (especially for state-listed noxious weed species) as soon as possible, and continue to monitor the growth and spread of weeds in disturbed areas.

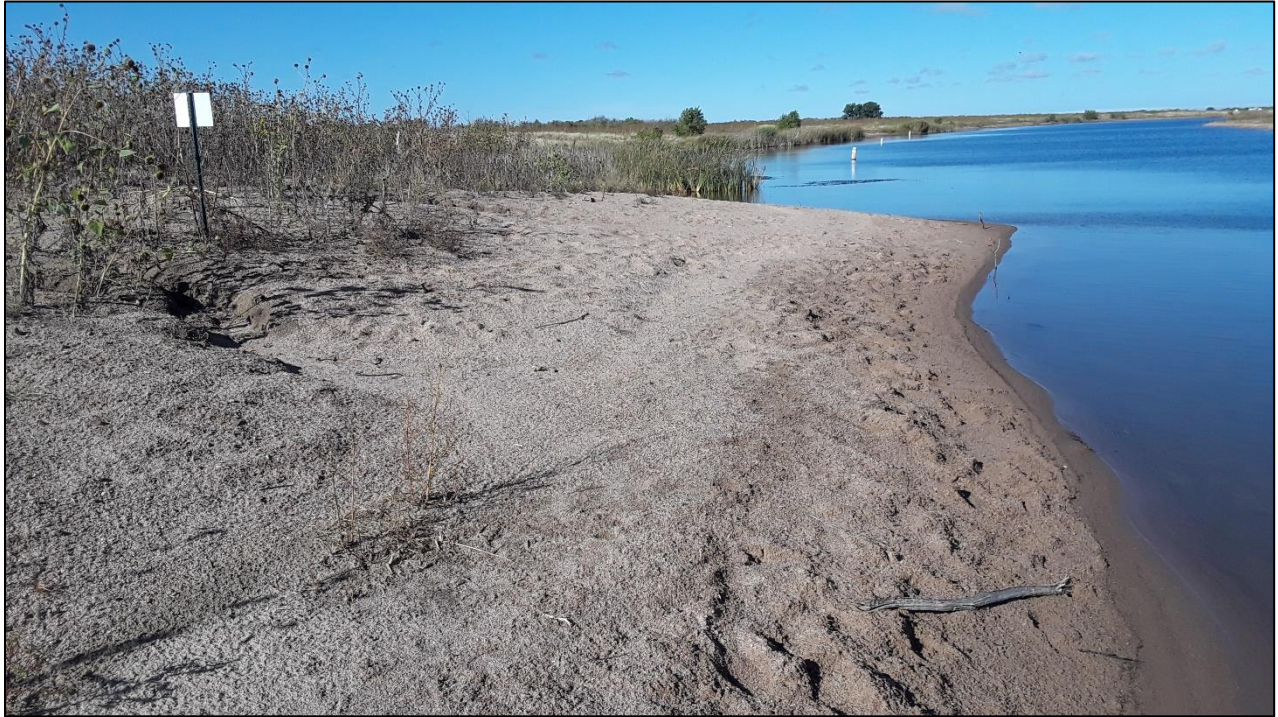
**Photo 13.** View looking west across southern shoreline of channel area between two ponds, showing slopes at 6H:1V as approved for this area.

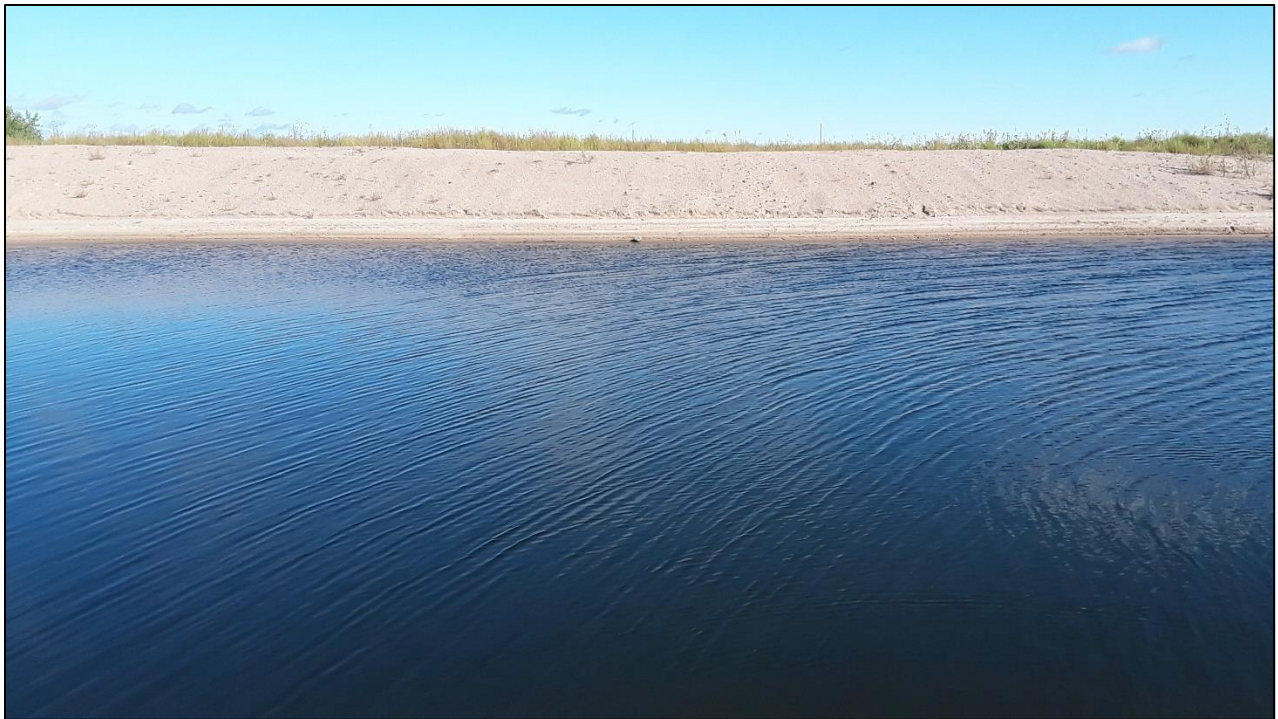
**Photo 14.** View looking north toward northern shoreline of channel area between two ponds, showing shoreline left as sandy beach as approved.

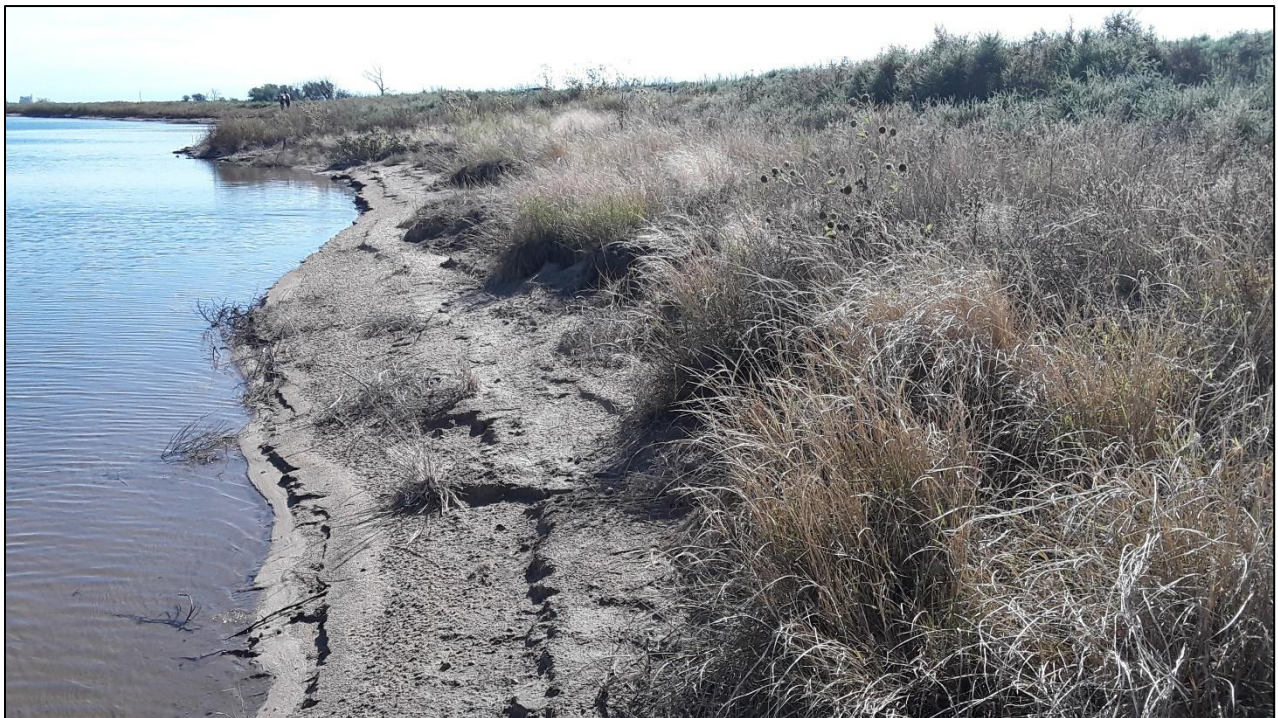
**Photo 16.** View looking east across southern shoreline of eastern pond where steep bank was knocked down and the shoreline graded to 3H:1V or flatter.

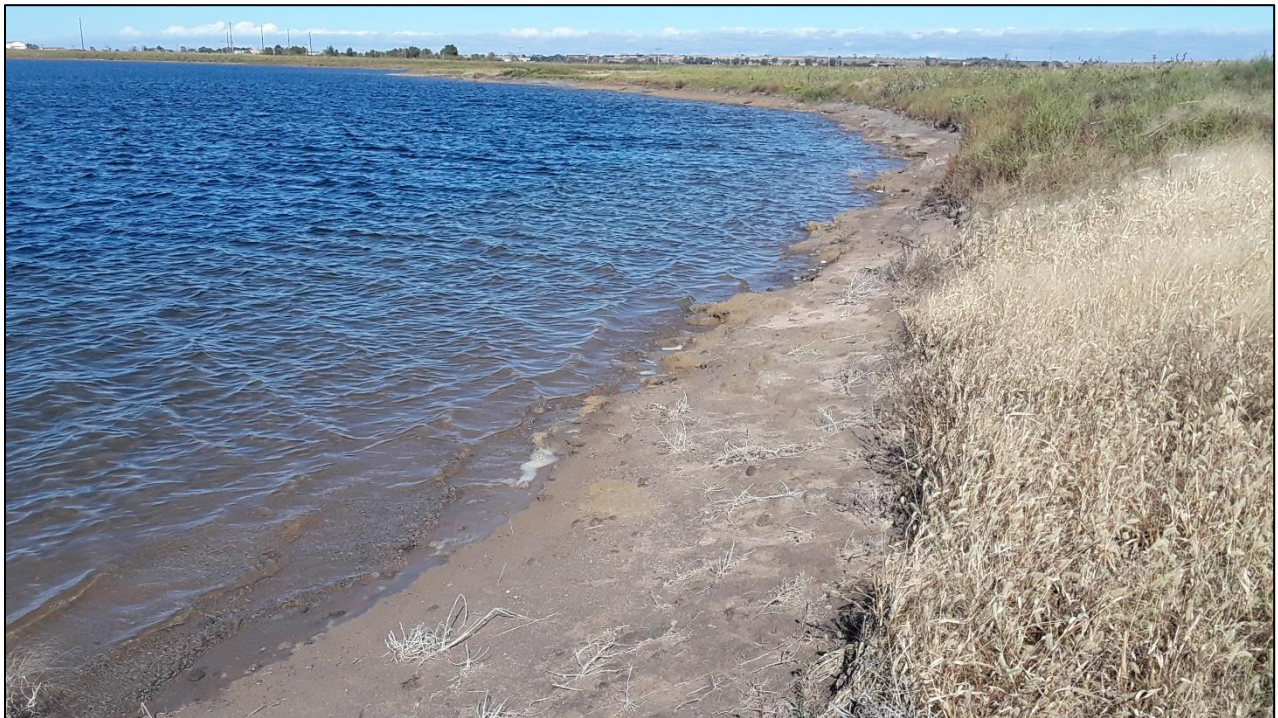
**Photo 20.** View looking north across portion of eastern shoreline of eastern pond graded to 6H:1V as approved.

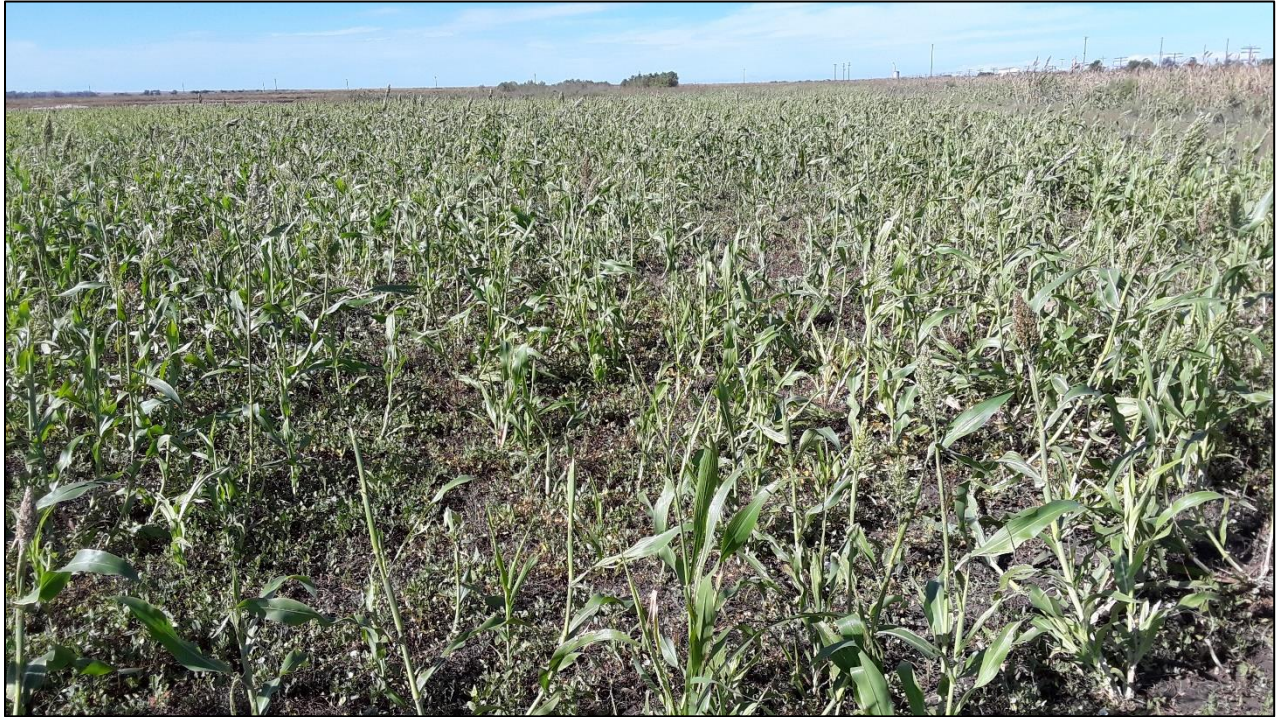
**Photo 21.** View looking west across northeastern portion of disturbed area, showing cover crop (sorghum) that was planted in early summer.

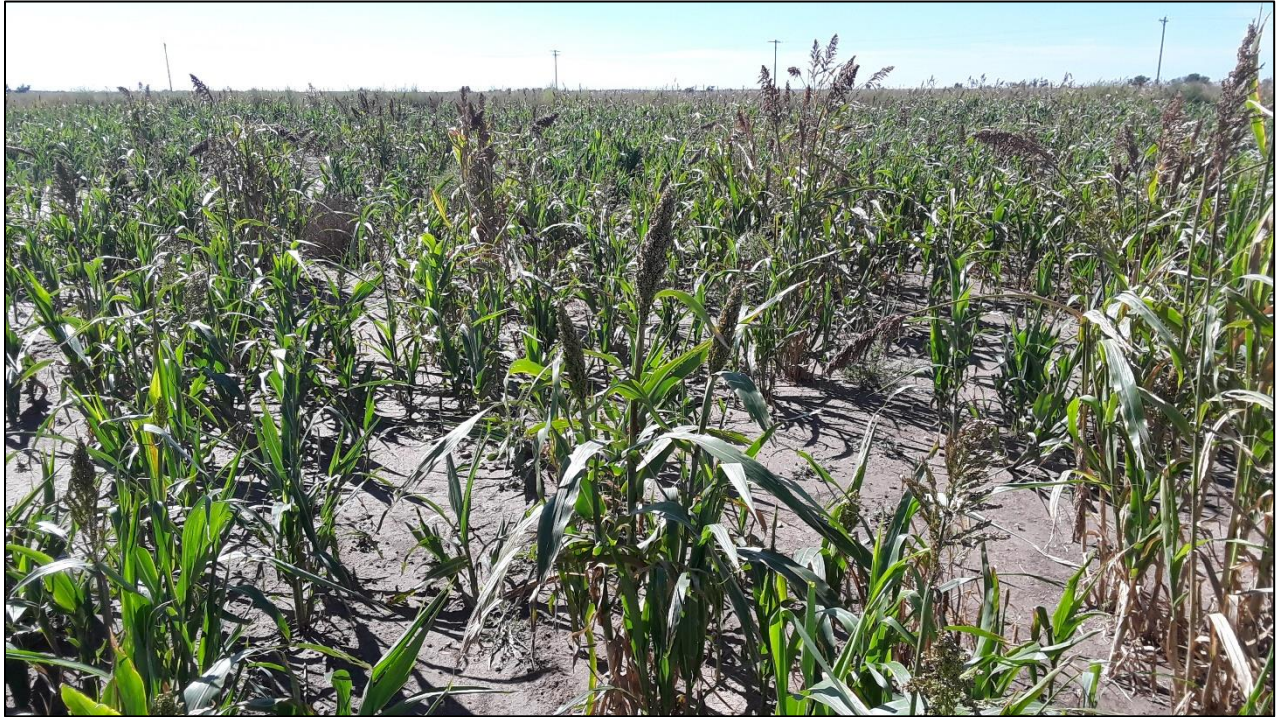
**Photo 23.** View looking east across disturbed area between ponds, showing cover crop (sorghum) that was planted in early summer.

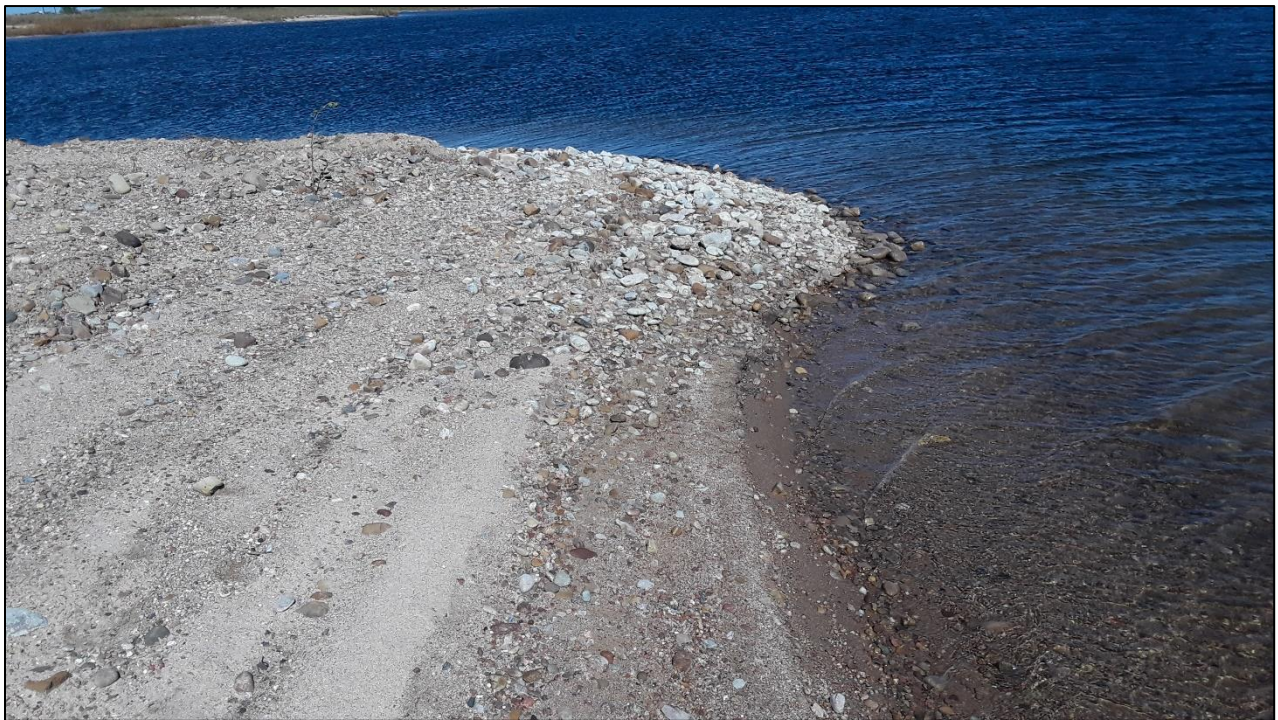
**Photo 26.** View of edge of peninsula along western shoreline of eastern pond. Its rockier surface appears to protect the slope fairly well from wave action erosion.

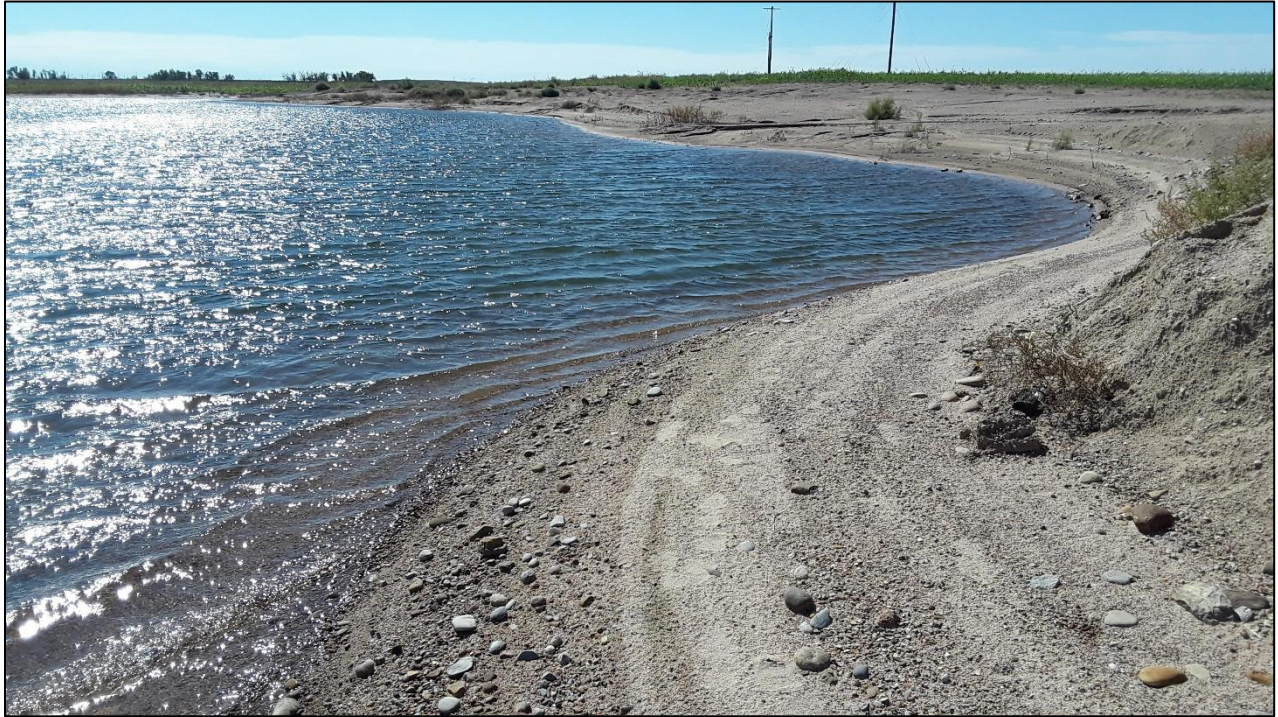
**Photo 27.** View looking south across western shoreline of eastern pond left as sandy beach as approved.

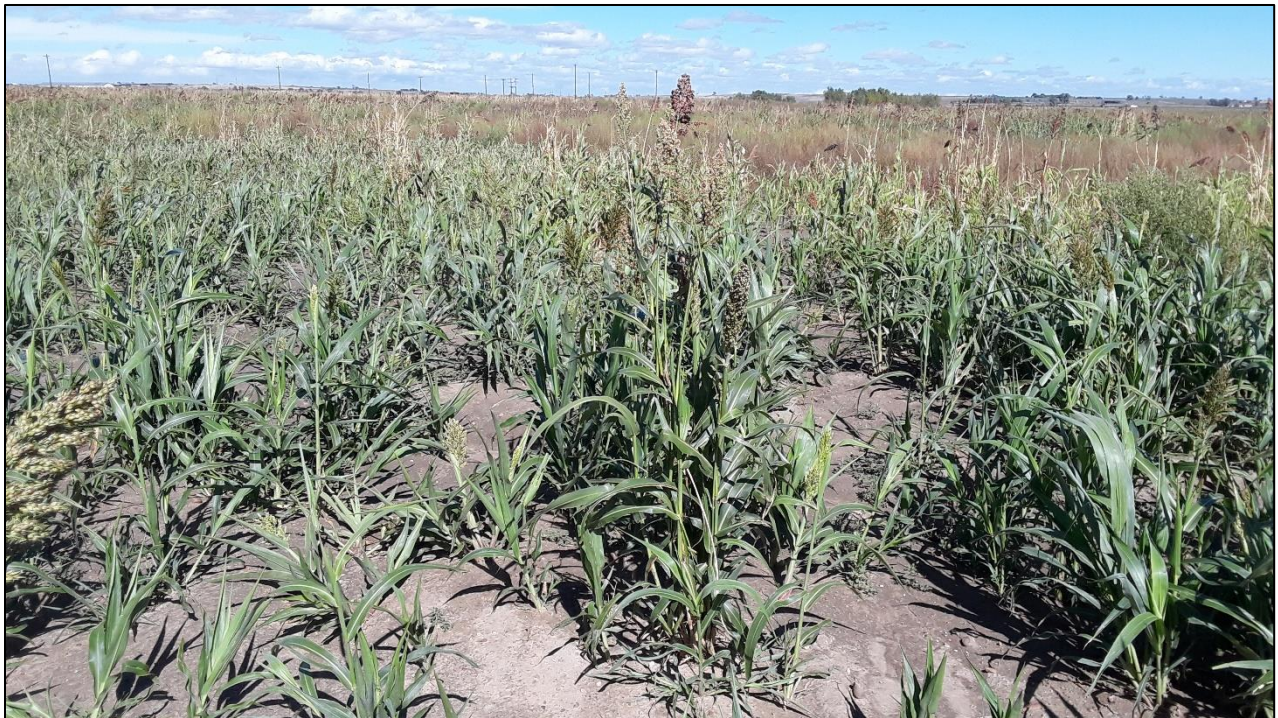
**Photo 28.** View looking northwest across disturbed area between ponds, showing cover crop (sorghum) that was planted in early summer
