***RE: Cole Gravel Pit, Permit No. M-2004-020, Unresolved Problem(s) Noted in a Past Inspection Report***

**MINERALS PROGRAM INSPECTION REPORT****PHONE: (303) 866-3567**

<b>MINE NAME:</b> Cole Gravel Pit	<b>MINE/PROSPECTING ID#:</b> M-2004-020	<b>MINERAL:</b> Sand and gravel	<b>COUNTY:</b> Mesa
<b>INSPECTION TYPE:</b> Monitoring	<b>INSPECTOR(S):</b> Stephanie J. Mitchell	<b>INSP. DATE:</b> April 19, 2017	<b>INSP. TIME:</b> 13:00
<b>OPERATOR:</b> M.A. Concrete Construction, Inc.	<b>OPERATOR REPRESENTATIVE:</b> Martin Azcarraga	<b>TYPE OF OPERATION:</b> 112c - Construction Regular Operation

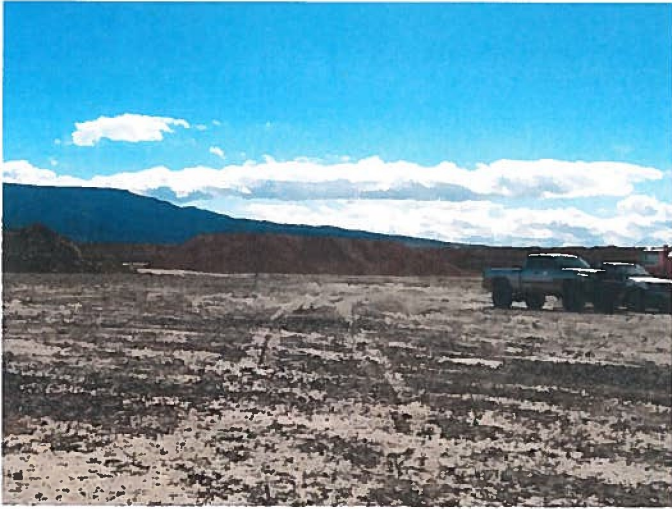
**There are two fuel tanks on site. One tank is double walled with adequate secondary containment. The second fuel tank needs to be protected by secondary containment. This is noted as a problem at the beginning of this inspection report.**

Fuel Storage- Double walled
