2018 ANNUAL REPORT STRUCTURAL GEOLOGY EVALUATION SPECIFICATIONS AGGREGATE QUARRY

**Martin Marietta Materials
Golden, Colorado**

17C64009.00
February 14, 2018

**Subject: Project 17C64009.00, 2018 Annual Report, Structural Geology Evaluation,
Specification Aggregates Quarry, Golden, Colorado**

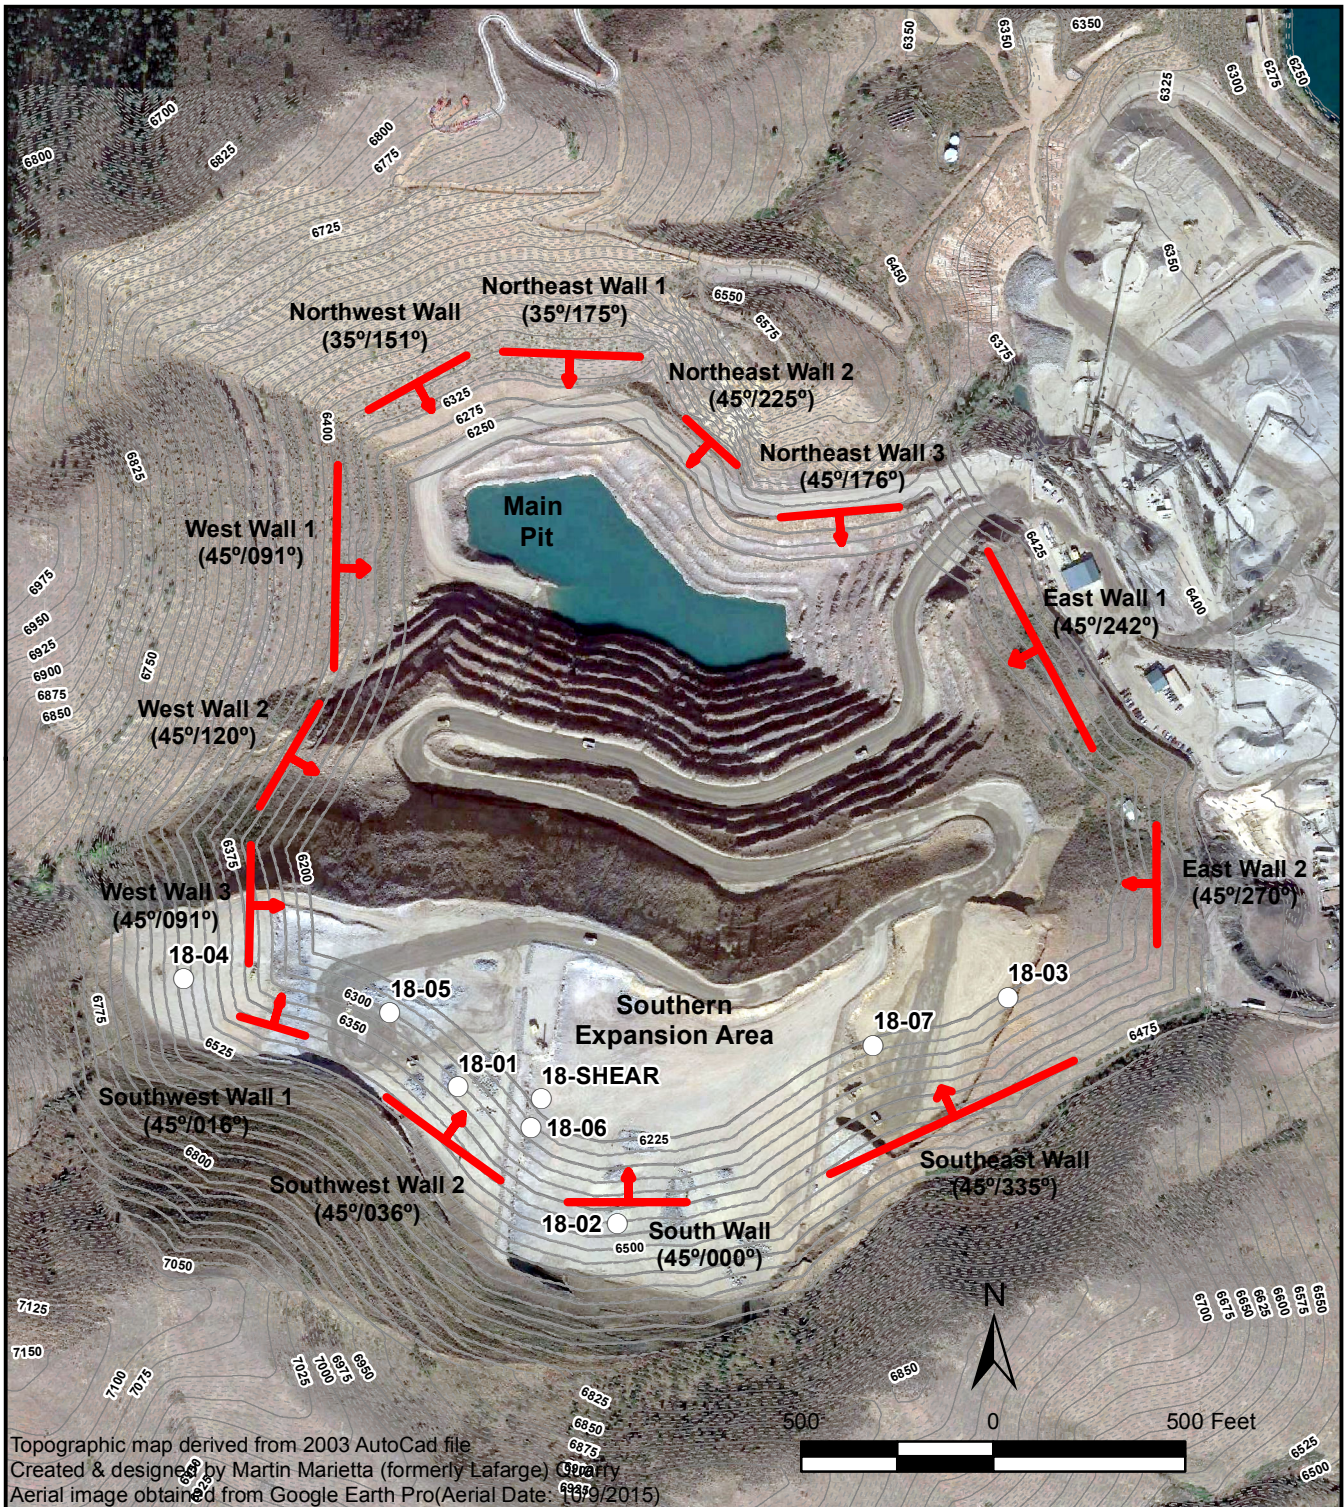
Figure 2

Significant mining activity has taken place in the Southern Expansion Area since our last annual report and between our July and December 2017 site visits (Photos 1 to 3). The mining is being accomplished with four active temporary benches with reclamation occurring in stages following excavation along permanent benches. The uppermost bench exists near the western margin of the Southern Expansion Area (see Stations 18-04 in Figure 2). The next bench to the east is in the vicinity of Stations 18-05 and 18-01 (Figure 2) and the next near Stations 18-02 and 18-06 (Figure 2). The final, lowest bench is in the vicinity of Stations 18-03 and 18-07 (Figure 2) and is at approximately EL 6,580 ft, based on concrete monuments spray-painted with elevation markings. Each bench appears to be approximately 35 feet lower than the bench to its west.

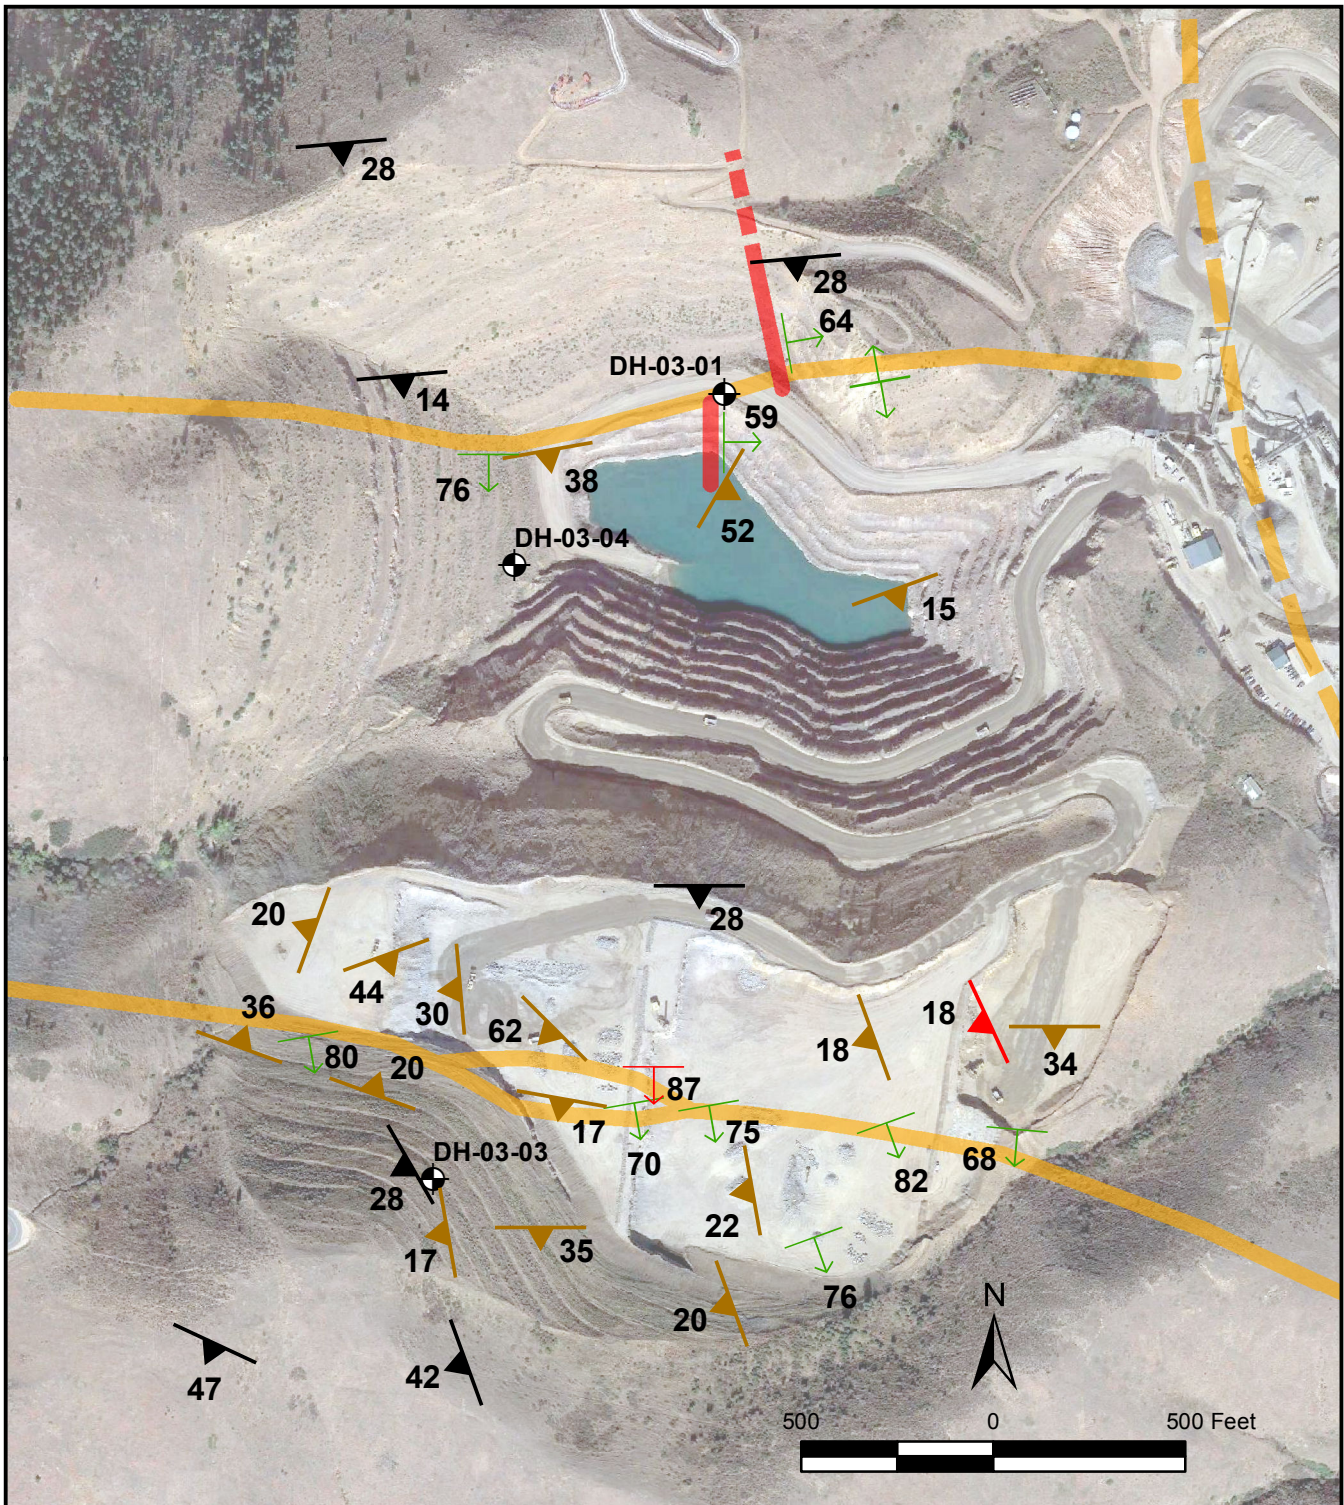
Two regional fault orientations, trending approximately east-west and north-south, have been mapped within the property by others (Gable, 1968; Scott 1972), and multiple fault orientation measurements have been recorded in our site visits over the years, as shown in Figure 3.

An approximately east-west trending fault is mapped by Gable (1968) across the northern margin of the quarry. This fault is exposed in the northern portion of the main quarry pit (Figure 3).

In the Southern Expansion Area, Gable (1968) mapped a third fault that also trends roughly east-west (Figure 3). This fault was initially exposed during the 2006 investigation, and was noted by a distinct pegmatite vein that was surrounded by decomposed weak biotite rich gneiss. The fault was exposed in temporary excavation walls along the western and southern margin of the Southern Expansion Area during previous and current year site visits. GPS measurements taken along the margin of the fault exposure (18-SHEAR) were registered in Google Earth to the existing fault map yielding a good match with the previously mapped trace (Figure 2 and Photo 3).

Two other approximately north-south trending faults have been exposed in the northern quarry walls, as shown on Figure 3 and discussed in the previous 2013 report (Lachel, 2013). They roughly parallel the Golden Fault, which is a major fault that forms the north-northwest trending hogback immediately east of the quarry property. These two faults remain unchanged since there is no mining activities in the main pit area.
