MINERALS PROGRAM INSPECTION REPORT
PHONE: (303) 866-3567

| MINE NAME: Mule Farm Gravel Pit | MINE/PROSPECTING ID#: M-1991-079 | MINERAL: Sand and gravel | COUNTY: Mesa |
| INSPECTION TYPE: Monitoring | INSPECTOR(S): Amy C. Yeldell | INSP. DATE: March 20, 2018 | INSP. TIME: 11:30 |

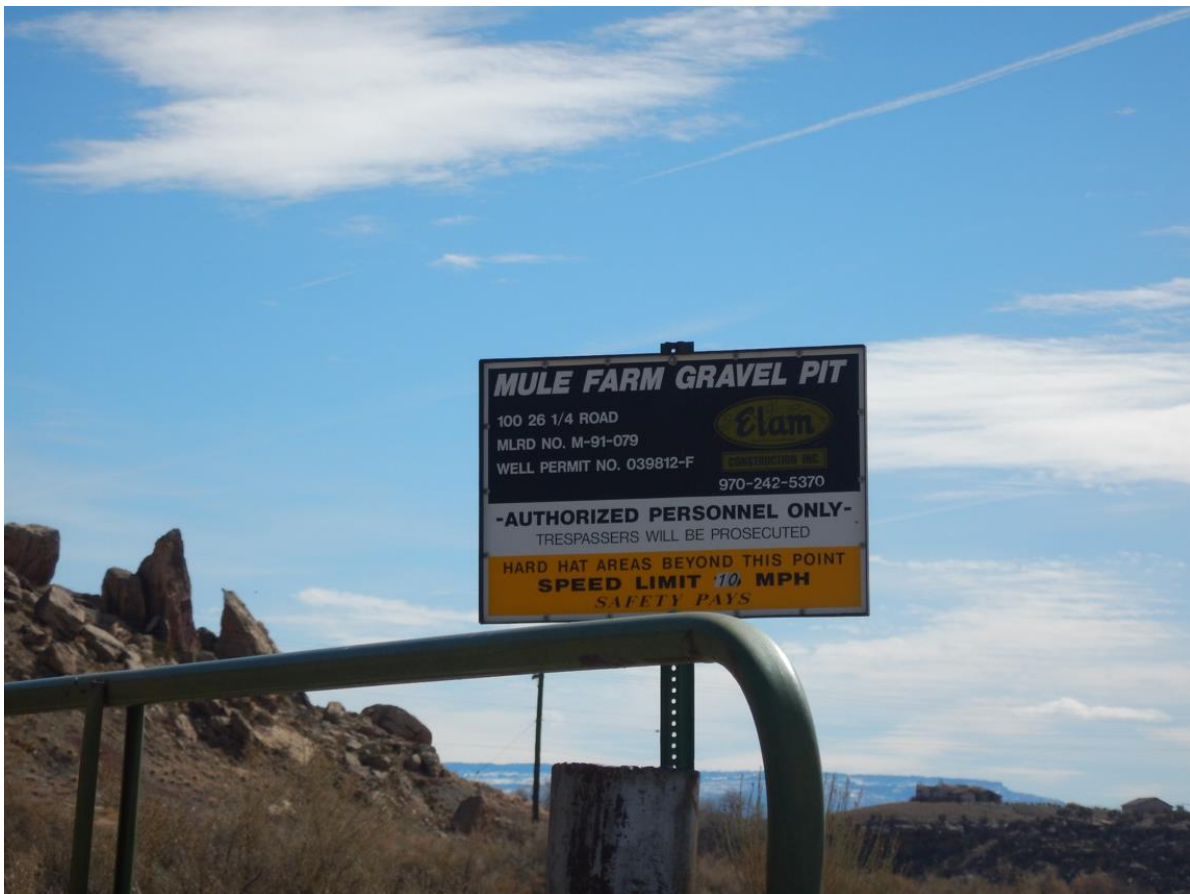
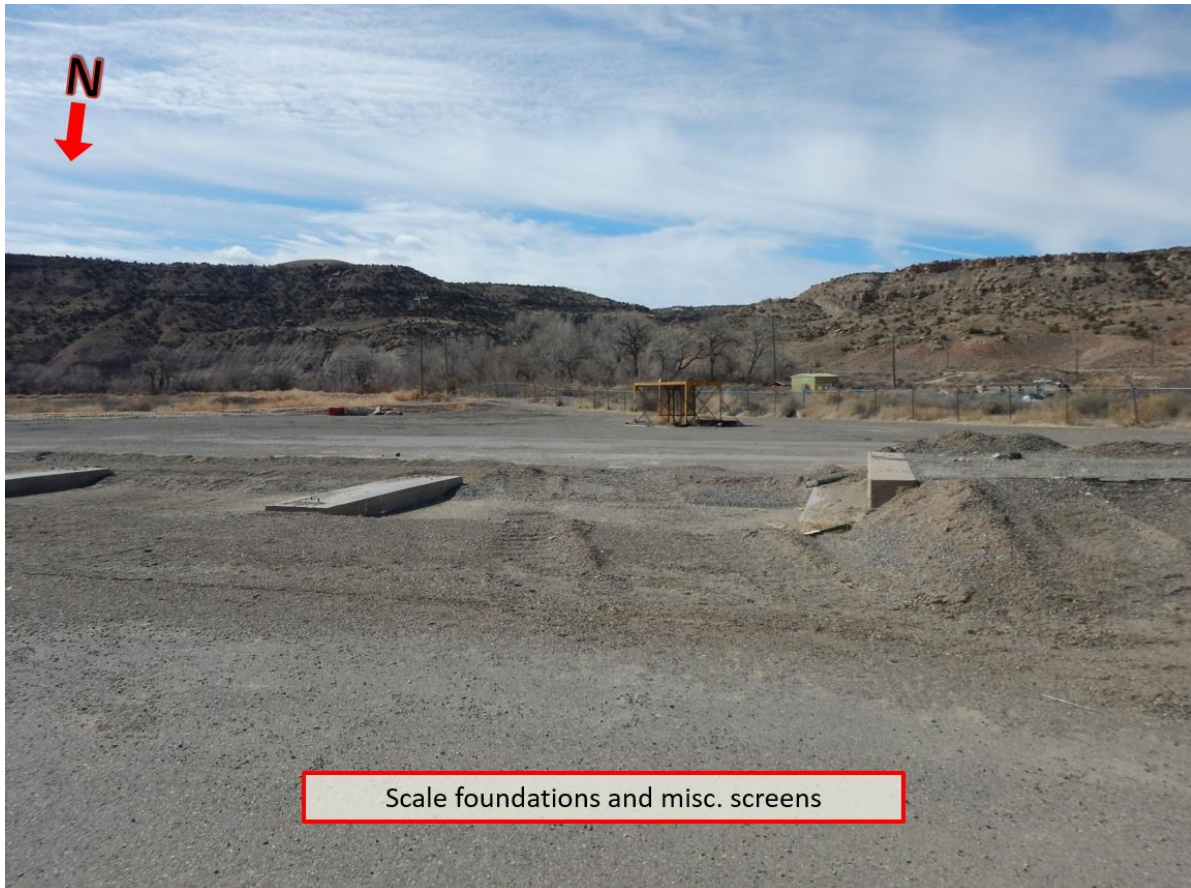
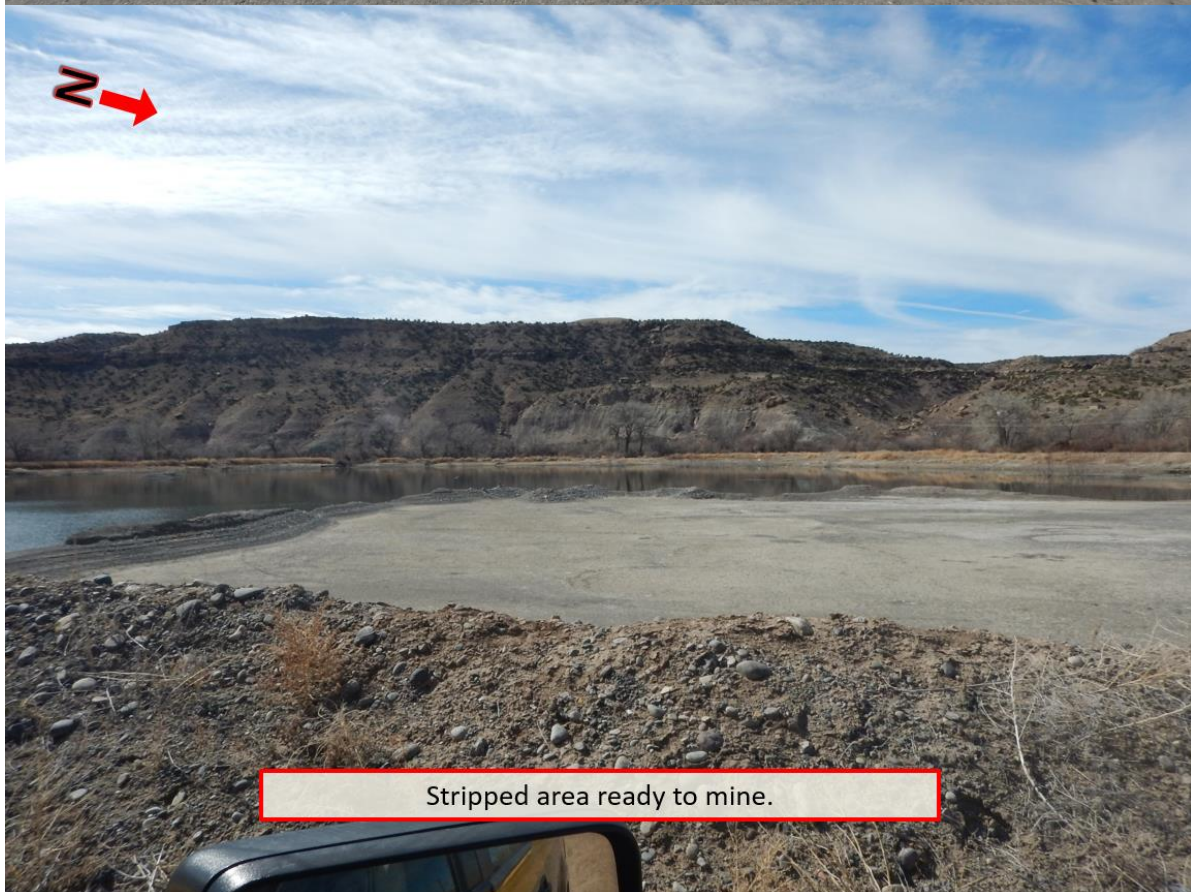
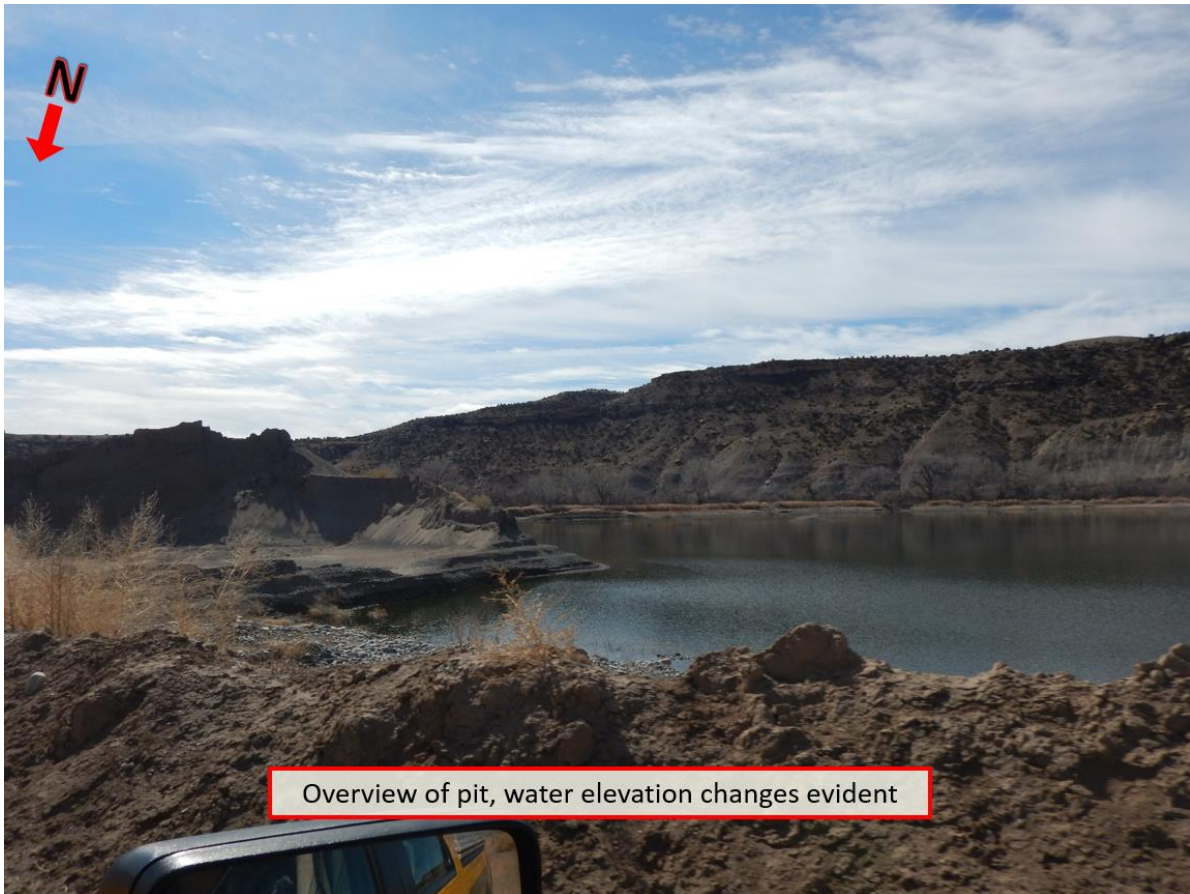
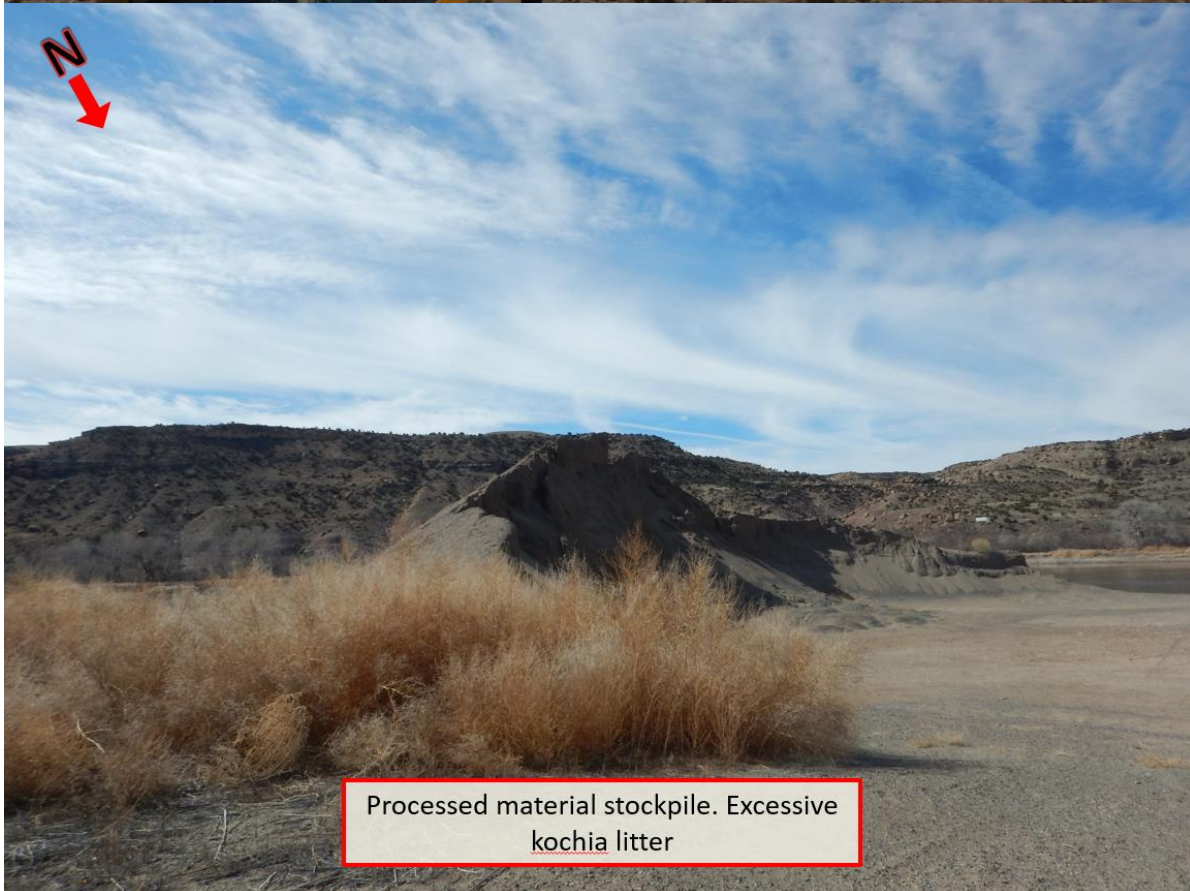
Last summer due to the roller damn being closed just downstream, the Gunnison River swelled significantly. In some areas the river overtopped the buffer between the river and the pit. In several areas established reclamation was also washed away. The areas where erosion had taken place have been repaired by the addition of material to strengthen the berm. In other low areas the berm has been elevated. No reseeding efforts have taken place to date. A significant Kochia infestation has taken hold of these disturbed areas. Mr. Muller has indicated that their weed contractor has been scheduled. They will manually remove last year's dead growth before herbicide treatments to this year's growth. The Division also recommends reseeding this area as soon as practical to help stabilize the slopes.
