MINERALS PROGRAM INSPECTION REPORT

MINE NAME: Spor Pit	MINE/PROSPECTING ID#: M-1995-038	MINERAL: Gravel	COUNTY: San Miguel
INSPECTION TYPE: Monitoring	INSPECTOR(S): Lucas J. West	INSP. DATE: March 27, 2018	INSP. TIME: 15:45
OPERATOR: Mountain View Enterprises Limited Liability	OPERATOR REPRESENTATIVE: Chancy Marolf	TYPE OF OPERATION: 110c - Construction Limited Impact

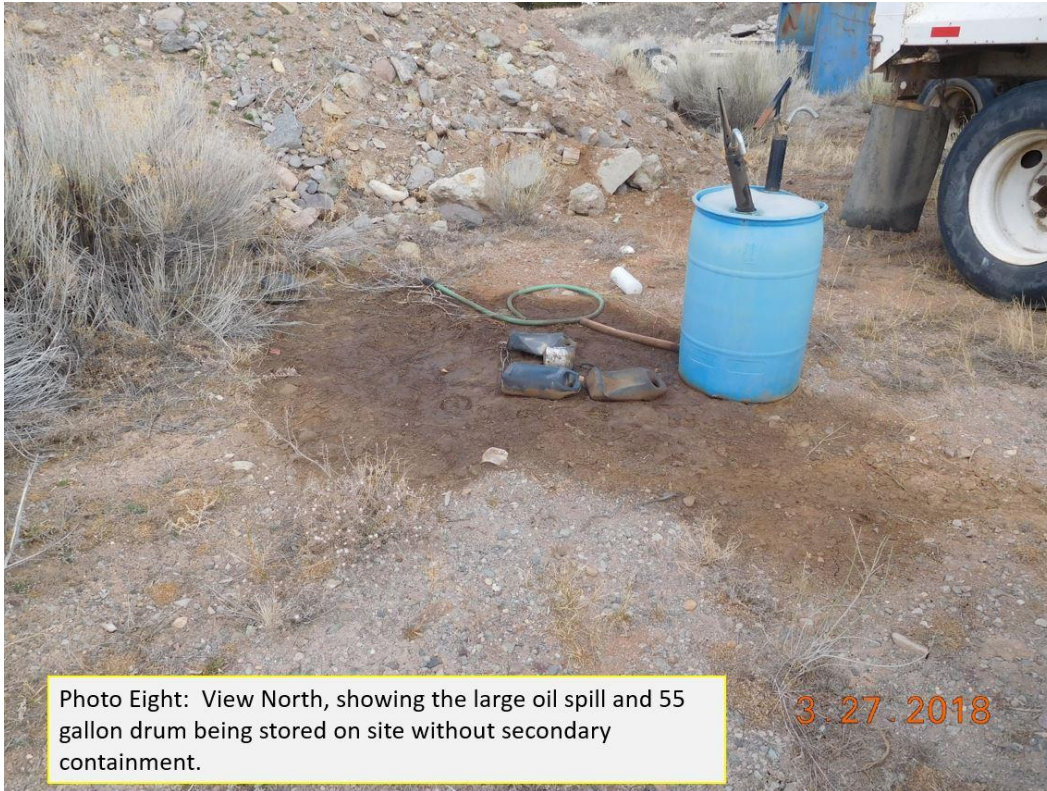
A problem was identified during the inspection that was discussed on site with the Operator. Multiple oil spills have occurred at the site which has impacted soils and improper storage and containment of fuels and/or other hazardous materials was present on site. Adjacent to the van trailer located on the pit floor, several small oil spills were observed, in addition to several containers of oil, and hydraulic fluid not being stored with appropriate secondary containment. The containers and spill in this area can be seen in Photos Six and Seven. Similarly, in the area being used as a storage area, two other spills were observed. A large spill was observed near the 55 gallon blue plastic drum of an unknown substance. This container was also being stored without proper secondary containment. The drum and spill can be seen in Photo Eight. Observations were also made near the tongue of the low-boy trailer in the area, which are consistent with a hydraulic fluid leak from the trailer that will need to be cleaned up. This spill can be seen in Photo Nine.

Also, petroleum and any hazardous materials on site for any period of time shall have appropriate secondary containment. The site will also have to comply with all applicable SPCC requirements. Please supply photo documentation that any and all fuel or hazardous materials containers are stored properly - including applicable secondary containment structures by the corrective action date. Note that secondary containment structures shall consist of an impermeable containment which could contain all contents of the tanks and various containers (when full) plus 10% of the total capacity. Several options for proper storage were discussed with the Operator during the inspection.

The Operator should submit the photo documentation, letter describing the cleanup efforts that took place and photo documentation of all fuel, oils and hazardous materials being stored with proper secondary containment within **60 days** of the date of this report. Evidence of compliance must be received by the Division no later than **Friday June 1, 2018**.
