MINERALS PROGRAM INSPECTION REPORT PHONE: (303) 866-3567

MINE NAME:		MINE/PROSPECTING ID#:	MINERAL:	COUNTY:		
St Jude Mine		M-1978-039-HR	Uranium and vanadiu	San Miguel		
INSPECTION TYPE:		INSPECTOR(S):	INSP. DATE:	INSP. TIME:		
Monitoring		Lucas J. West	March 28, 2018	10:22		
OPERATOR:		OPERATOR REPRESENTATIVE:	TYPE OF OPERATION:			
Pinon Ridge Mining LLC		George Glasier, Mike Rutter	110d - Designated Limited Impact			
REASON FOR INSPECTION:		BOND CALCULATION TYPE:	BOND AMOUNT:			
Normal I&E Program		Complete Bond	\$47,700.00			
DATE OF COMPLAINT:		POST INSP. CONTACTS:	JOINT INSP. AGENCY:			
NA		None	None			
WEATHER:	INSPECTOR'S SIGNATURE:		SIGNATURE DATE:			
Clear	Agan		April 5, 2018

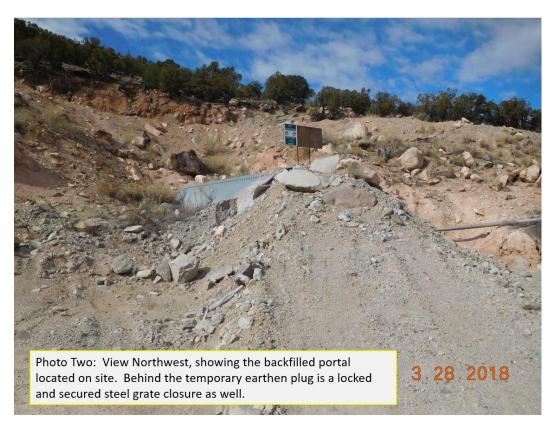
As seen in Photo One, the permit ID sign was observed at the entrance to the site. The permit boundary markers were also observed. All disturbances are contained within the permitted areas. The remote vent shaft sites were not inspected at this time. The diversion ditches and storm water control devices appear to be functioning as designed and no significant erosion was observed throughout the site. The main work area, adjacent to the portal and shops, appeared to be stable and in good condition. The portal located on this site has been backfilled and secured. Photo Two shows the earthen cover placed over the portal. No evidence of vandalism or attempted unauthorized entry to the portal was observed during the inspection.
