PITCH RECLAMATION PROJECT COLORADO MINED LAND RECLAMATION BOARD 2017 ANNUAL RECLAMATION REPORT

RECLAMATION PERMIT NUMBER M-1977-004

Homestake Mining Company of California P.O. Box 40 Sargents, Colorado 81248

April 19, 2018

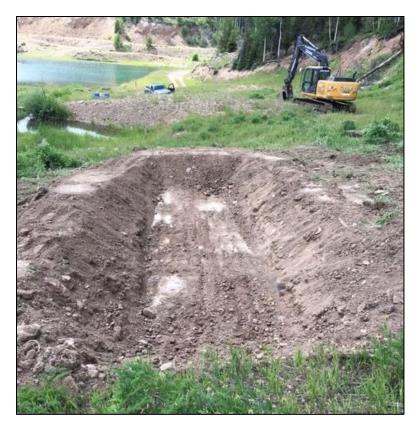
Photograph 4: Area excavated for the ETC

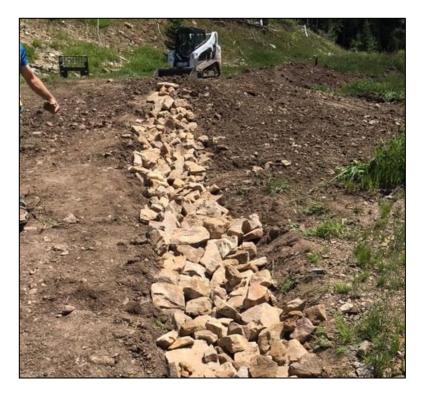
• Emplacement of piping and a riprap channel to route water to and from the Tie Camp drainage (Photograph 5).

Photograph 5: ETC riprap channel used to route treated water to Tie Camp Drainage

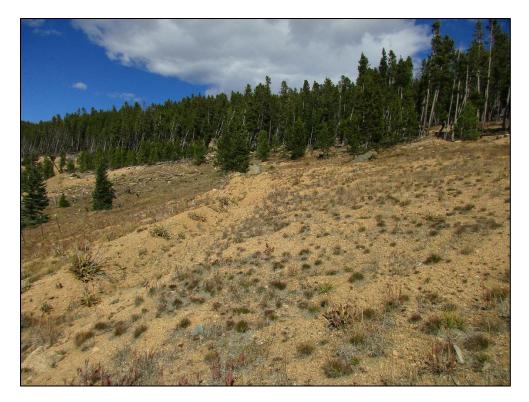
Snowmelt, summer precipitation, and springs in the east wall of the North Pit have caused recurring erosion since the pit was developed almost four decades ago. A topographic low exists on the east wall of the North Pit between the 10,800 and 10,600 benches that concentrates surface drainage from a relatively large area above the crest of the east wall. In 2010, displacement in the 10,600 bench, coupled with snow pack and precipitation, caused a pond to form. The pond was graded and filled to re-establish appropriate drainage along the bench. The repairs were effective in keeping water from ponding on the 10,800 and 10,600 benches. In 2012, a diversion ditch was constructed to channel water from the 10,800 bench to the 10,600 bench and on to the "Spring" channel. This channel was effective until May 2015 when a sluff occurred on the east wall of the North Pit below the 10,800 bench. The area continues to be monitored following snowmelt to confirm that water does not pond on the 10,800 or 10,600 benches. Photograph 7, taken in 2017, shows that no additional sluffing has occurred on the east wall of the North Pit since 2015. Photograph 8 shows the diversion ditch in 2017. Photograph 9 was taken in October 2017 following fertilizer addition on the 10,800 bench above the diversion ditch. Straw bales were also placed for additional erosion control.

Photograph 8: East Wall of the North Pit in 2017 with the diversion ditch constructed in 2012 to channel water from the 10,800 bench to the 10,600 bench

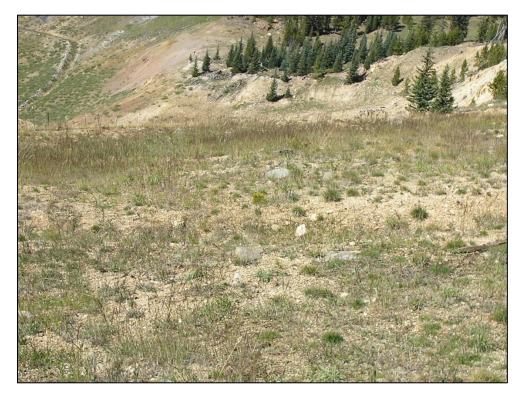
Photograph 9: East Wall of the North Pit in 2017 from the 10,800 bench above the diversion ditch

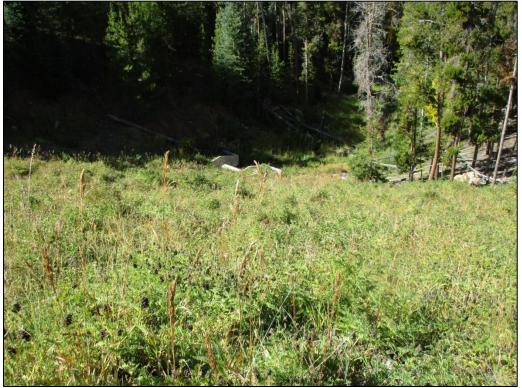
In 2012, repair work was completed on the top three benches and dump slope faces between benches to remove sediment build up that was directing snowmelt and stormwater down the dump face and creating rill erosion. Monitoring in 2017 showed that the repairs completed in 2012 have resolved issues on the top three benches and that the repairs continue to function. Photographs 11, 12, and 13, taken in 2017, show snowmelt and precipitation continue to move off the bench into the adjacent forested area with no sediment buildup and rill erosion on the face of the rock dump.

Photograph 12: Tie Camp Rock Dump looking down to the stilling basin from the bottom bench showing no signs of erosion in 2017

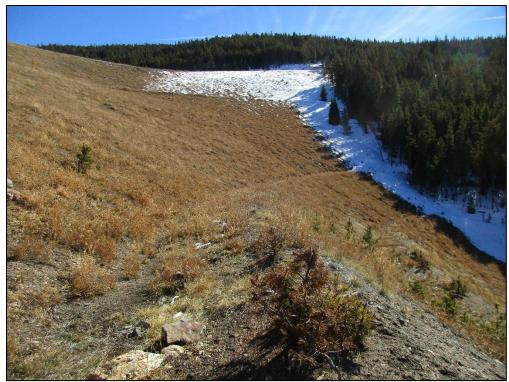
Photograph 13: Tie Camp Rock Dump slope face with no sign of rill erosion in 2017 between second and third benches

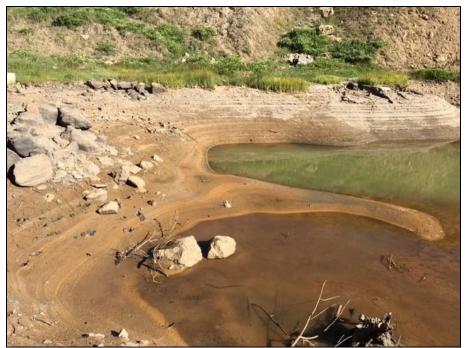
Routing of water around the lake resulted in a maximum diversion of approximately 37% and facilitated the rapid drawdown of North Pit Lake. The drawdown of the North Pit Lake was successful in providing useful information on the feasibility of lake level manipulation for water treatment and potential closure and reclamation purposes, as well as for informing lake recharge dynamics. Within the 8 feet of drawdown, no additional seeps were identified along Chester Fault, indicating that additional uranium-influenced groundwater discharge is occurring at depth. Temperature and conductivity loggers placed on a mooring line anchored to the lake bottom will monitor lake stratification through spring 2018. Photograph 30 shows the North Pit Lake after 6.5 feet of drawdown.

Photograph 30: North Pit Lake shoreline following 6.5 feet of drawdown

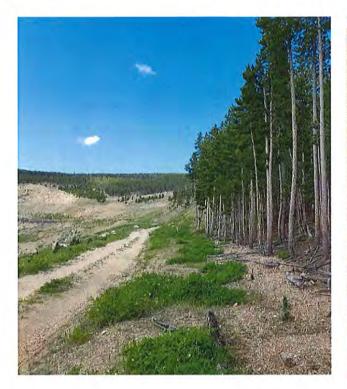
Notes from North Star indicated that MP97-75 was disturbed during well pad construction activities yielding an anthropogenic shift of 0.46 feet in a direction near-perpendicular to the slope fall line. The displacement data is not representative of potential ground movement and is thereby not comparable with the 2016 survey program. Future 2018 survey program measurements may be considered for comparison with the 2017 survey program position data to generate a potentially representative displacement value (T. Weber, email, January 18, 2018). No survey monitoring points were destroyed in the zone and no survey monitoring points were added to this zone. No new ground movement site features were observed in the zone (Photo 4).

Photo 04. North Pit- South Wall: photo taken looking east obliquely across the zone from the western edge of the zone.

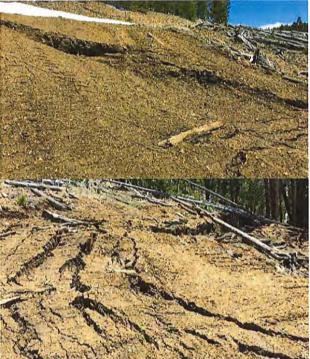
was measured at MP14-93 on the southern edge of the area amongst hummocky and deformed ground (Photo 5).

Photo 05. South Pit: (TOP) photo taken looking southeast at a scarp below an access road. (BOTTOM) photo taken looking south across the west-facing slope near the zone of greatest measured surficial deformation.

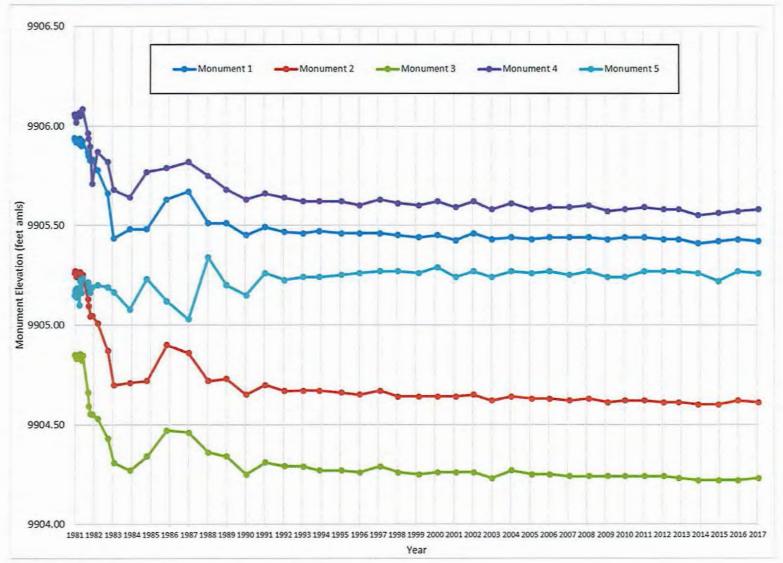
A graph illustrating the vertical displacement since construction of the embankment is provided as **Figure 2**. There has not been significant movement since the initial settlement (1981 to 1984).

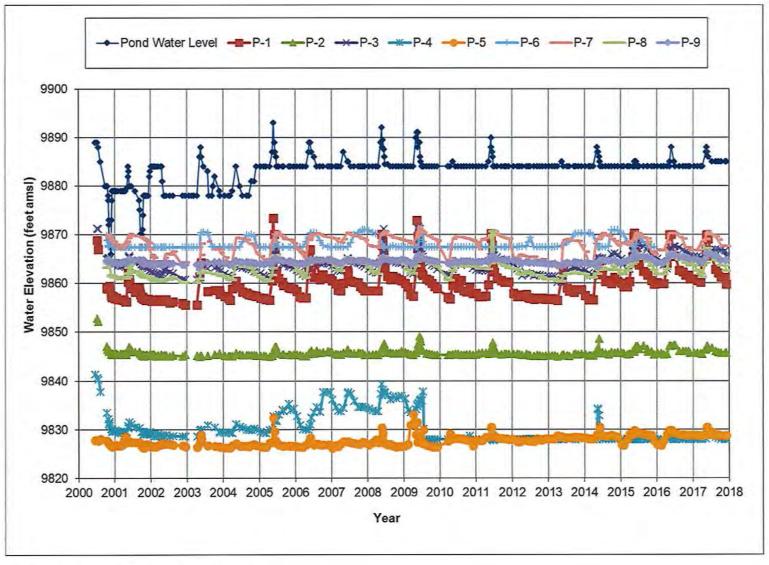
Figure 3: Impoundment piezometer history.

Piezometer and pond water elevation data from year 2000 to present are presented in Figure 3.

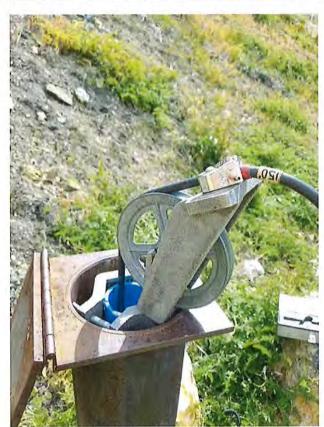
Photo 01 Hole depth measured with a combination of cable and weighted tape measure.

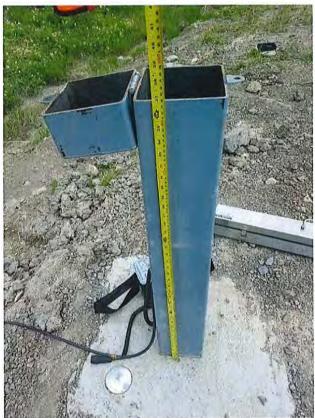
Photo 02. Stickup measurement taken from concrete apron to top of a capped casing using the top of an open standpipe as an intermediate measurement reference point.

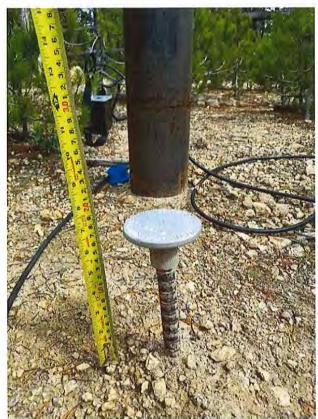
Photo 03. Ground surface for 198-1, 198-2 and 198-3 defined as the top of survey markers positioned near the base of each inclinometer standpipe.

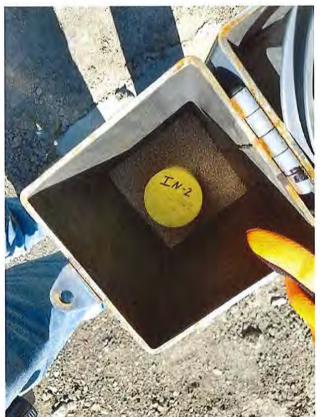
Photo 04. Example of a capped casing. Stickup = Distance from concrete slab with survey marker to top of open standpipe (grey) – Distance from top of open standpipe to top of a capped casing (yellow "IN2" cap)

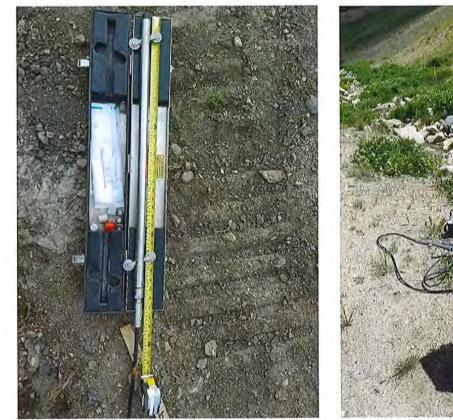
A cable pulley system was used to lower and raise the inclinometer probe during readings of 198-1, 198-2 and 198-3 (Appendix D, Photo 06.) The pulley system rests on top of the inclinometer casing and is clamped to the top of the casing using two wingnuts (Appendix D, Photo 07). Limited spacing between the standpipe and the inclinometer casing interfered with tightening the wingnuts and fully fastening the pulley system to the top of the inclinometer casing (Appendix D, Photo 08). The wingnuts were hand tightened prior to placing the pulley system on top of the inclinometer casing. A quarter inch of potential movement is possible between readings if the pulley system is not well-seated on the casing during surveys.

Photo 05. Length of probe adds 15 inches (1.25 feet) to every cable measurement.

Photo 06. A cable pulley system used to lower and raise probe and cable in 198-1, 198-2 and 198-3.

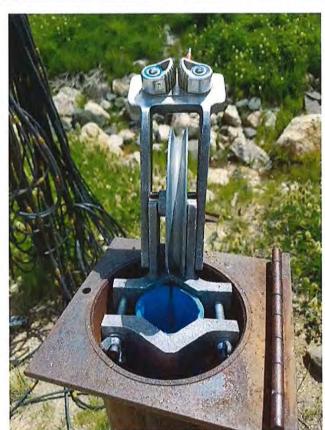
Photo 07. The tight space between the inclinometer casing and standpipe prevents complete fastening of the cable pulley system to the casing.

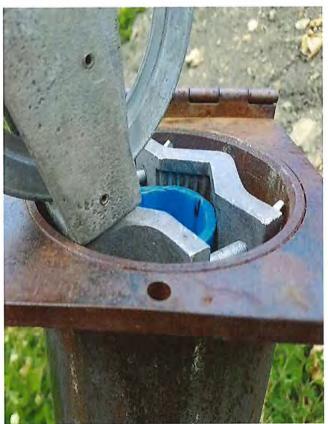
Photo 08. The cable pulley system has a gap between the designed seated position of the cable pulley system.

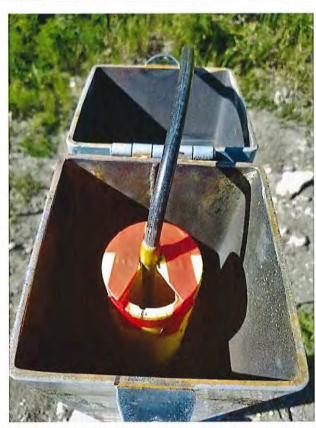
The top of inclinometer casing was below the top of the standpipe for IN 1, IN2 and IN 3. This spacing did not allow for the use of the cable pulley system for lowering and raising the inclinometer. A cable-catch was made with the inclinometer casing cap (cap) from IN1 in place of the cable pulley system (Appendix D, Photo 09). Without the cable pulley system, the cable is shortened by one foot which makes the even-marked measurements along the cable offset by 1.25 feet (Appendix D, Photo 05). Cable measurements were adjusted by adding one foot to each indicated measurement to account for this change (i.e., a cable measurement of 110 feet corresponds to a depth of 111 feet from the top of casing). A hand saw and electric hand drill were used to cut a v-notch in the cap of IN1 to catch cable interval marks during retrieval of the inclinometer probe. Electric tape was used to keep the cap in place within the inclinometer casing during inclinometer surveys (Appendix D, Photo 10).

Photo 09. A handmade cable catch was made using the plastic cap form IN-1.

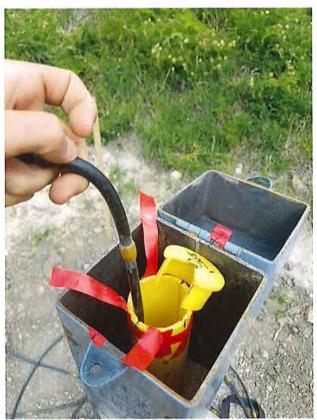
Photo 10. Electric tape was used to keep the cap in place within the inclinometer casing. Tape was removed after each use.

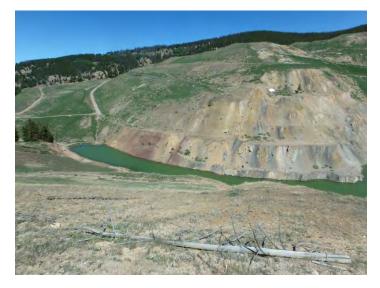
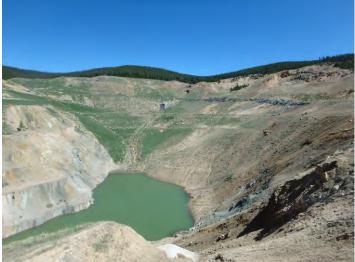
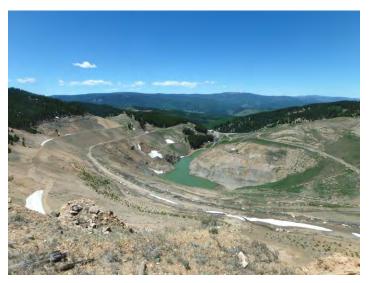
<u>North Pit</u>: Slope movement above the North Pit continues to be monitored. A final reclamation/stabilization plan is not yet developed for this area. Efforts are ongoing to control erosion and drainage on the east wall of the north pit.

Discharge from the North Pit Lake flows through the valve and culvert as designed. The Pinnacle Portal continues to discharge and flow is measured through a v-notch weir. The discharge reports to a marsh area above the facilities shop building.
