MINERALS PROGRAM INSPECTION REPORT
PHONE: (303) 866-3567

MINE NAME: West Sunday	MINE/PROSPECTING ID#: M-1981-021	MINERAL: Uranium and vanadium	COUNTY: San Miguel
INSPECTION TYPE: Monitoring	INSPECTOR(S): Lucas J. West	INSP. DATE: March 28, 2018	INSP. TIME: 10:45
OPERATOR: Pinon Ridge Mining LLC	OPERATOR REPRESENTATIVE: George Glasier, Mike Rutter	TYPE OF OPERATION: 112d-3 - Designated Mining Operation	
REASON FOR INSPECTION: Normal I&E Program	BOND CALCULATION TYPE: Complete Bond	BOND AMOUNT: \$85,036.00	
DATE OF COMPLAINT: NA	POST INSP. CONTACTS: None	JOINT INSP. AGENCY: None	
WEATHER: Clear	INSPECTOR'S SIGNATURE:

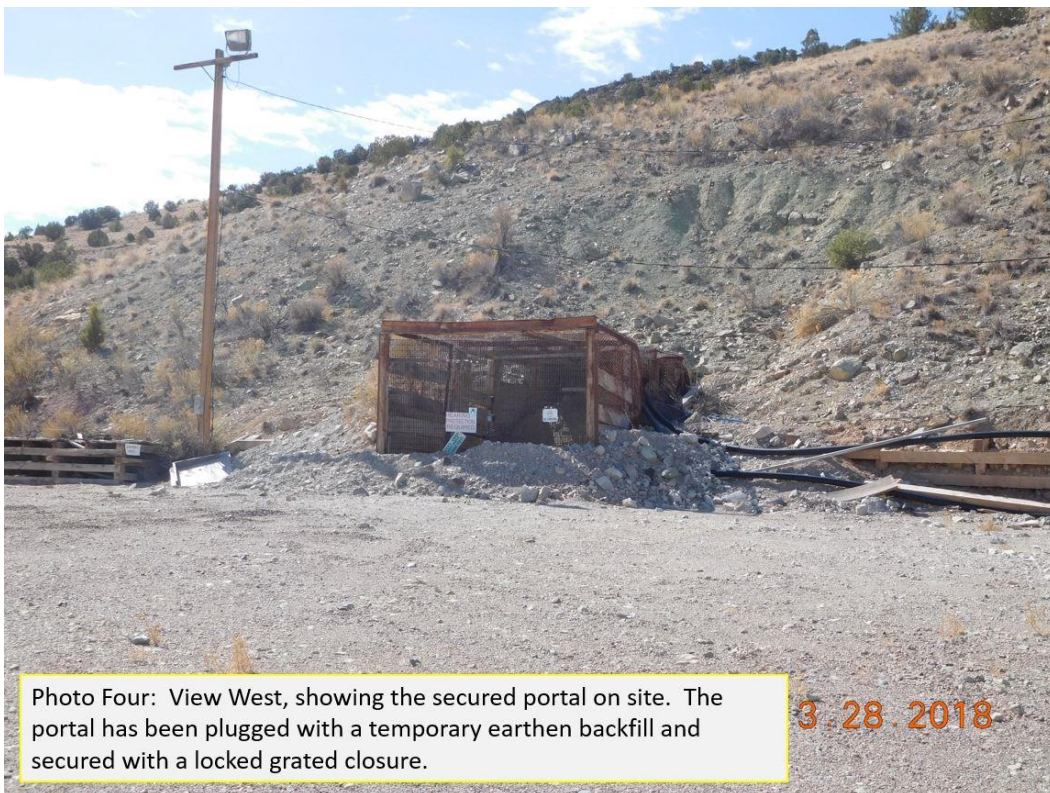
The main pad and work area was in good condition, evidence of weed management during the growing season was observed. The whole site exhibits positive drainage and no erosional issues were observed at this time. Some areas around the perimeter of the pad area have begun to revegetate themselves with volunteer species.
