**COLORADO**Division of Reclamation,
Mining and Safety

MINERALS PROGRAM INSPECTION REPORT**PHONE: (303) 866-3567**

MINE NAME: Climax Mine	MINE/PROSPECTING ID#: M-1977-493	MINERAL: Molybdenum	COUNTY: Summit
INSPECTION TYPE: Monitoring	INSPECTOR(S): Lucas J. West	INSP. DATE: April 12, 2018	INSP. TIME: 09:52
OPERATOR: Climax Molybdenum Company	OPERATOR REPRESENTATIVE: Diana Kelts, Emile McCormick	TYPE OF OPERATION: 112d-3 - Designated Mining Operation	
REASON FOR INSPECTION: Normal I&E Program	BOND CALCULATION TYPE: None	BOND AMOUNT: \$78,246,088.00	
DATE OF COMPLAINT: NA	POST INSP. CONTACTS: None	JOINT INSP. AGENCY: None	
WEATHER: Clear	INSPECTOR'S SIGNATURE:

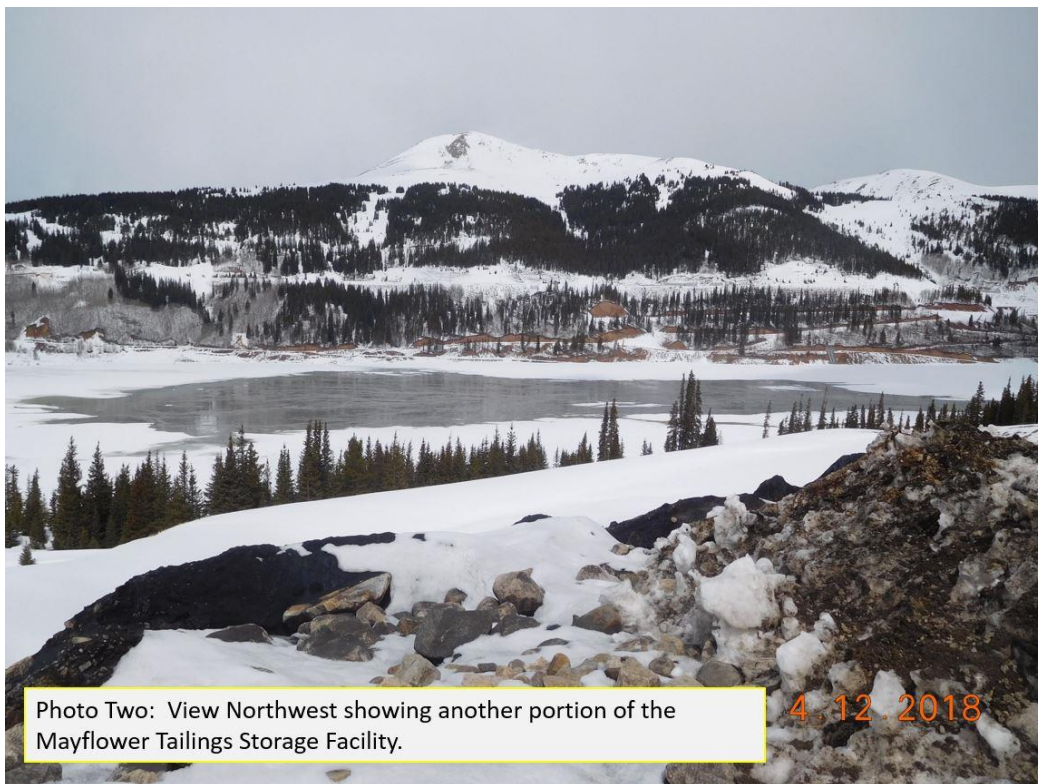
Tailings dams 1, 2 and 3 were observed despite the snowpack. The dams appeared to be in good condition and showed no signs of settling or slumping. The water management systems associated with these dams including both the Robinson Lake and Warren's ponds as well as the various pump stations and monitoring devices were observed. Discussions with the Operator Representatives indicate that all devices and systems are functioning properly. There are some preliminary discussions on upgrading the monitoring equipment communications systems but that will be a project to happen in the years to come. The Tenmile and Mayflower Tailings Storage Facilities were observed and appeared to be in good condition. The Mayflower TSF can be seen in Photos **One** and **Two**. The Tailings Deliver Line (TDL) was observed where it can be seen on the surface. The line appears to be functioning as designed and is in good condition and can be seen in Photo **Three**.
