**MINERALS PROGRAM INSPECTION REPORT**  
**PHONE: (303) 866-3567**

<b>MINE NAME:</b> Lamar East Pit	<b>MINE/PROSPECTING ID#:</b> M-1977-572	<b>MINERAL:</b> Sand and gravel	<b>COUNTY:</b> Prowers
<b>INSPECTION TYPE:</b> Monitoring	<b>INSPECTOR(S):</b> Amy Eschberger	<b>INSP. DATE:</b> November 27, 2017	<b>INSP. TIME:</b> 13:45
<b>OPERATOR:</b> City of Lamar	<b>OPERATOR REPRESENTATIVE:</b> John Sutherland, Jr. and Rick Ackers	<b>TYPE OF OPERATION:</b> 112c - Construction Regular Operation	
<b>REASON FOR INSPECTION:</b> Normal I&E Program	<b>BOND CALCULATION TYPE:</b> None	<b>BOND AMOUNT:</b> NA	
<b>DATE OF COMPLAINT:</b> NA	<b>POST INSP. CONTACTS:</b> None	<b>JOINT INSP. AGENCY:</b> None	
<b>WEATHER:</b> Clear	<b>INSPECTOR'S SIGNATURE:</b>

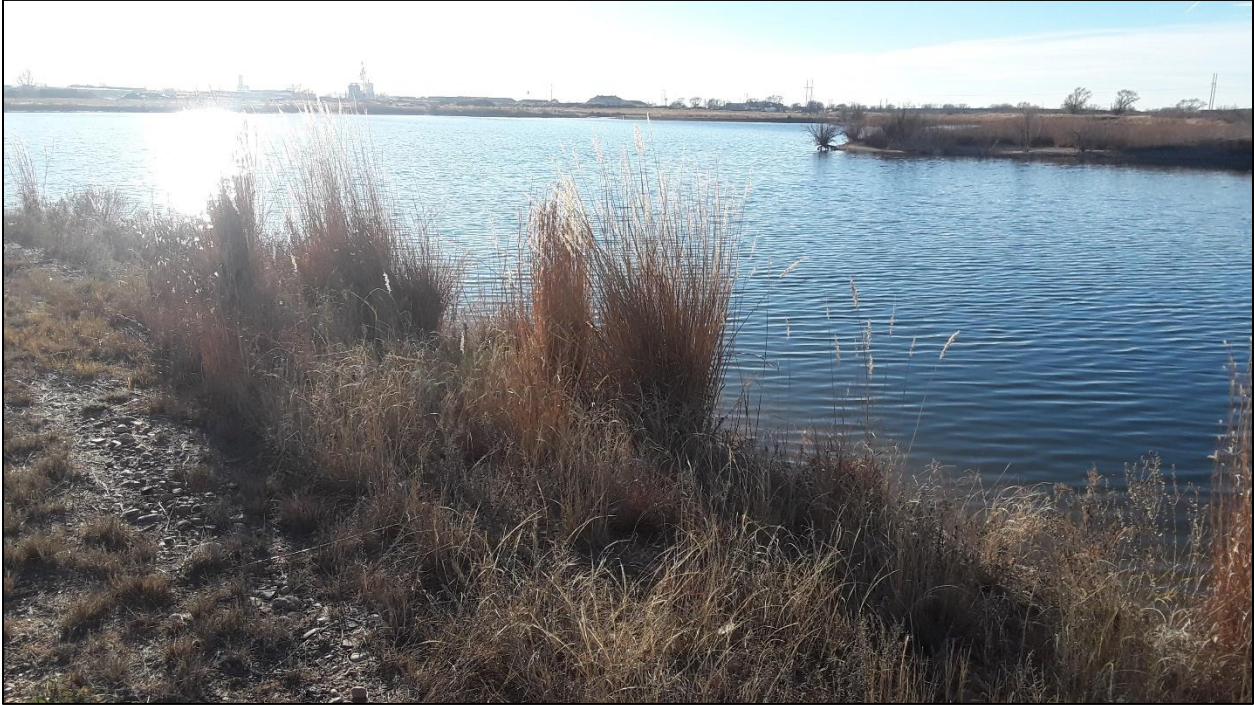
The Division observed the edge of the 24 inch overflow pipe installed in the berm separating the eastern pond from the river (**Photo 16**). The bottom edge of the pipe appeared to be approximately 1.5 feet from the pond water surface. The Division observed a well-established stand of grasses along the edge of the eastern shoreline of the eastern pond (**Photo 17**). The city mows the strip of land between the eastern pond and the gravel road (**Photos 18 and 19**). Vegetative cover across this area consists mainly of native grasses. The southern shoreline of the eastern pond was fairly well vegetated with newer grass growth than what is present along the northern shoreline (**Photos 20-25**). According to the operator, the southern and eastern shorelines of the middle and eastern ponds had experienced less revegetation success from the initial seeding completed by the previous operator in 2012. Therefore, in early summer of 2014, the city imported 6,000 tons of clean topsoil to the site and spread it across these areas. In early fall of 2014, the city reseeded these areas. The city's water department ran city water to the area from the east side, installing three fire hydrants along the southern shoreline for irrigation purposes. It is unclear how often the areas were irrigated, but the results show significant grass germination and growth along much of the southern shorelines. There are some minor patchy areas where grasses are less prevalent (**Photos 26-30**), particularly along the southeastern edge of the eastern pond, and the vegetation is less diverse than observed in other revegetated areas on site. However, overall, vegetation of the southern shorelines is off to a great start, especially west of the parking lot located between the two ponds. The Division recommends the operator continue to monitor revegetation success along the southern shorelines of the eastern ponds, and interseed and/or irrigate the area as needed.

**Photo 17.** View looking southwest across eastern shoreline of eastern pond, showing well established native grasses along the edge of the shoreline.

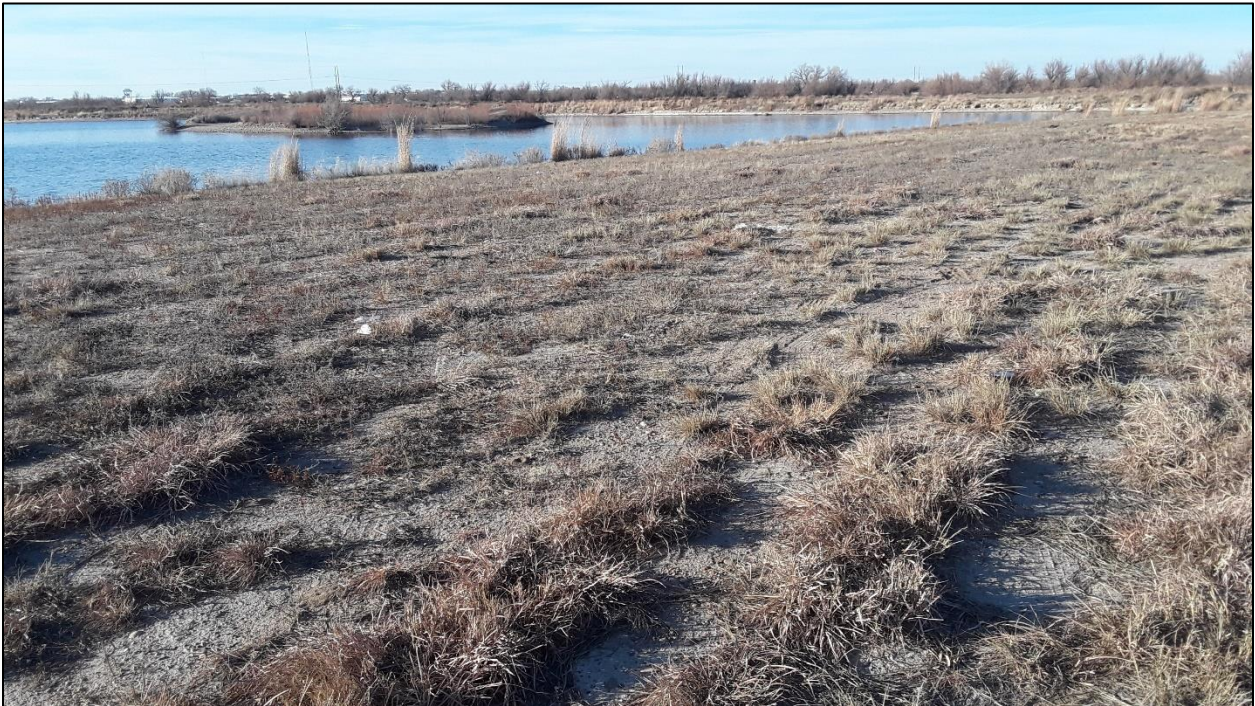
**Photo 18.** View looking northwest across land between eastern pond and gravel road. The operator keeps this area mowed. Note vegetative cover across area consisting mostly of native grasses.

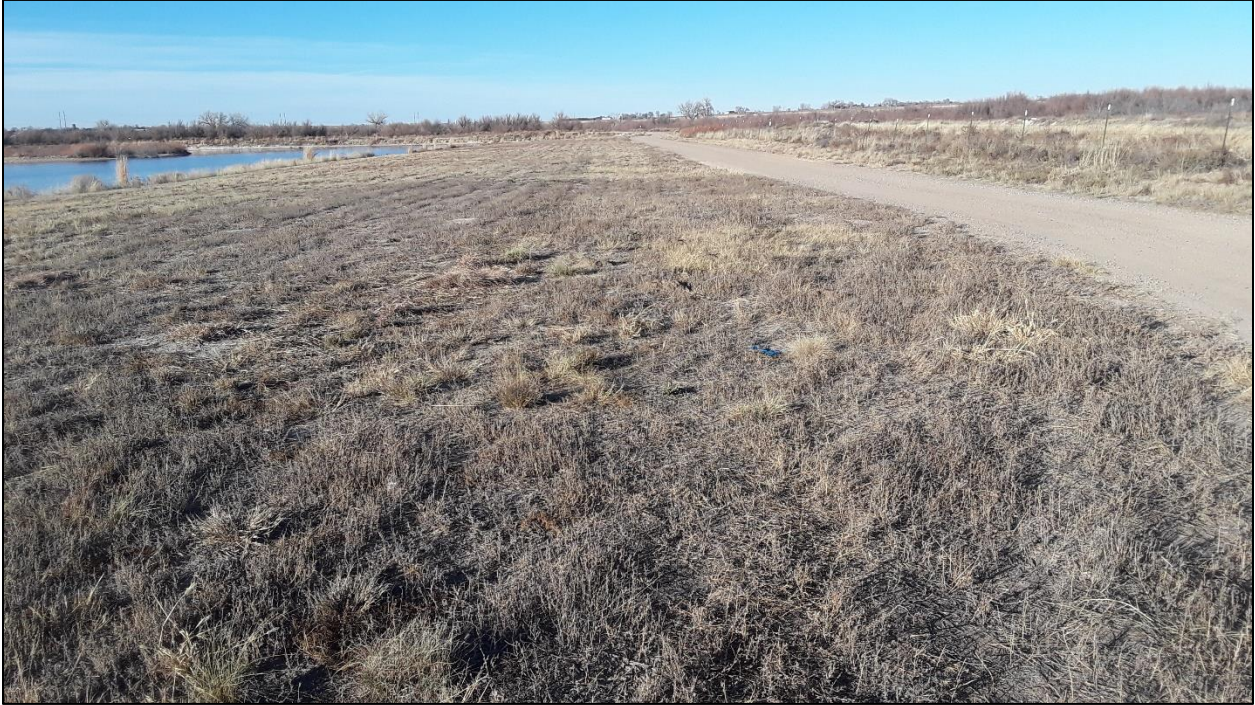
**Photo 19.** View looking north across land between eastern pond and gravel road. The operator keeps this area mowed. Note vegetative cover across area consisting mostly of native grasses. Gravel road that encircles the site shown at right.

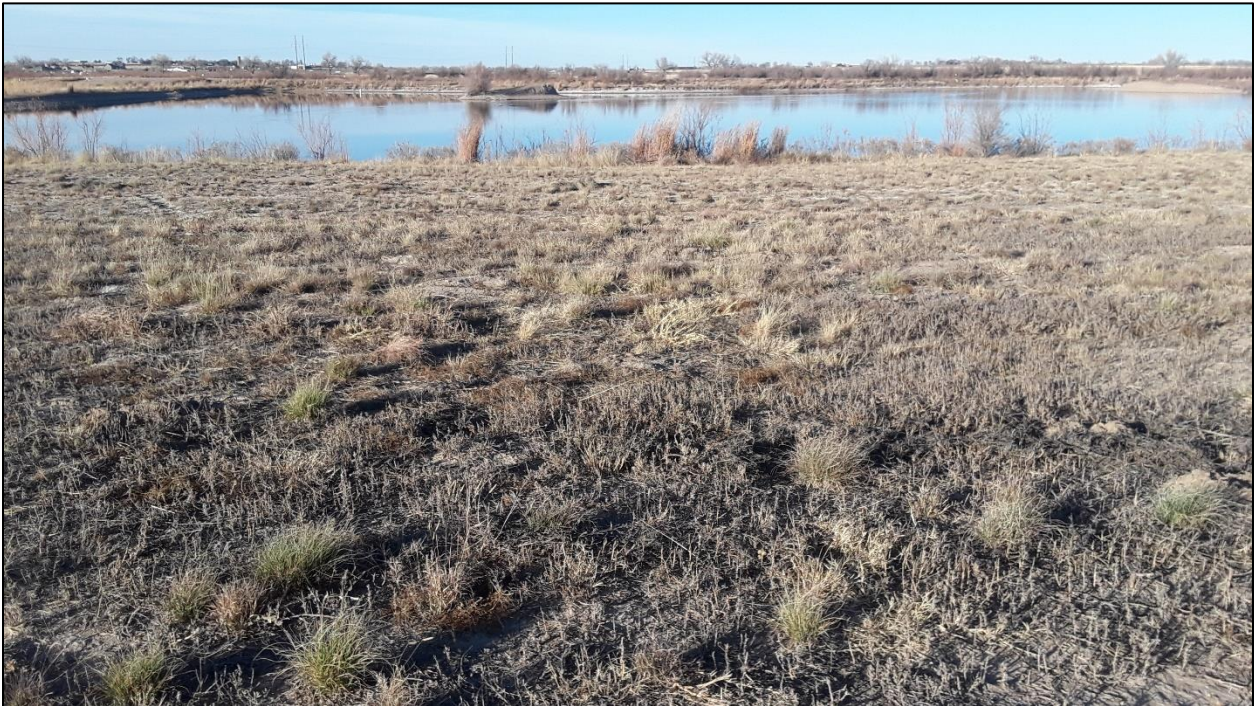
**Photo 20.** View looking north across land south of eastern pond, showing area fairly well vegetated with newer grass growth than present along northern shoreline.

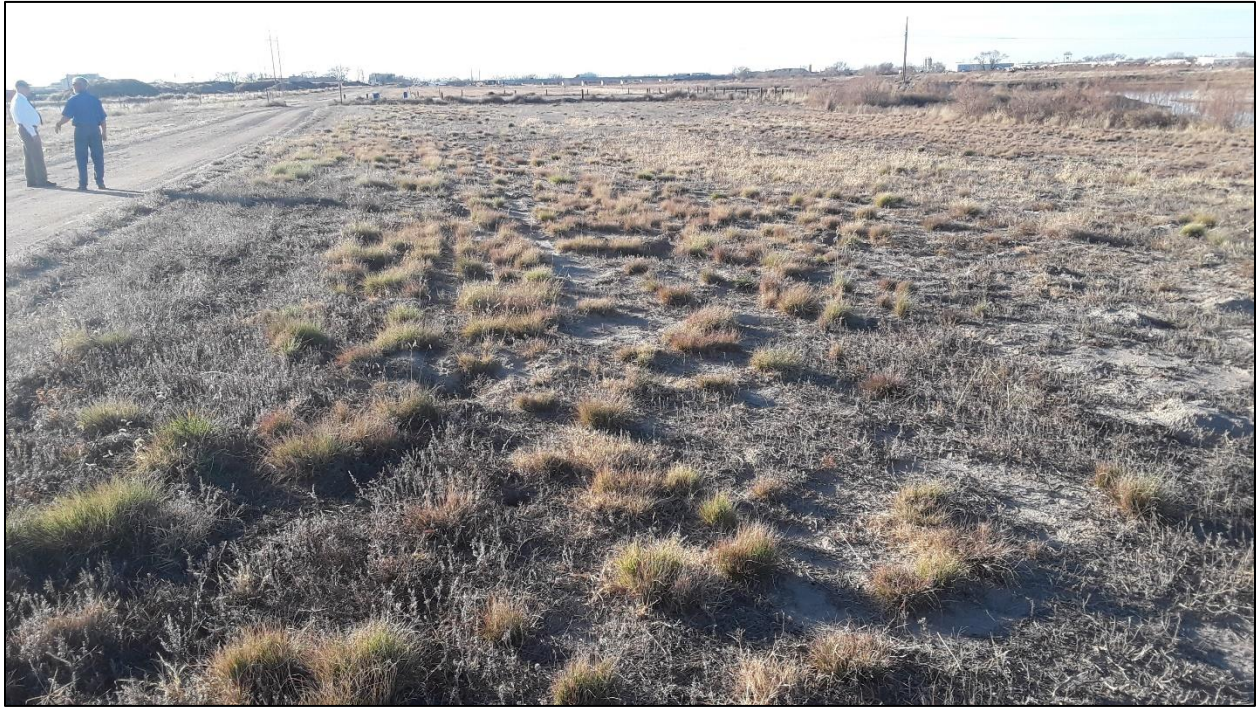
**Photo 21.** View looking west across land south of eastern pond, showing area fairly well vegetated with newer grass growth than present along northern shoreline.

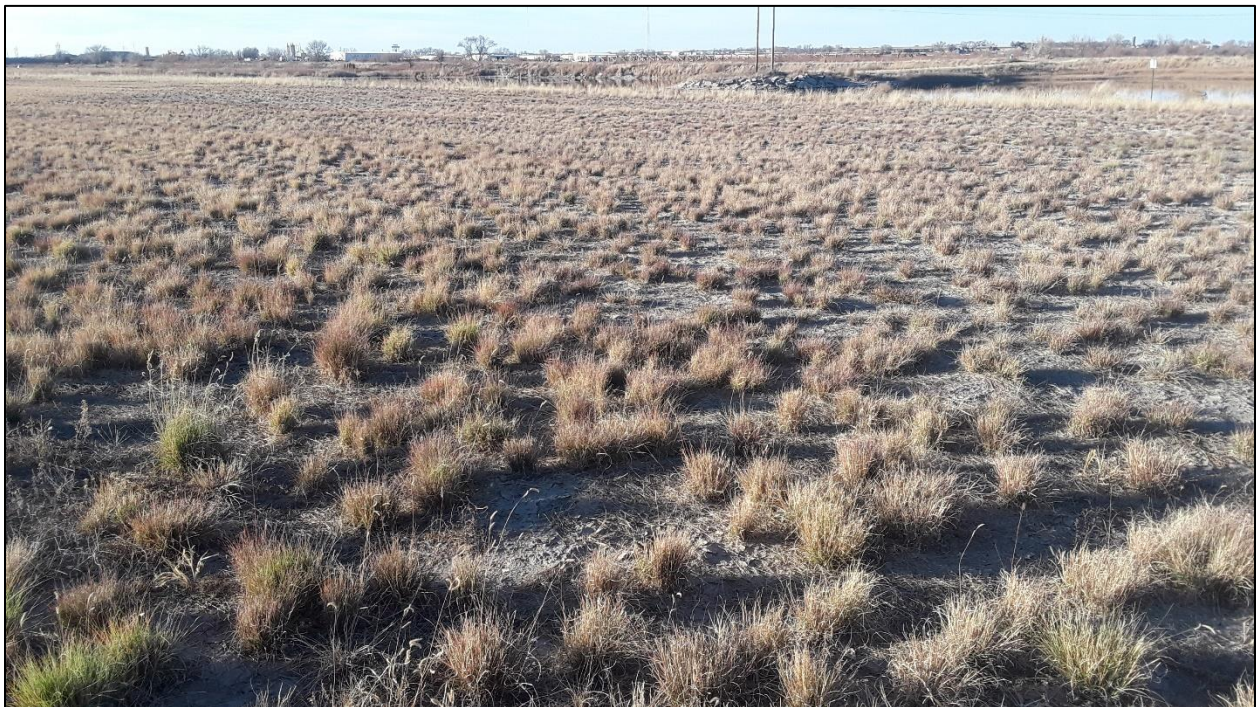
**Photo 22.** View looking northwest across land south of middle pond, showing area fairly well vegetated with newer grass growth than present along northern shoreline.

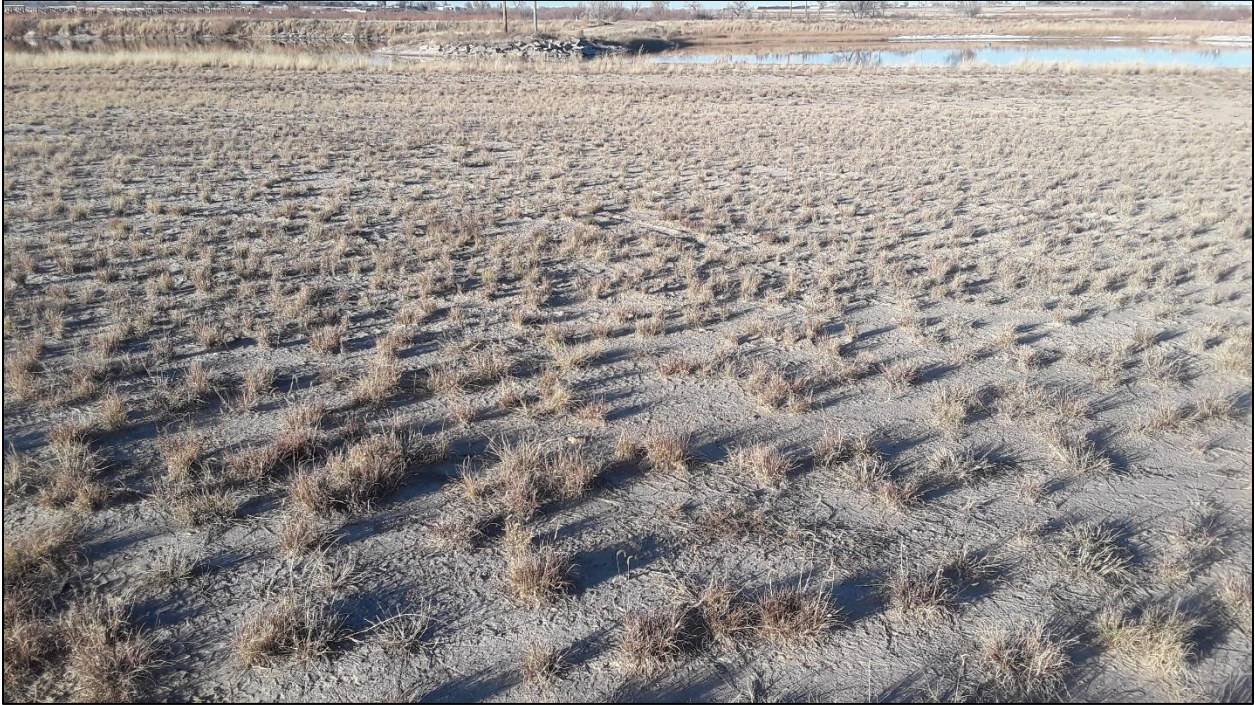
**Photo 23.** View looking north across land south of middle pond, showing area fairly well vegetated with newer grass growth than present along northern shoreline.

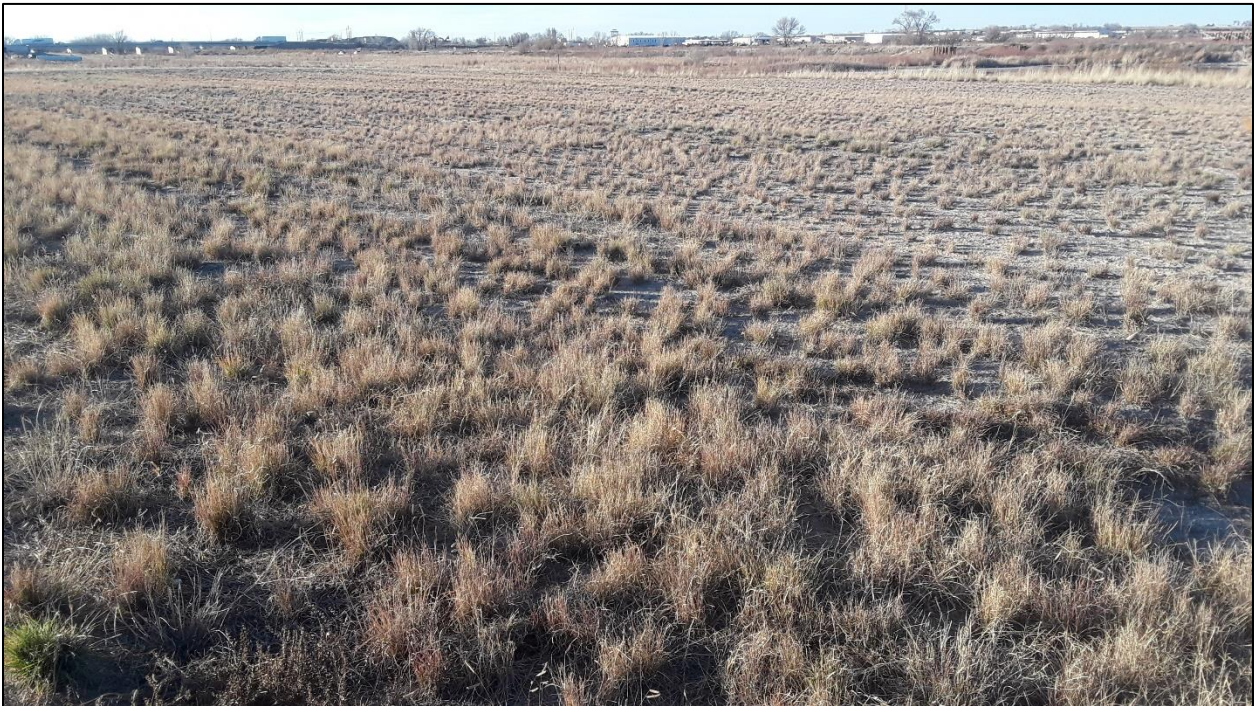
**Photo 24.** View looking west across land south of middle pond, showing area fairly well vegetated with newer grass growth than present along northern shoreline.

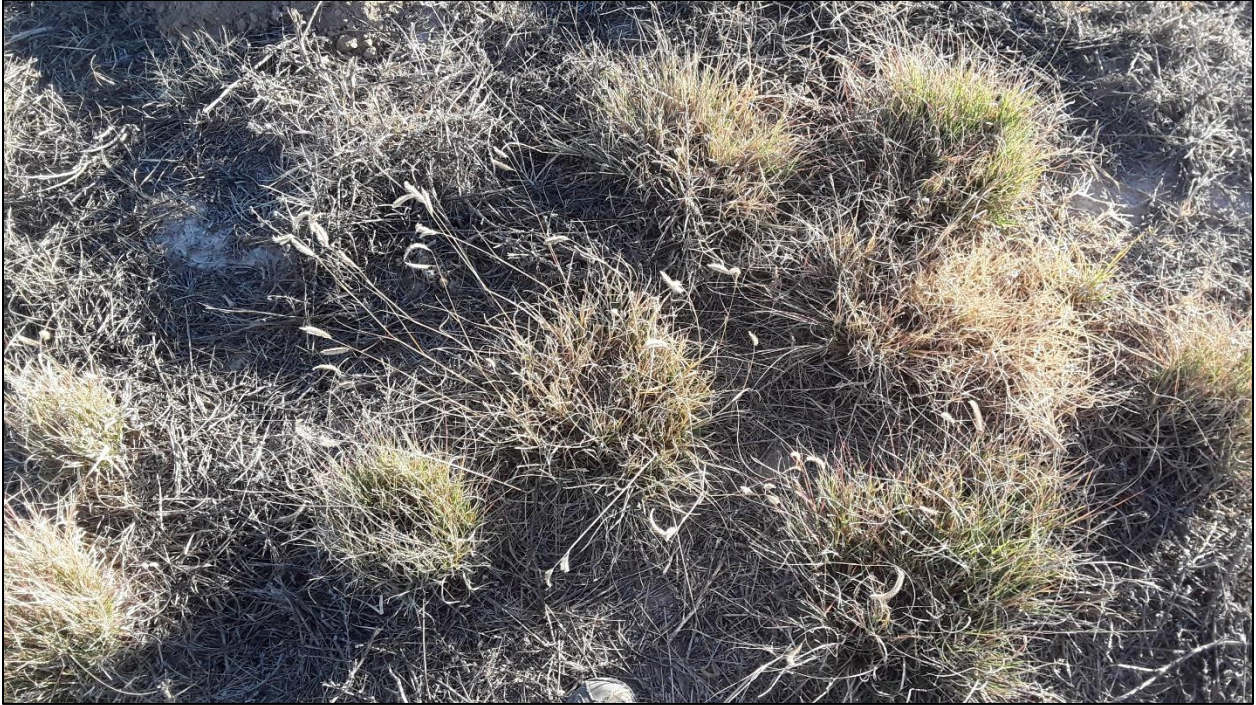
**Photo 25.** Representative ground view of land south of middle and eastern ponds with good grass growth.
