Weekly VLF2 Update

The geomembrane liner integrity investigation has continued to make steady progress with Newfields overseeing Ames Construction as they continue to remove material from the investigation area. Utilizing several pieces of equipment including; a CAT 321C L excavator, a CAT D6T LGP dozer and a CAT D9T dozer, material has been removed between the 9850' elevation and the 9650' bench.

Cripple Creek and Victor Gold Mining Co.

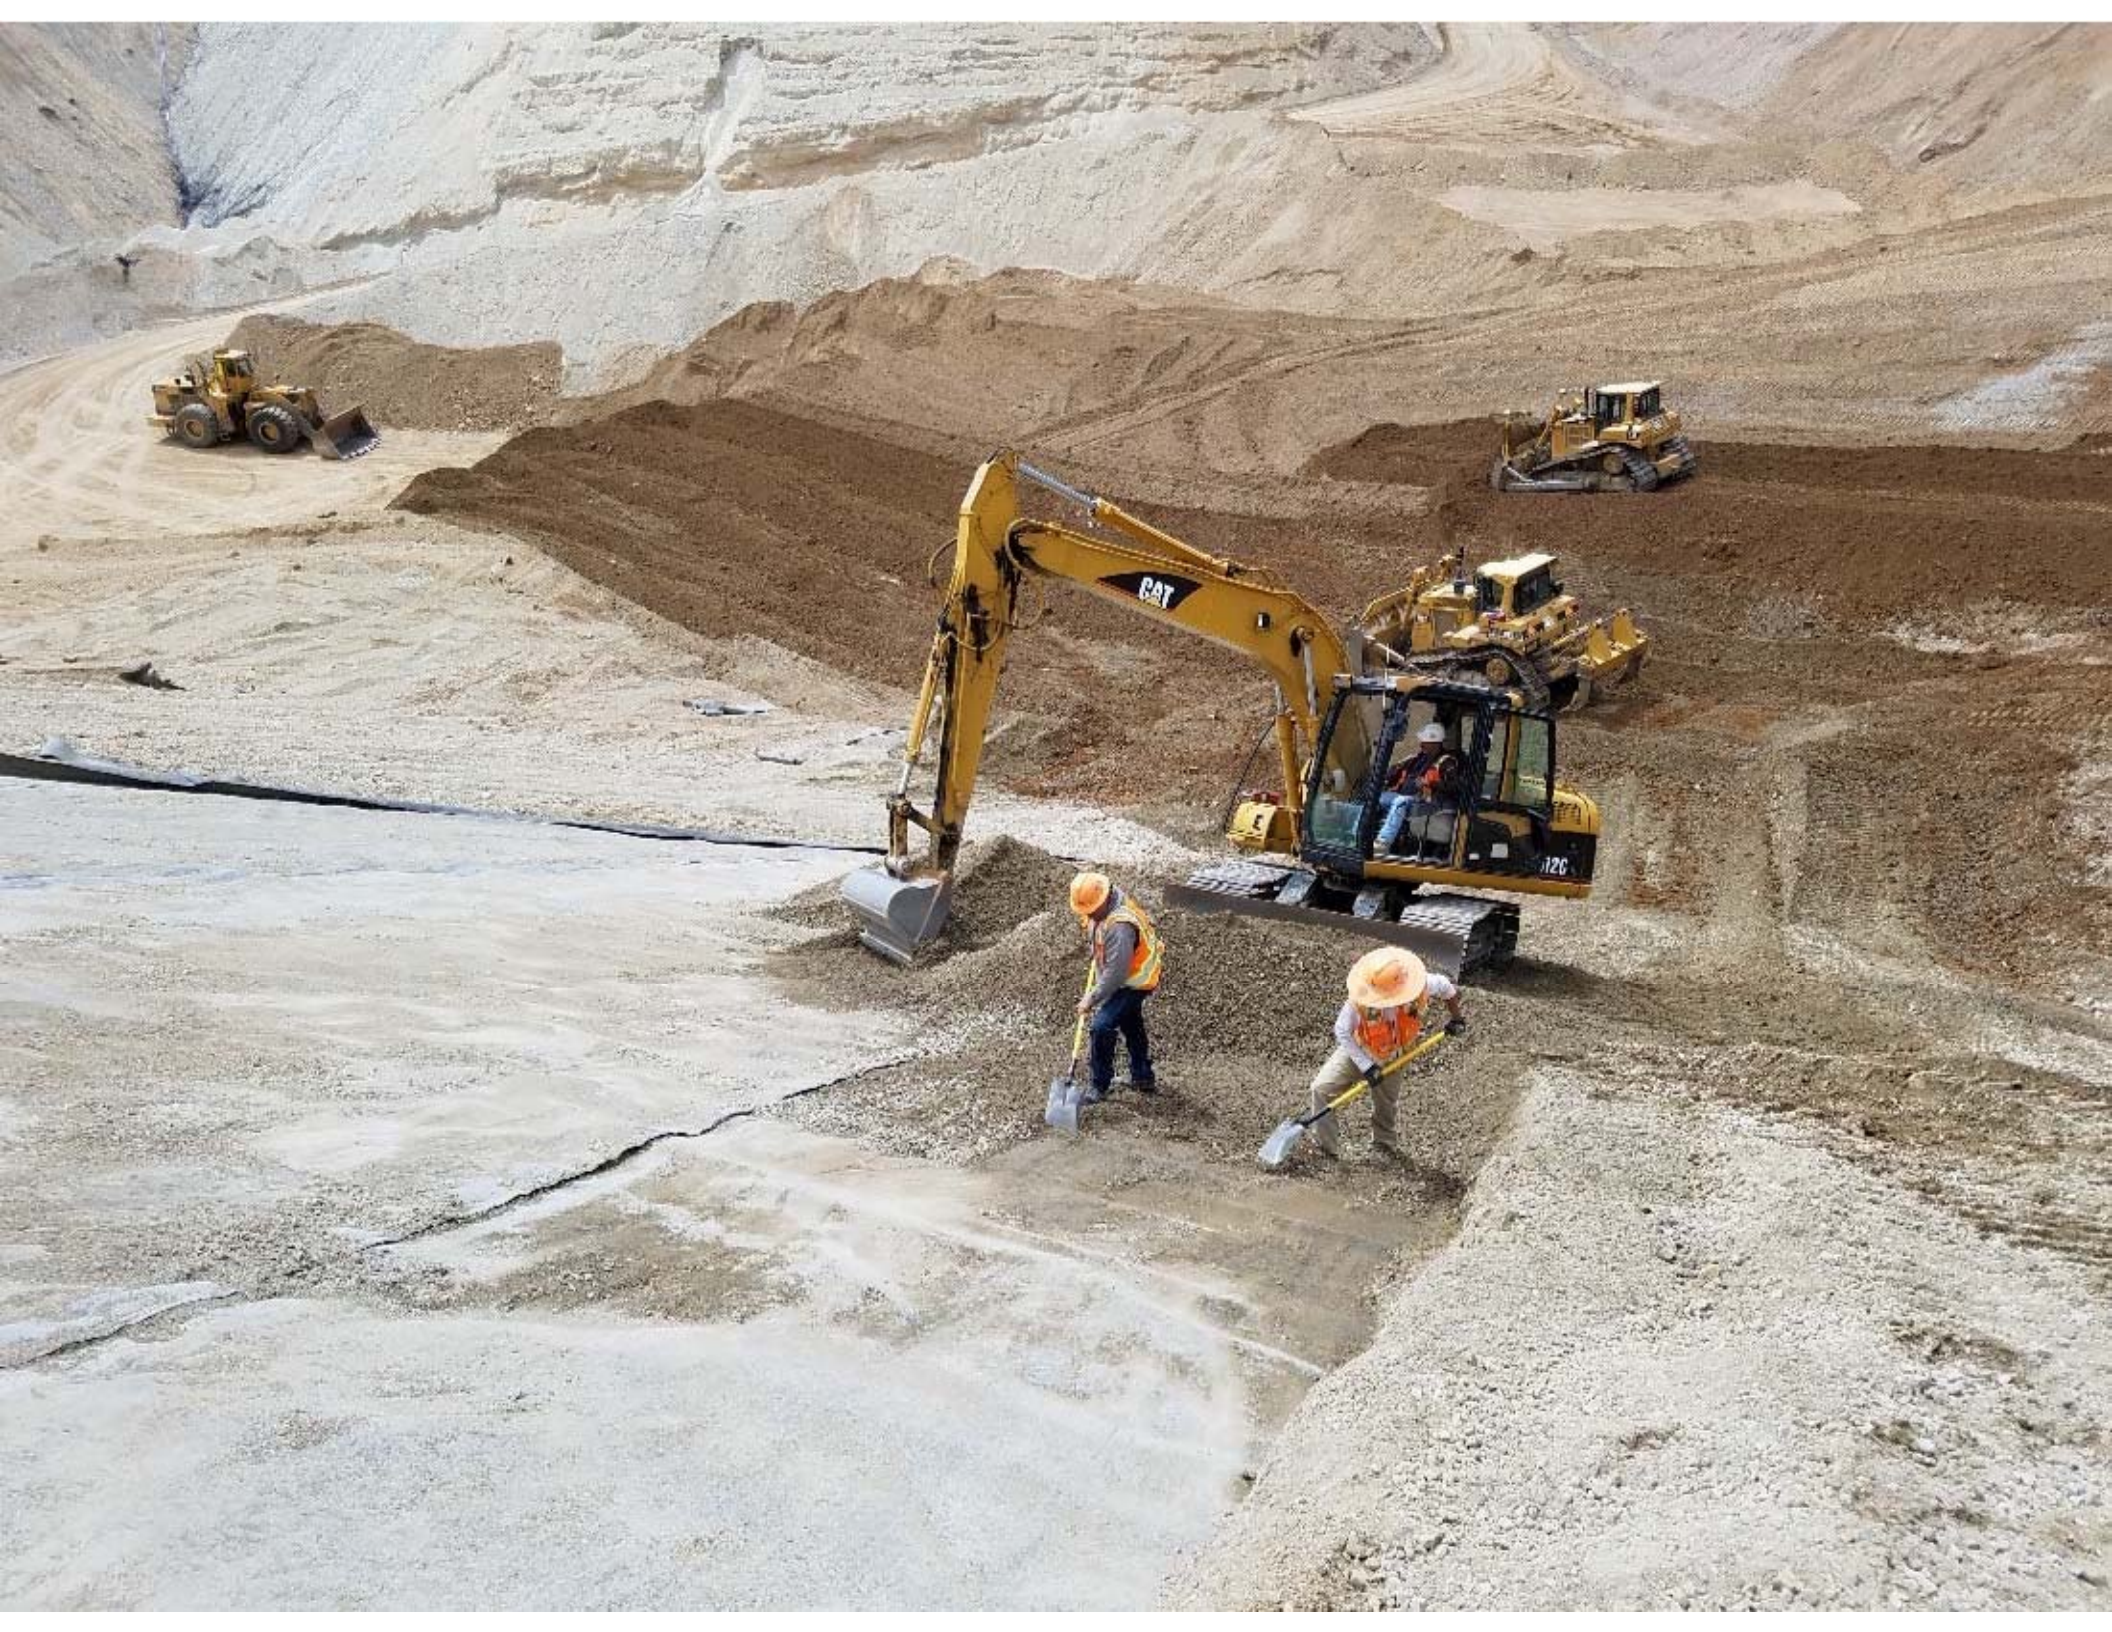
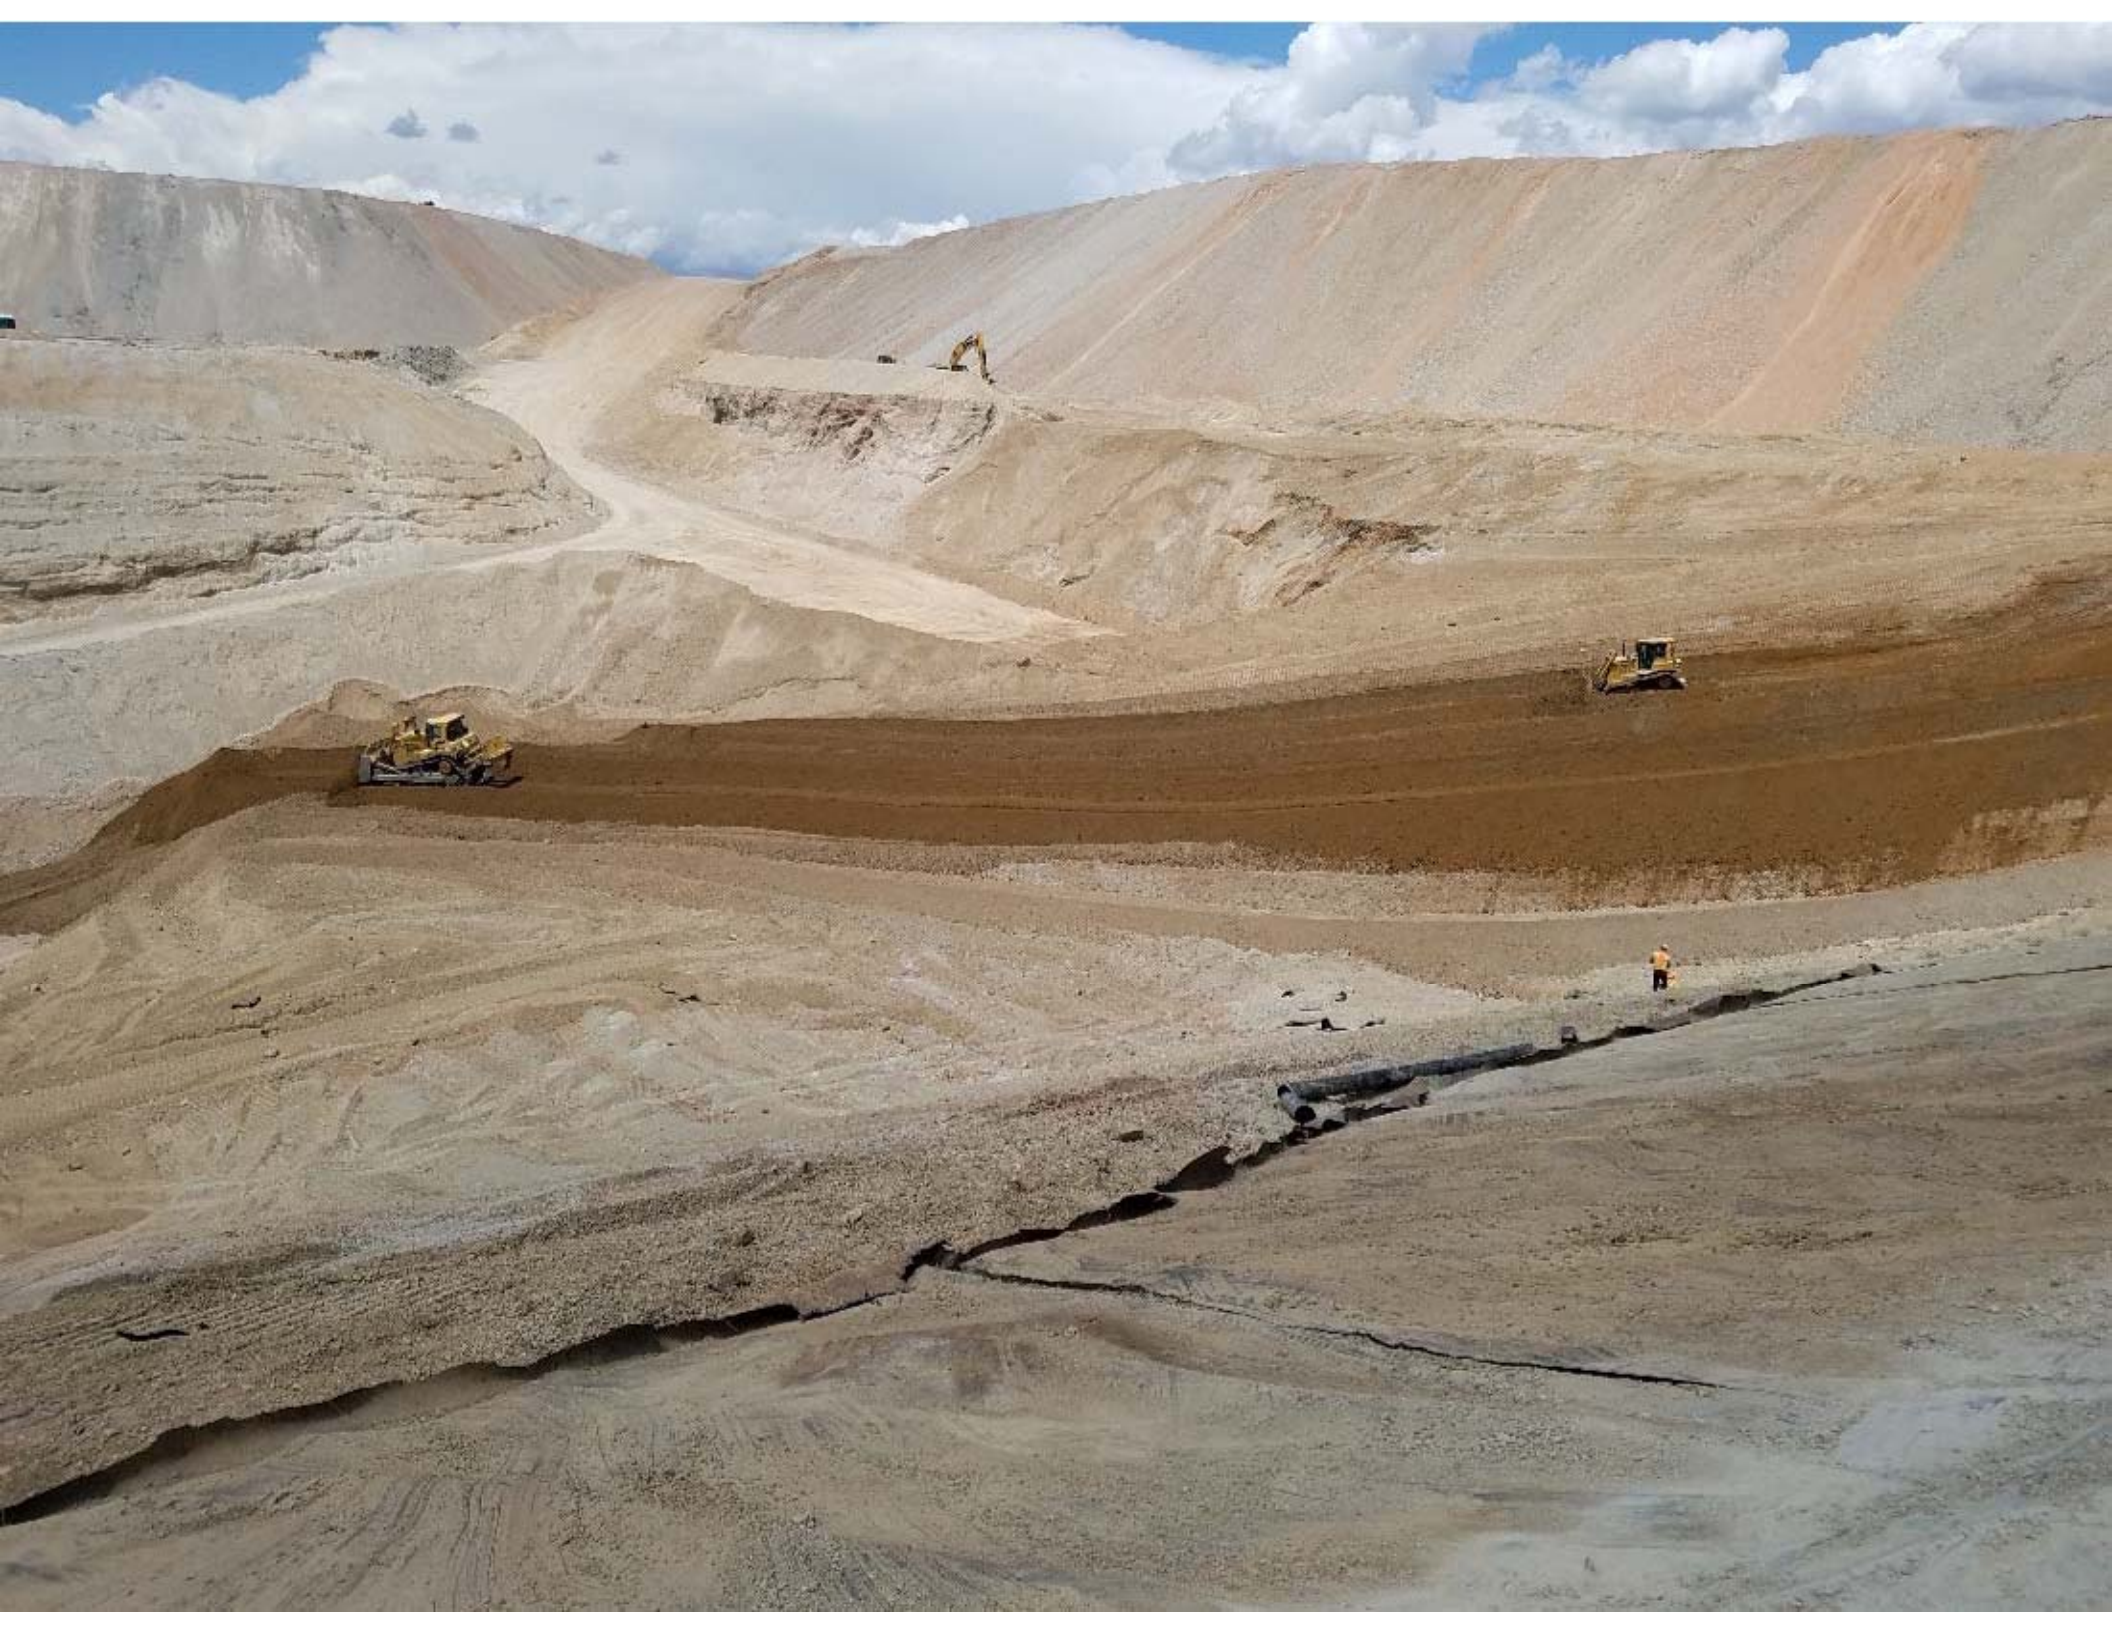
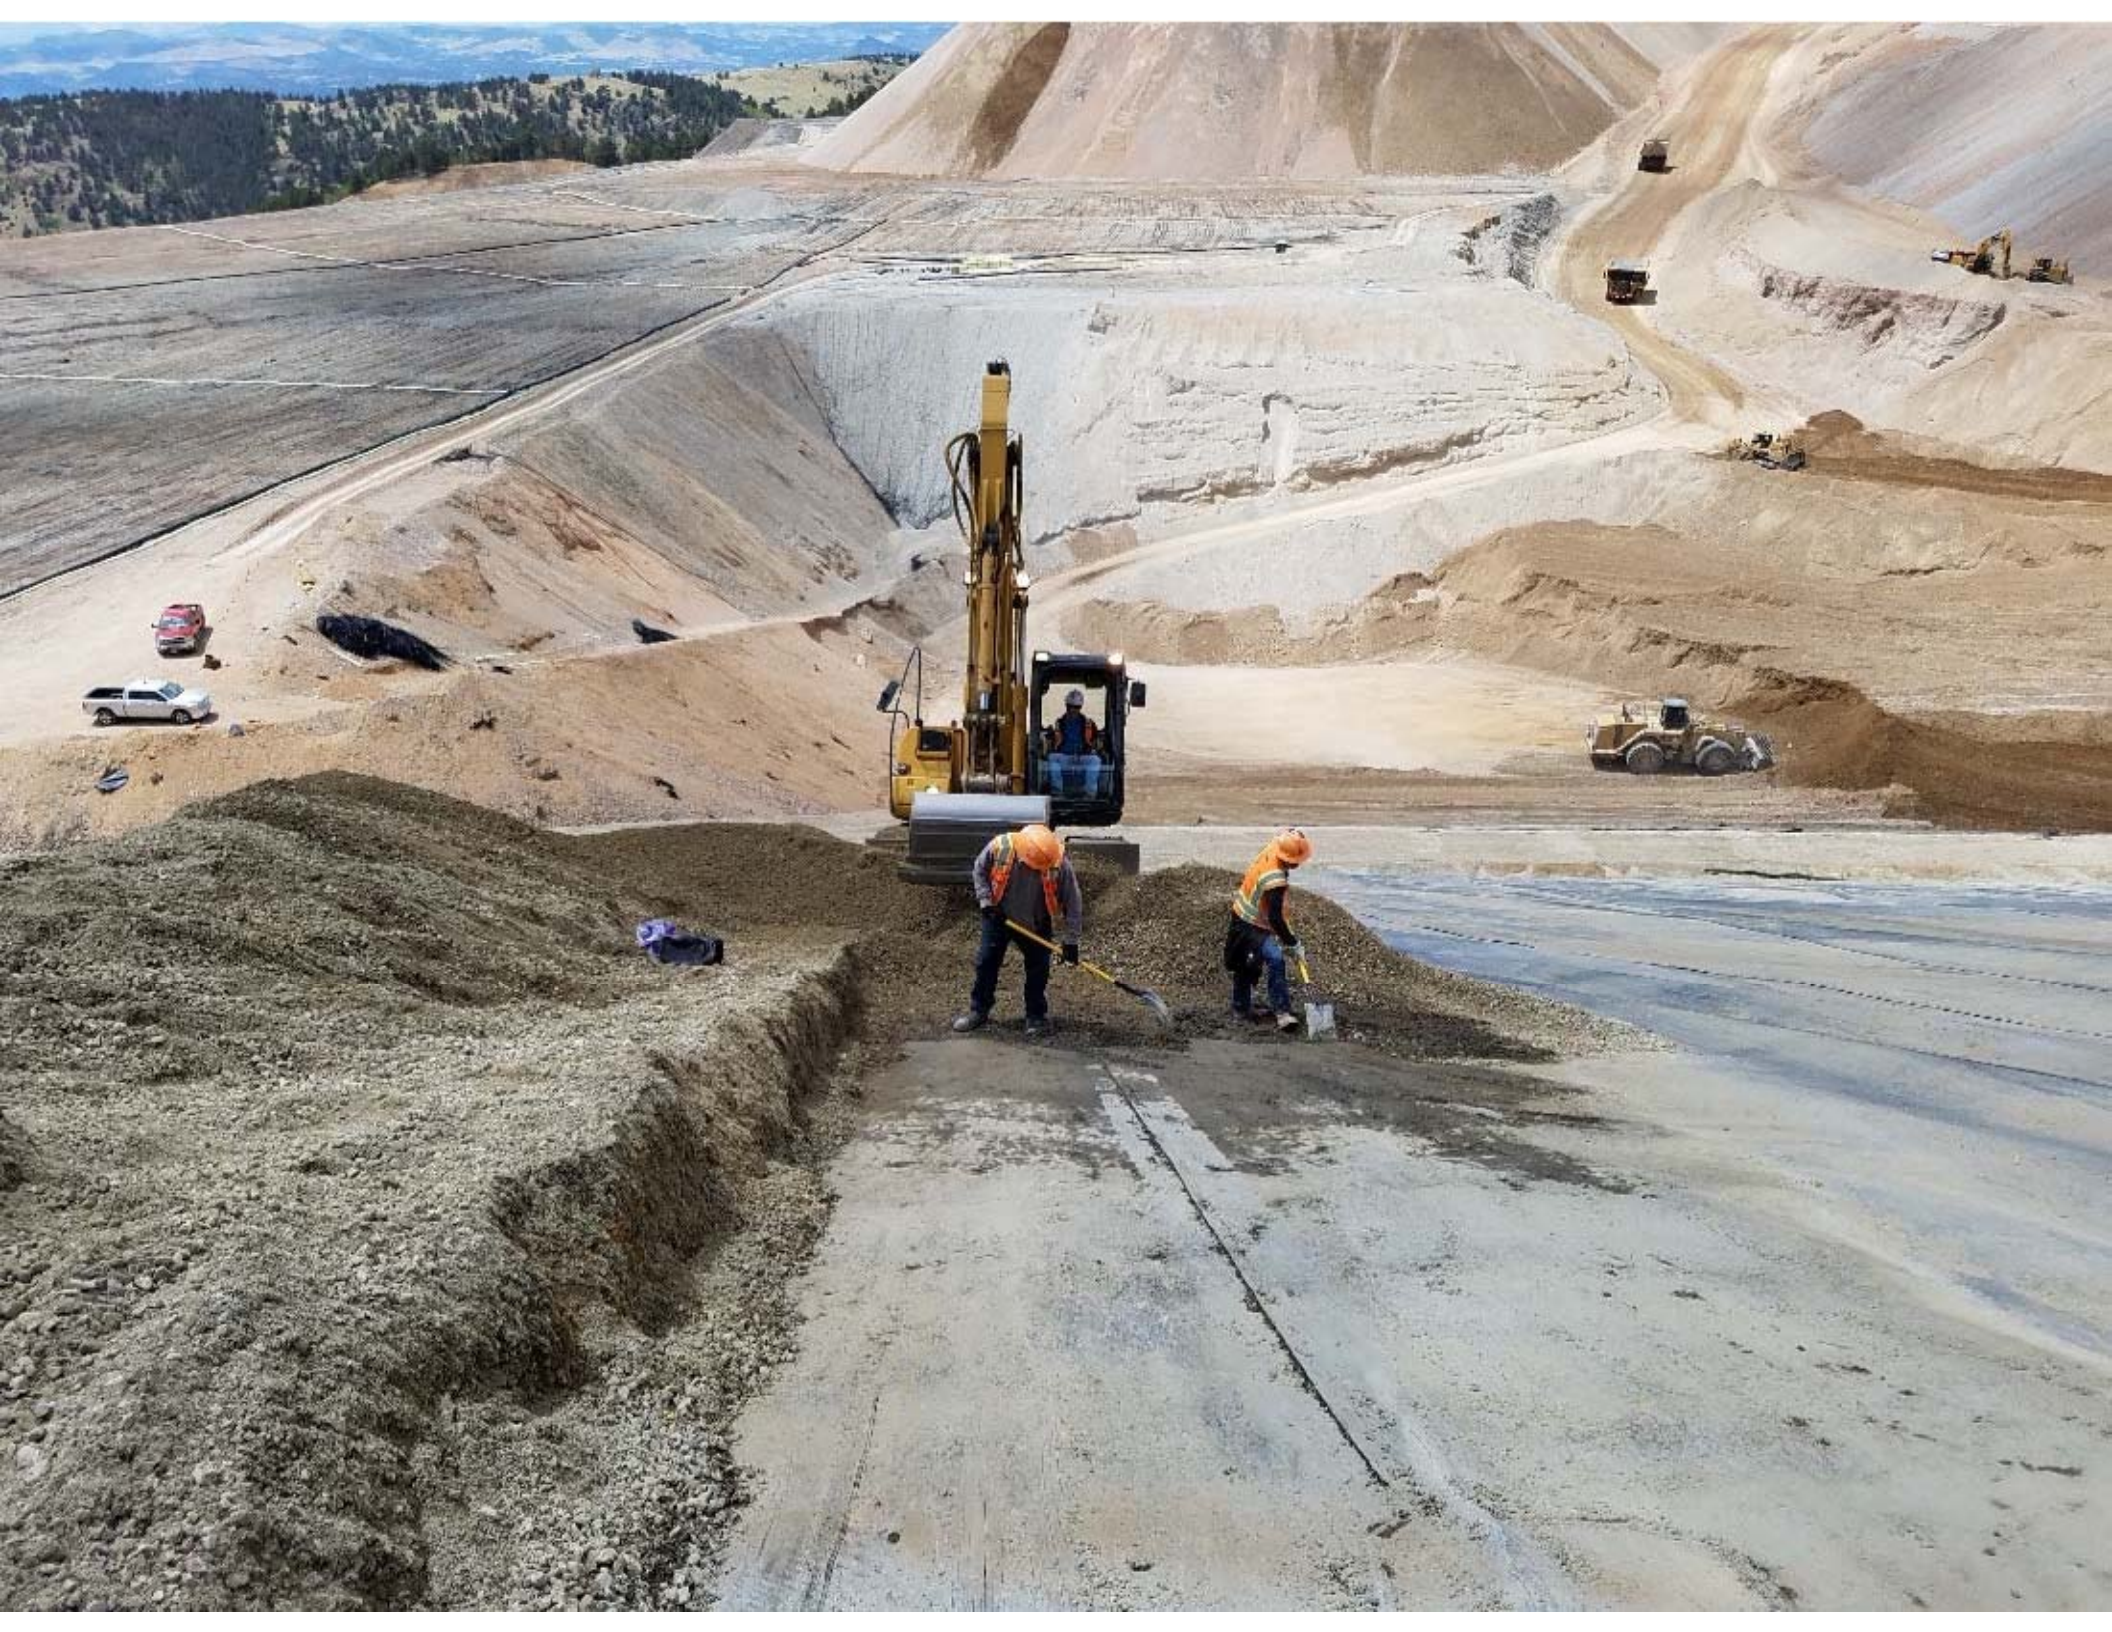
Currently, material has been removed and the liner exposed from approximately the 9660' elevation to the 9850' bench. Approximately 50' of liner has been exposed to the north of the liner tear, and 40' to the south of the liner tear.
