Weekly Liner Update

Liner replacement has continued without issue in the VLF2 repair area. Liner placement was completed between the 9650' and 9750' elevations on June 23. The anchor trench at the 9850' bench was excavated using a CAT 305.5 E mini excavator. A Cat 336 F excavator was used to remove geomembrane and expose the soil liner fill between the 9750' and 9850' benches. Drain cover fill (DCF) was removed from the 9750' bench to expose existing geomembrane. Four soil liner fill (SLF) depth checks were completed between the 9750' and 9850' benches; all test results indicated >12" of SLF.

Newmont Mining Corporation
Cripple Creek and Victor Gold Mining Co.

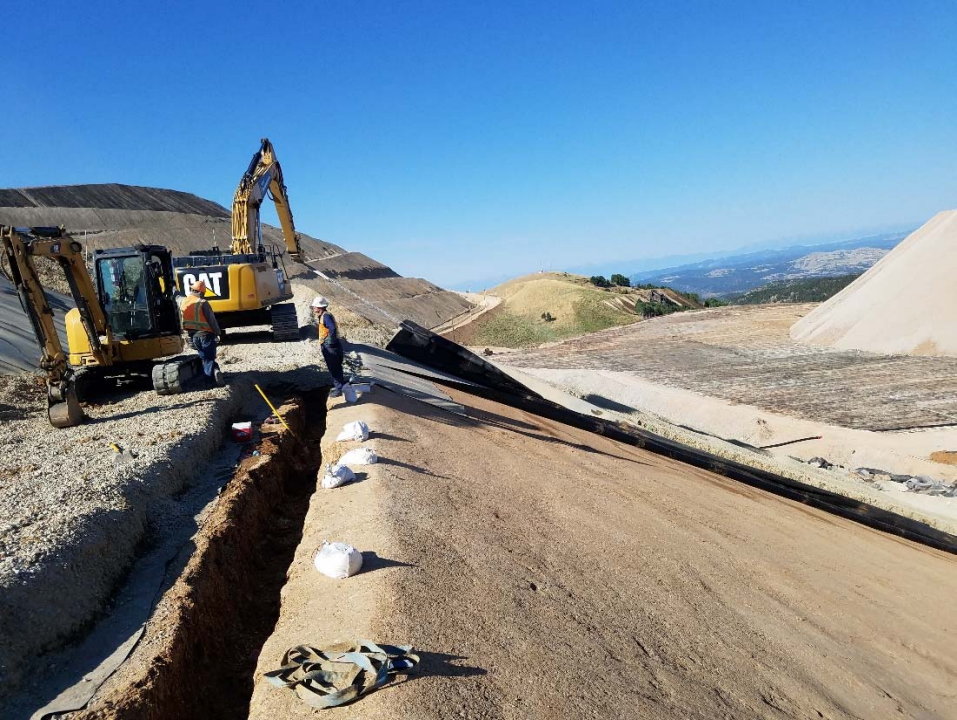
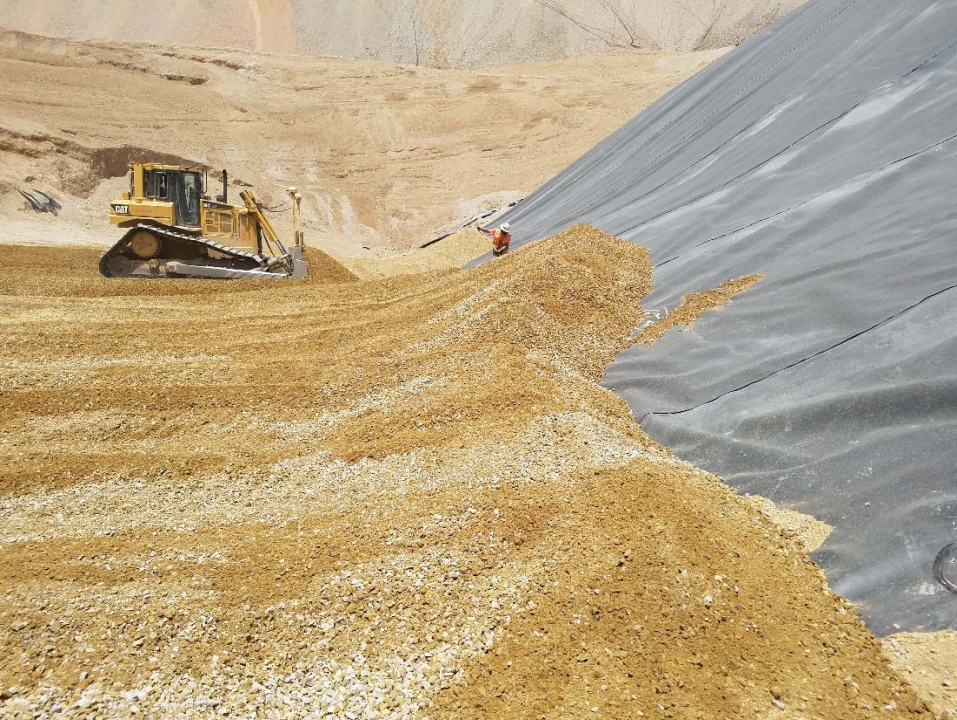
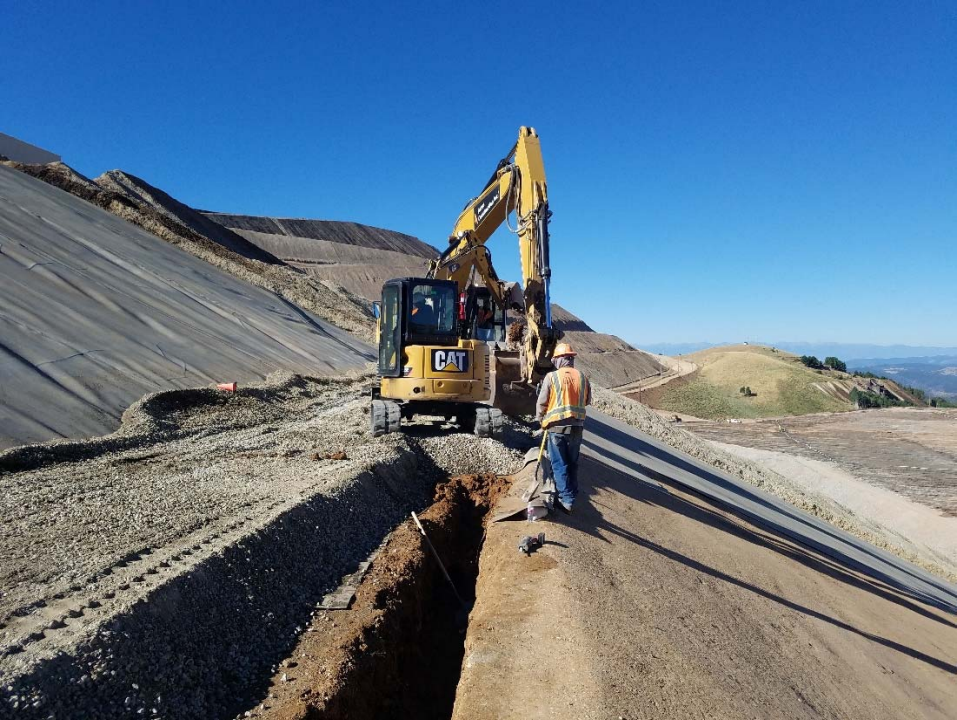
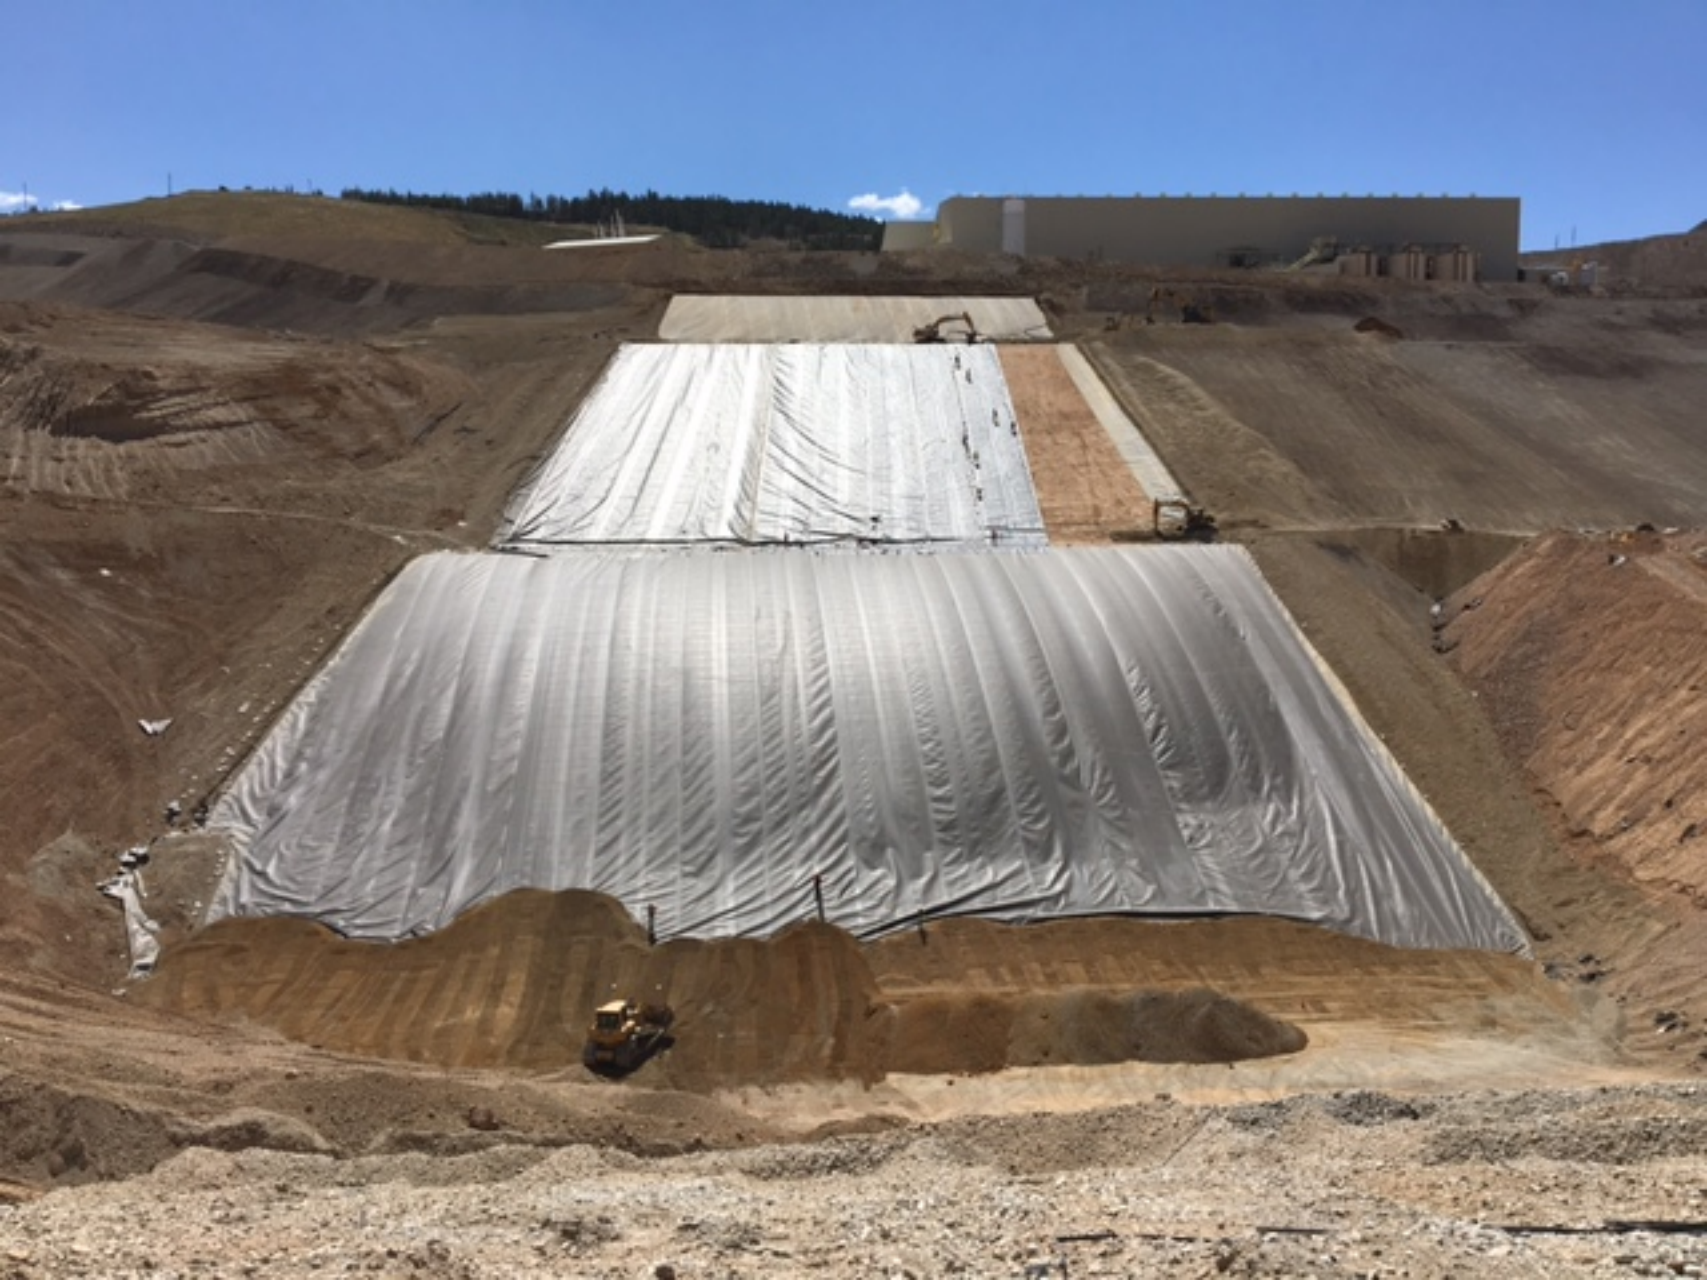
Deployment of 80 Mil LLPDE double sided textured geomembrane began between the 9850' and 9750' elevations began on June 27th. The liner panel seaming was performed using one fusion machine/operator method. Non-destructive testing was performed for fusion welded seams. Repairs were performed using the extrusion welding method for all marked defects.

DCF was stockpiled at the 9650' bench. Once Newfields inspected and approved the panels between the 9650' and 9750' elevations for DCF placement, Ames began pushing a two-foot lift of DCF from the 9650' stockpile onto the geomembrane using a CAT D6 LGP dozer.
