MINERALS PROGRAM INSPECTION REPORT
PHONE: (303) 866-3567

MINE NAME: Base Product Gravel Pit 1	MINE/PROSPECTING ID#: M-1994-053	MINERAL: Sand and gravel and material for construc	COUNTY: Montrose
INSPECTION TYPE: Preoperation Inspection	INSPECTOR(S): Lucas J. West	INSP. DATE: July 10, 2018	INSP. TIME: 10:10
OPERATOR: Rock Pile, LLC	OPERATOR REPRESENTATIVE: Doug Flowers	TYPE OF OPERATION: 112c - Construction Regular Operation	
REASON FOR INSPECTION: Pre-operation Inspection	BOND CALCULATION TYPE: None	BOND AMOUNT: \$32,303.00	
DATE OF COMPLAINT: NA	POST INSP. CONTACTS: None	JOINT INSP. AGENCY: None	
WEATHER: Clear	INSPECTOR'S SIGNATURE:

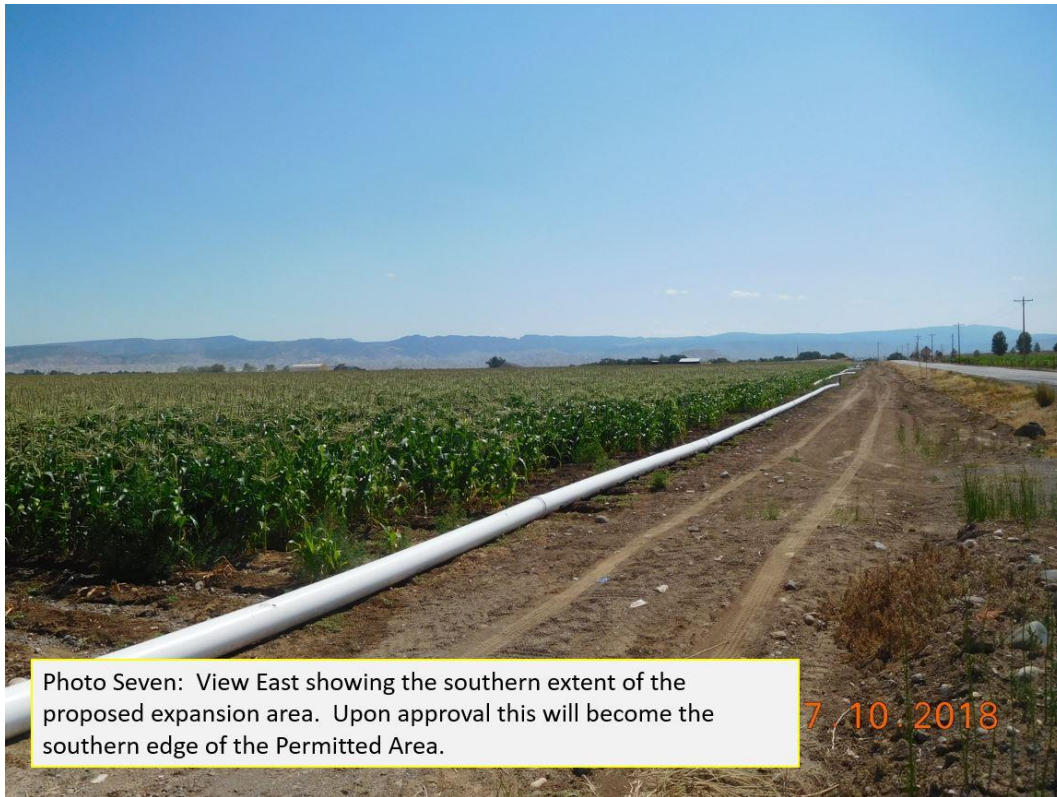
The expansion area consists of two 40 acre fields that are currently being utilized for irrigated crop land. The area can be seen in Photos Four through Seven. The proper public notice signage was posted at the entrance to the site as required by Rule 1.6.2 (b). Discussions with the operator indicate that this area is being permitted as a reserve and will likely remain unaffected for several years until both the Phase One and Phase Two areas are mined out. The expansion area is in good condition and remain to be utilized as irrigated cropland until such time as the mining activity progresses.

Photo Six: View North showing the proposed expansion area. This photo is taken from the far Southwest corner of the expansion area.
