MINERALS PROGRAM INSPECTION REPORT**PHONE: (303) 866-3567**

MINE NAME: West Farm Pit	MINE/PROSPECTING ID#: M-2008-078	MINERAL: Gravel and sand	COUNTY: Prowers
INSPECTION TYPE: Monitoring	INSPECTOR(S): Amy Eschberger	INSP. DATE: June 14, 2018	INSP. TIME: 13:45
OPERATOR: Prowers Aggregate Operators, LLC	OPERATOR REPRESENTATIVE: Ron Peterson	TYPE OF OPERATION: 112c - Construction Regular Operation

REASON FOR INSPECTION: Citizen Complaint	BOND CALCULATION TYPE: None	BOND AMOUNT: \$575,000.00
DATE OF COMPLAINT: June 11, 2018	POST INSP. CONTACTS: Colorado Parks & Wildlife	JOINT INSP. AGENCY: Colorado Parks & Wildlife - Jim Ramsay
WEATHER: Clear	INSPECTOR'S SIGNATURE:

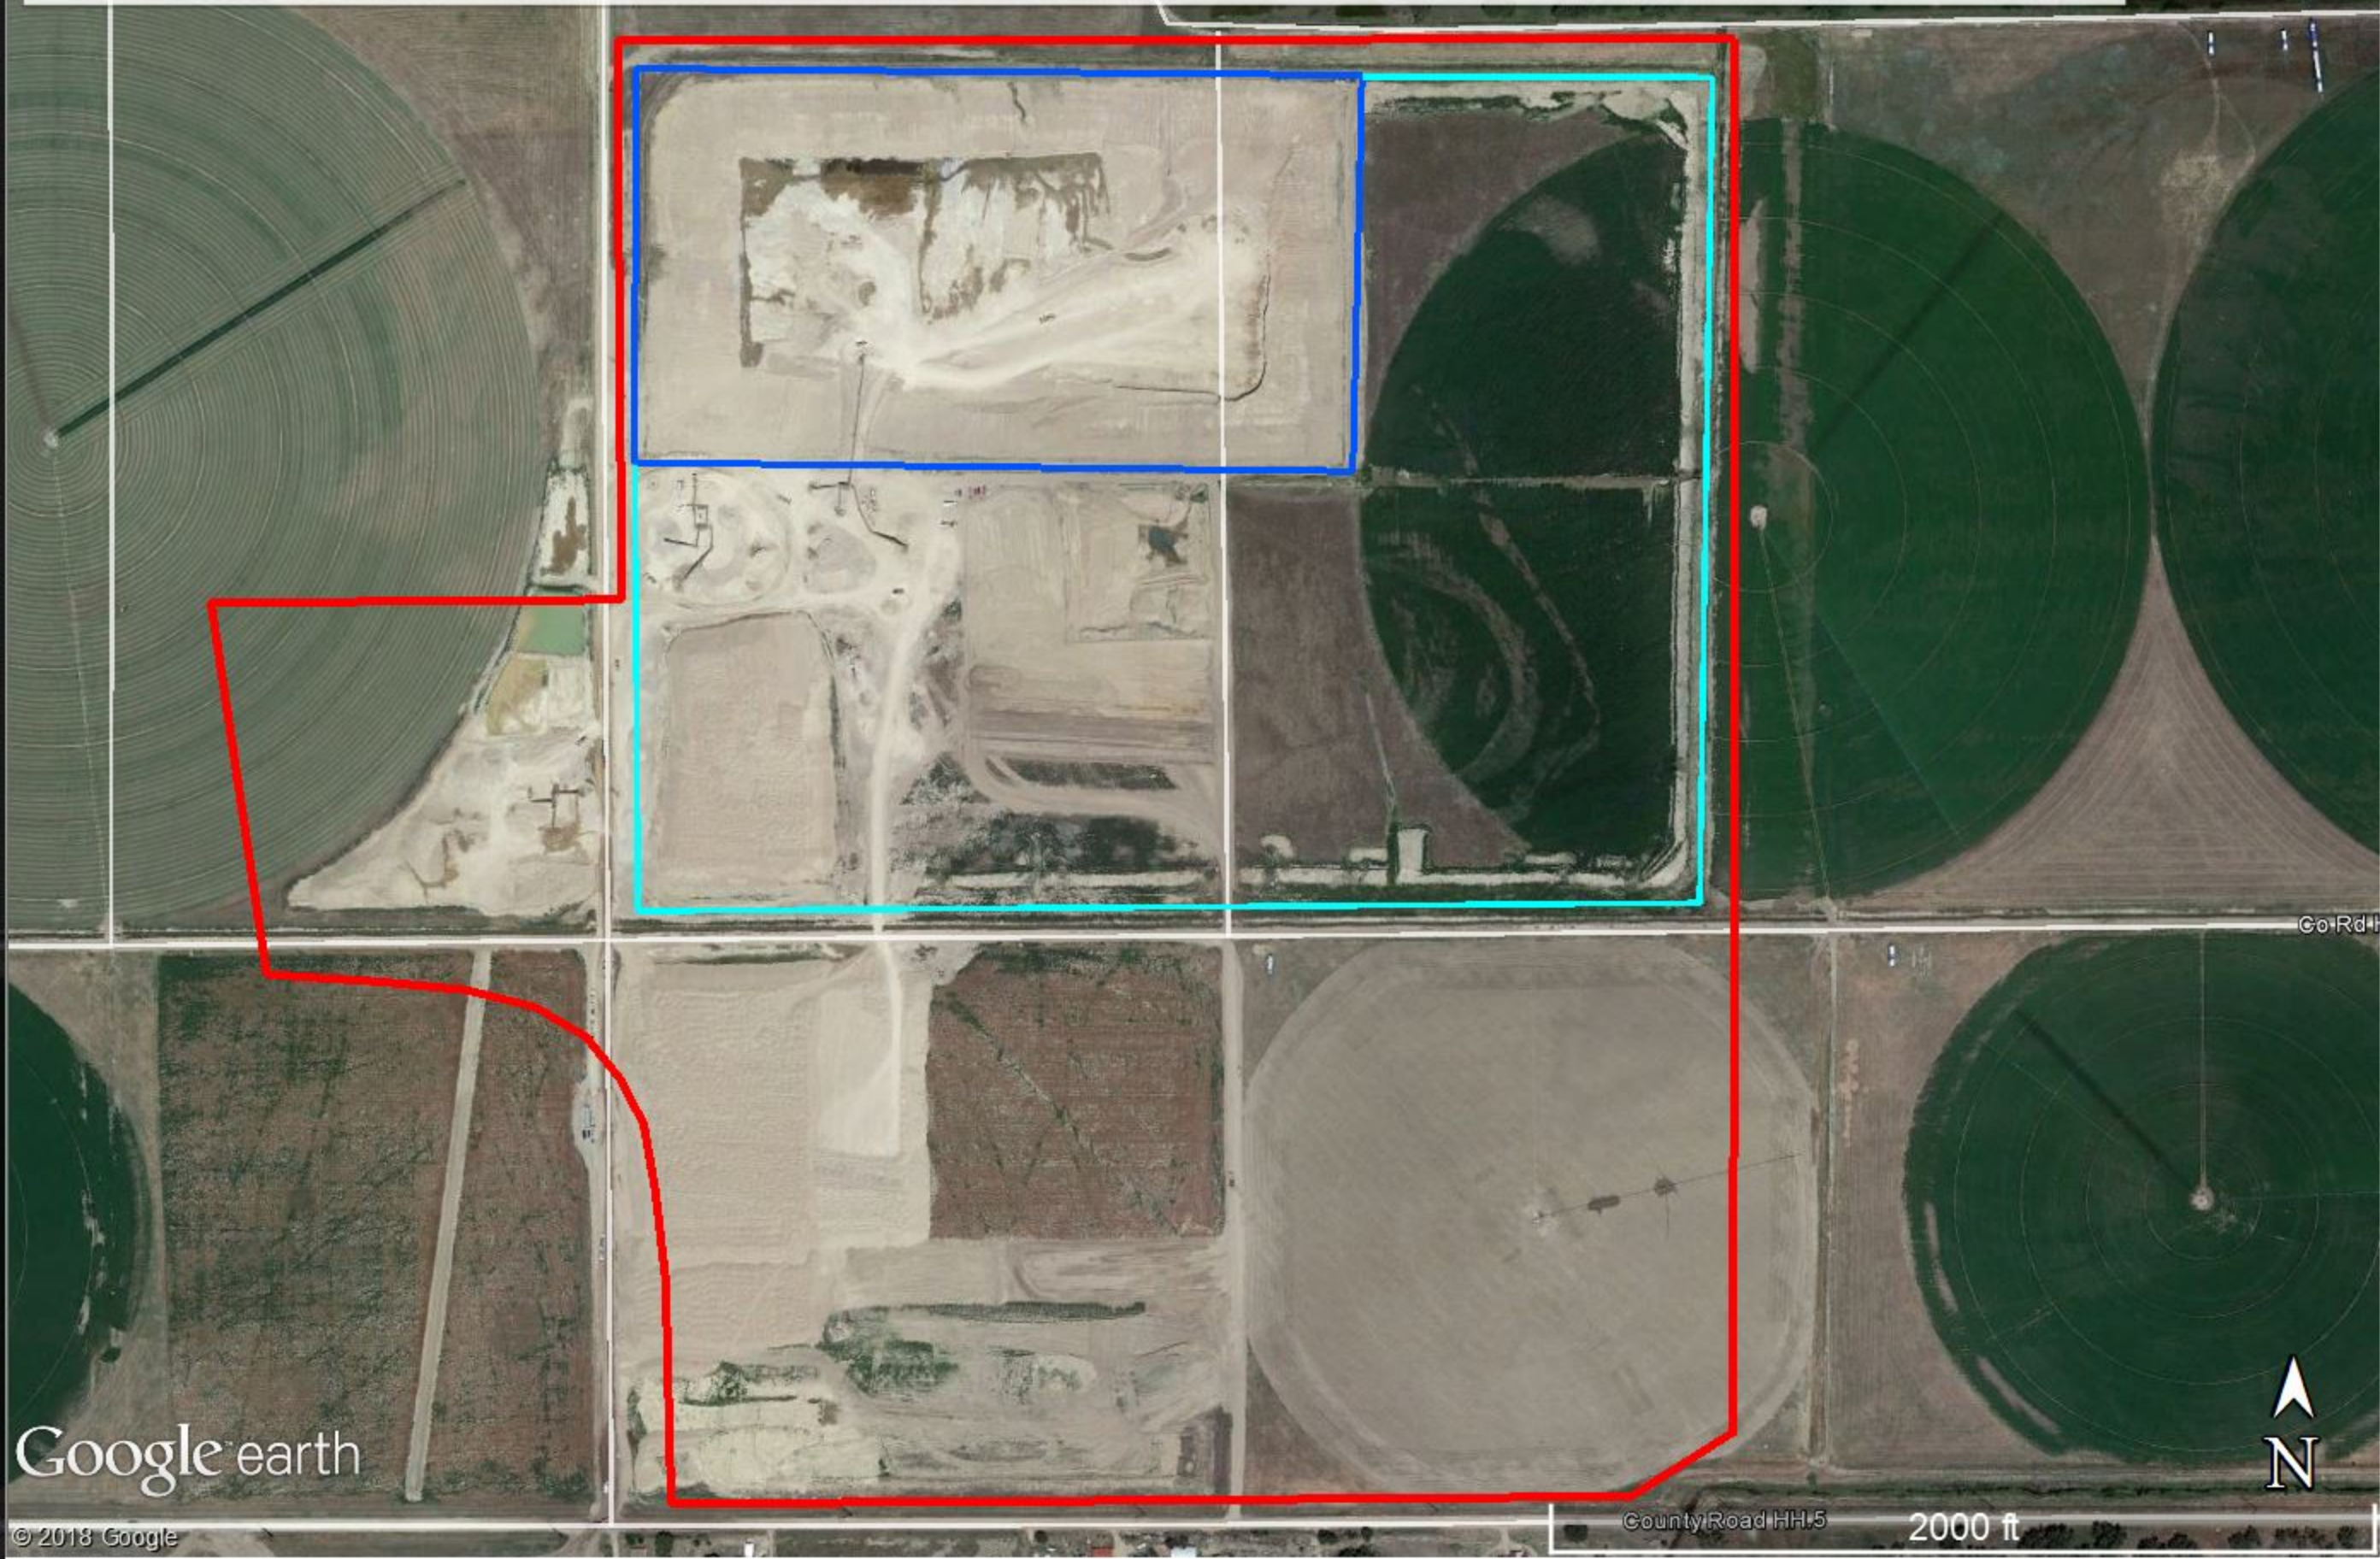
Dark Blue Outline = 37.77 acres = Old Slurry Wall Enclosure (Phase 1-4)

Light Blue Outline = 81 acres = Approx. Location of New Slurry Wall Enclosure (Phases 5-12)
