Weekly Liner Update

Cripple Creek and Victor Gold Mining Co.

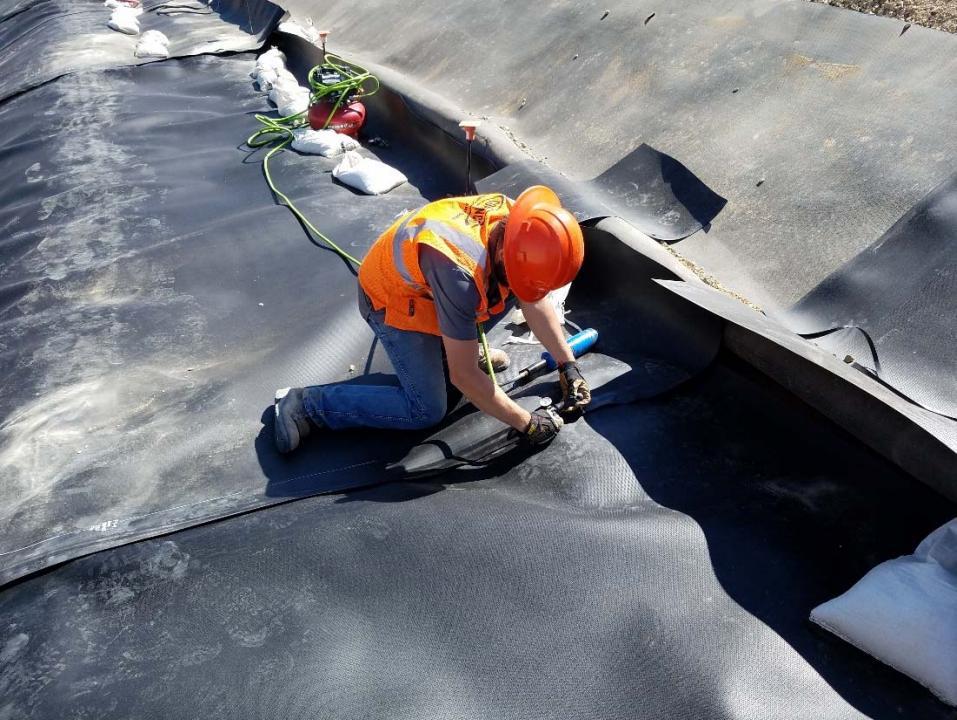
07.06_AnchorTrench.jpg 169K

Additionally, the geomembrane liner between the 9850'-9900' elevations was removed using a CX210C CASE excavator. A CAT 336F and CAT 305.5 E mini excavator were used to complete excavation of the anchor trench on the 9900' bench. Approximately, 22,275 square feet of 80 MIL LLDPE double sided textured geomembrane was installed by Comanco between 9850-and 9900' on July 7, 2018. The liner panel seaming was performed using one fusion machine/operator method. Non-destructive testing was performed for fusion welded seams. Repairs were performed using the extrusion welding method for all marked defects.
