**MINERALS PROGRAM INSPECTION REPORT**  
**PHONE: (303) 866-3567**

<b>MINE NAME:</b> Revenue Mine	<b>MINE/PROSPECTING ID#:</b> M-2012-032	<b>MINERAL:</b> Lead, silver and gold	<b>COUNTY:</b> Ouray
<b>INSPECTION TYPE:</b> Monitoring	<b>INSPECTOR(S):</b> Travis H. Marshall	<b>INSP. DATE:</b> July 31, 2018	<b>INSP. TIME:</b> 10:30
<b>OPERATOR:</b> Ouray Silver Mines Inc.	<b>OPERATOR REPRESENTATIVE:</b> Brian Briggs	<b>TYPE OF OPERATION:</b> 112d-1 - Designated Mining Operation	
<b>REASON FOR INSPECTION:</b> Normal I&E Program	<b>BOND CALCULATION TYPE:</b> Complete Bond	<b>BOND AMOUNT:</b> \$476,269.41	
<b>DATE OF COMPLAINT:</b> NA	<b>POST INSP. CONTACTS:</b> None	<b>JOINT INSP. AGENCY:</b> None	
<b>WEATHER:</b> Clear	<b>INSPECTOR'S SIGNATURE:</b>

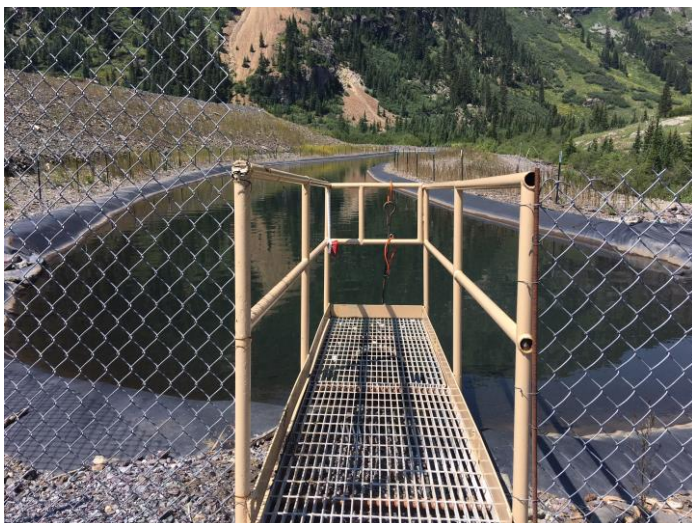
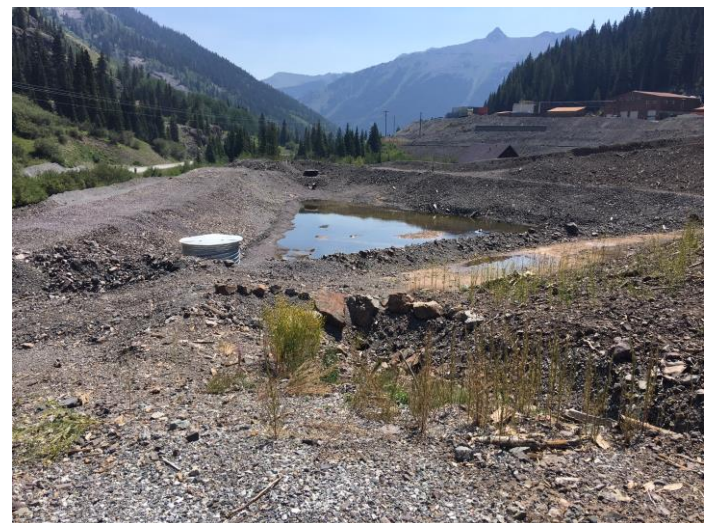
Abandoned Well GW-3A

The replacement well for GW-3A well GW-3R was observed as well as the plugged and abandoned GW-3A well. The operator was notified that the that the abandoned well GW-3A must be in compliance with the Division of Water Resources Rules and Regulations for Water Well Construction, Pump Installation, Cistern Installation and Monitoring and Observation Hole / Well Construction. Specifically, Rule 16 Standards for Plugging, Sealing and Abandoning Wells and Boreholes. Cement was observed in abandoned GW-3A. Please provide the abandonment report required by DWR to DRMS for the Division's record.
