MINERALS PROGRAM INSPECTION REPORT

MINE NAME: Superior S&G Pit	MINE/PROSPECTING ID#: M-1979-189	MINERAL: Sand and gravel	COUNTY: Arapahoe
INSPECTION TYPE: Monitoring	INSPECTOR(S): Jared L. Ebert	INSP. DATE: September 20, 2017	INSP. TIME: 09:00
OPERATOR: City of Aurora	OPERATOR REPRESENTATIVE: Eric Watts, City of Aurora	TYPE OF OPERATION: 112c - Construction Regular Operation

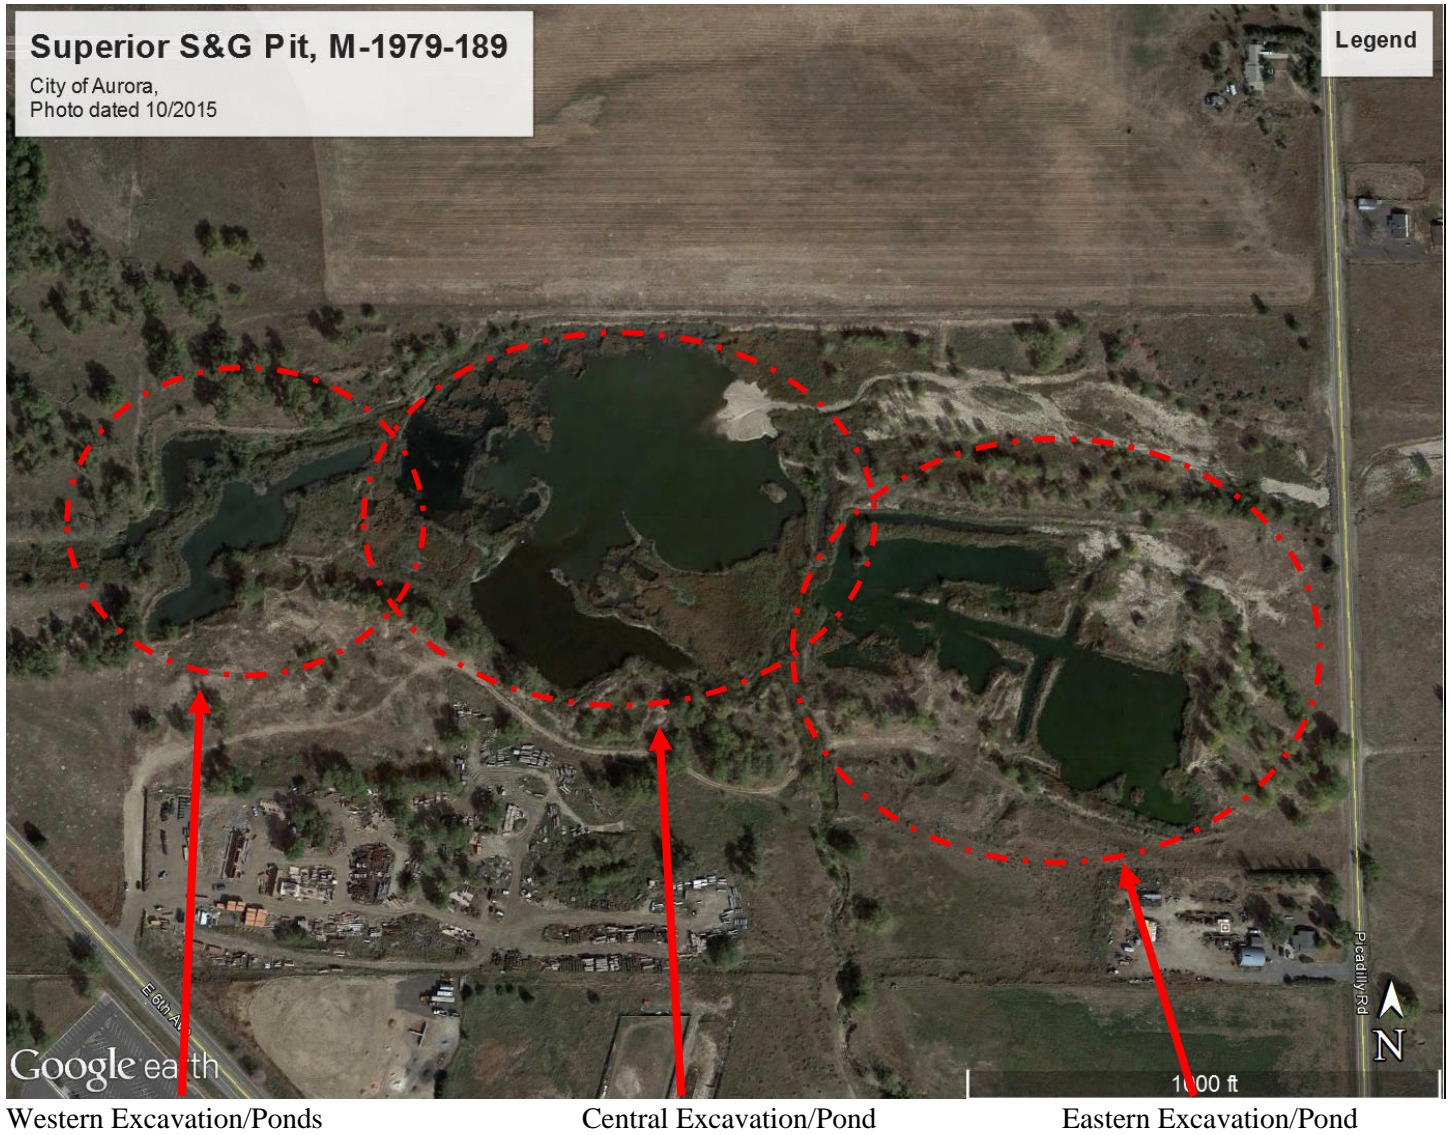
Figure 12. Pond slopes on the southernmost pond/excavation on the west side of the site. Steep 1H:1V slopes into the pond.
