**COLORADO**Division of Reclamation,
Mining and Safety

MINERALS PROGRAM INSPECTION REPORT**PHONE: (303) 866-3567**

MINE NAME: Pitch Project	MINE/PROSPECTING ID#: M-1977-004	MINERAL: Uranium	COUNTY: Saguache
INSPECTION TYPE: Monitoring	INSPECTOR(S): Dustin M. Czaplá	INSP. DATE: July 25, 2018	INSP. TIME: 11:00
OPERATOR: Homestake Mining Company	OPERATOR REPRESENTATIVE: David Wykoff	TYPE OF OPERATION: 112d-3 - Designated Mining Operation	
REASON FOR INSPECTION: Normal I&E Program	BOND CALCULATION TYPE: None	BOND AMOUNT: \$2,263,000.00	
DATE OF COMPLAINT: NA	POST INSP. CONTACTS: None	JOINT INSP. AGENCY: None	
WEATHER: Clear	INSPECTOR'S SIGNATURE:

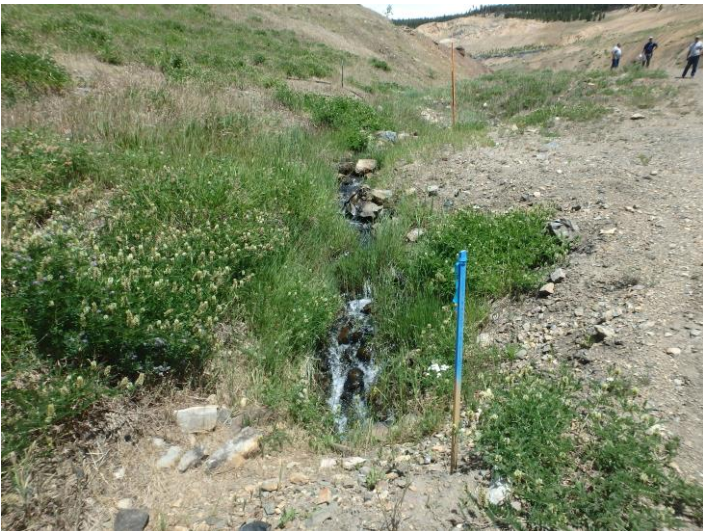
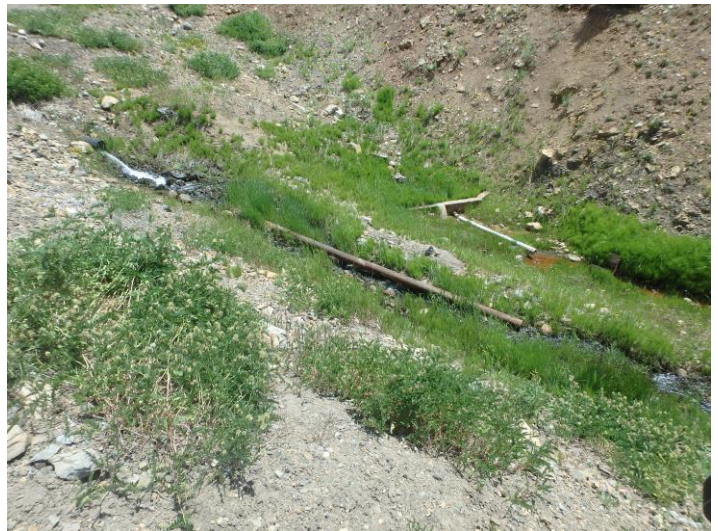
Indian Rock Dump: Slopes appear stable and vegetation is becoming well established on the reclaimed slopes. No significant erosional features were noted. The phosphate injection program and geotechnical study are ongoing in this area. Drilling was occurring during this inspection. No problems with the drill pads, wells or associated equipment were noted.
