**MINERALS PROGRAM INSPECTION REPORT**  
**PHONE: (303) 866-3567**

<b>MINE NAME:</b> Montoya Pit	<b>MINE/PROSPECTING ID#:</b> M-1980-146	<b>MINERAL:</b> Sand and gravel	<b>COUNTY:</b> La Plata
<b>INSPECTION TYPE:</b> Preoperation Inspection	<b>INSPECTOR(S):</b> Lucas J. West	<b>INSP. DATE:</b> August 7, 2018	<b>INSP. TIME:</b> 13:30
<b>OPERATOR:</b> C & J Gravel Products, Inc.	<b>OPERATOR REPRESENTATIVE:</b> John Gilliland	<b>TYPE OF OPERATION:</b> 112c - Construction Regular Operation	
<b>REASON FOR INSPECTION:</b> Pre-operation Inspection	<b>BOND CALCULATION TYPE:</b> Complete Bond	<b>BOND AMOUNT:</b> \$85,476.00	
<b>DATE OF COMPLAINT:</b> NA	<b>POST INSP. CONTACTS:</b> None	<b>JOINT INSP. AGENCY:</b> None	
<b>WEATHER:</b> Clear	<b>INSPECTOR'S SIGNATURE:</b>

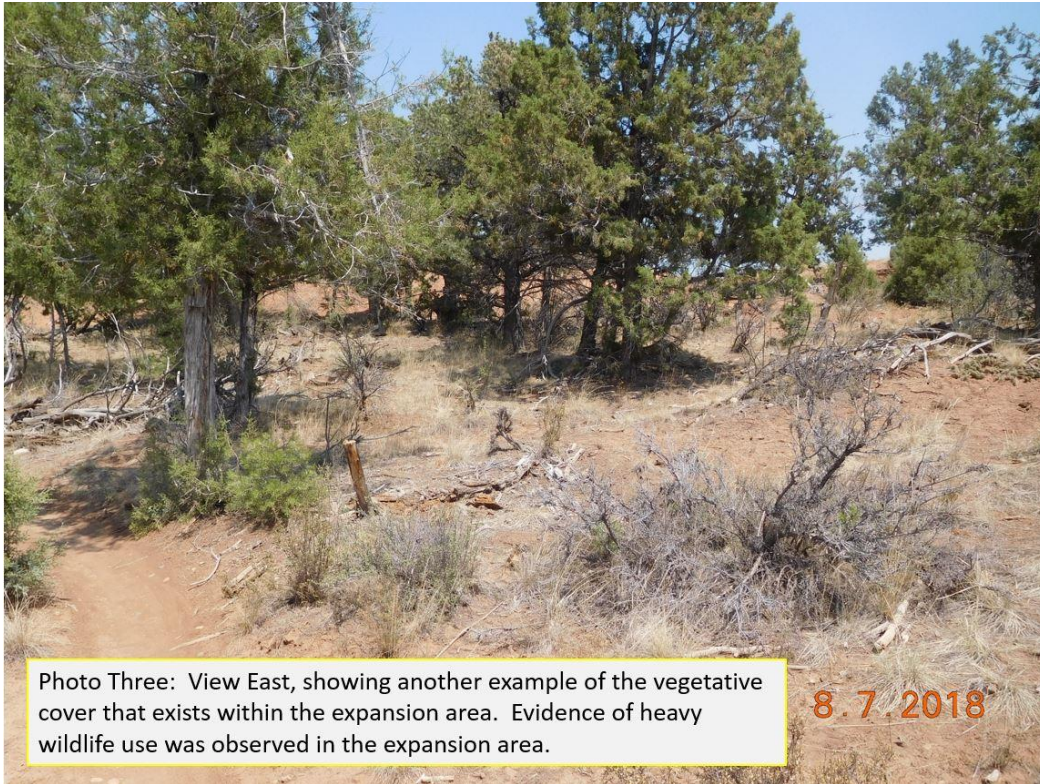
The expansion area is 18.3 acres taking up a large knob that is bordered by the open pit to the east, and Sale Barn canyon to the west. The entire expansion area lies on BLM lands and the sales contract and stipulations of the BLM permit is being finalized. The present land use of the expansion area is wildlife habitat, and evidence of heavy wildlife traffic was observed. The expansion area, as well as all lands administered by the BLM will be reclaimed to support a post mining land use of wildlife habitat. The area is well vegetated and consists of bunch grasses, small shrubs and pinyon and juniper trees. Examples of the vegetative cover in the expansion area can be seen in Photos Two and Three. Portions of the BLM managed bike trail called the Sale Barn Canyon Trail run through the expansion area. The trail, in agreement with BLM will be relocated as the mining activities progress and eventually be permanently re-routed. The plan for the re-route has been reviewed and approved by BLM.
