MINERALS PROGRAM INSPECTION REPORT**PHONE: (303) 866-3567**

MINE NAME: Longmont Distel Operations	MINE/PROSPECTING ID#: M-1989-029	MINERAL: Sand and gravel	COUNTY: Weld
INSPECTION TYPE: Surety-Related Inspection	INSPECTOR(S): Peter S. Hays	INSP. DATE: August 14, 2018	INSP. TIME: 10:00
OPERATOR: Aggregate Industries - WCR, Inc.	OPERATOR REPRESENTATIVE: Christine Felz	TYPE OF OPERATION: 112c - Construction Regular Operation

The Longmont Distel Operations site was inspected by Peter Hays with the Division of Reclamation, Mining and Safety (Division/DRMS) in response to an acreage reduction request (AR-01) and surety reduction request (SR-01) submitted by the Operator on July 2, 2018. The acreage and surety reduction requests were considered filed by the Division on July 2, 2018. The Division is required by Rule 4.17.2 to inspect the site within 60-days from the filed date to determine if the Permittee has complied with all applicable requirements of the Reclamation Plan. The decision due date for approval of the acreage and surety reductions is

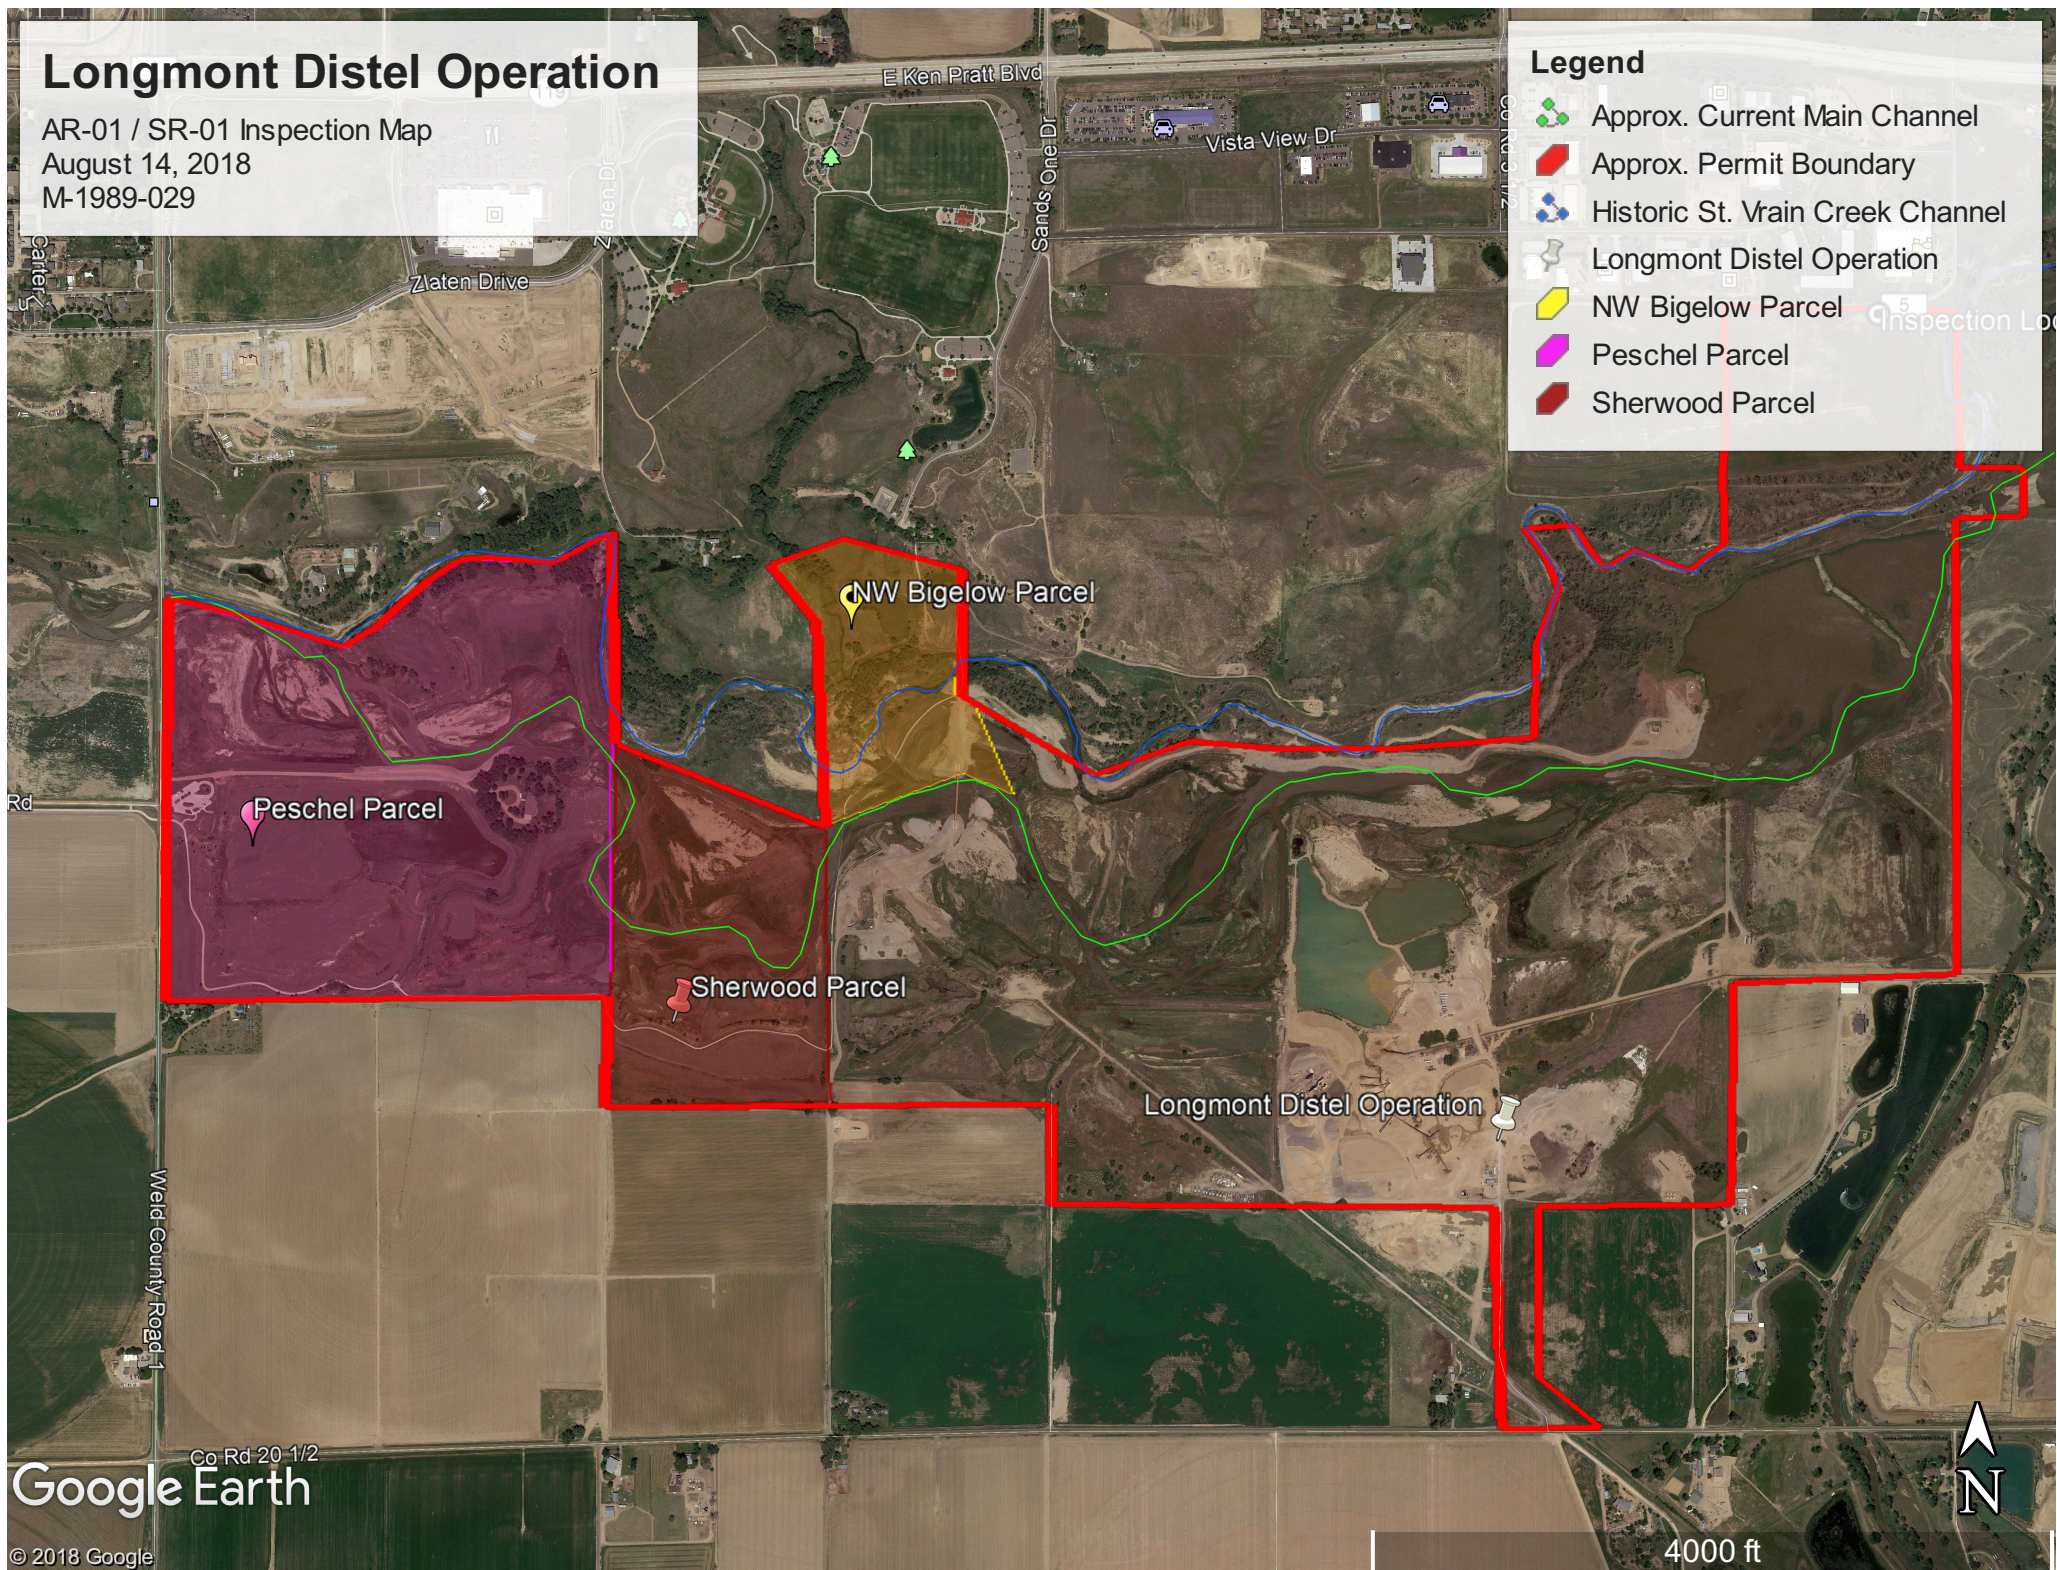
Sherwood Parcel

The Sherwood parcel was impacted by the 2013 river capture event resulting in the erosion of the bike trail embankment. The embankment was repaired as part of the FEMA restoration work. The repaired slope was stable, covered by jute netting and vegetated with reclamation seed mix forbs and annual weeds. Russian olive trees and Canada thistle were observed south of the St. Vrain River. As cited as a problem above, the
