MINERALS PROGRAM INSPECTION REPORT
PHONE: (303) 866-3567

MINE NAME: Henderson Mine	MINE/PROSPECTING ID#: M-1977-342	MINERAL: Molybdenum	COUNTY: Clear Creek, Grand
INSPECTION TYPE: Monitoring	INSPECTOR(S): Peter S. Hays	INSP. DATE: September 27, 2018	INSP. TIME: 09:00
OPERATOR: Climax Molybdenum Company	OPERATOR REPRESENTATIVE: Geoff Niggeler, Aaron Hilshorst, Amber Parmet	TYPE OF OPERATION: 112d-3 - Designated Mining Operation	
REASON FOR INSPECTION: Normal I&E Program	BOND CALCULATION TYPE: None	BOND AMOUNT: \$37,993,785.00	
DATE OF COMPLAINT: NA	POST INSP. CONTACTS: None	JOINT INSP. AGENCY: None	
WEATHER: Clear	INSPECTOR'S SIGNATURE:

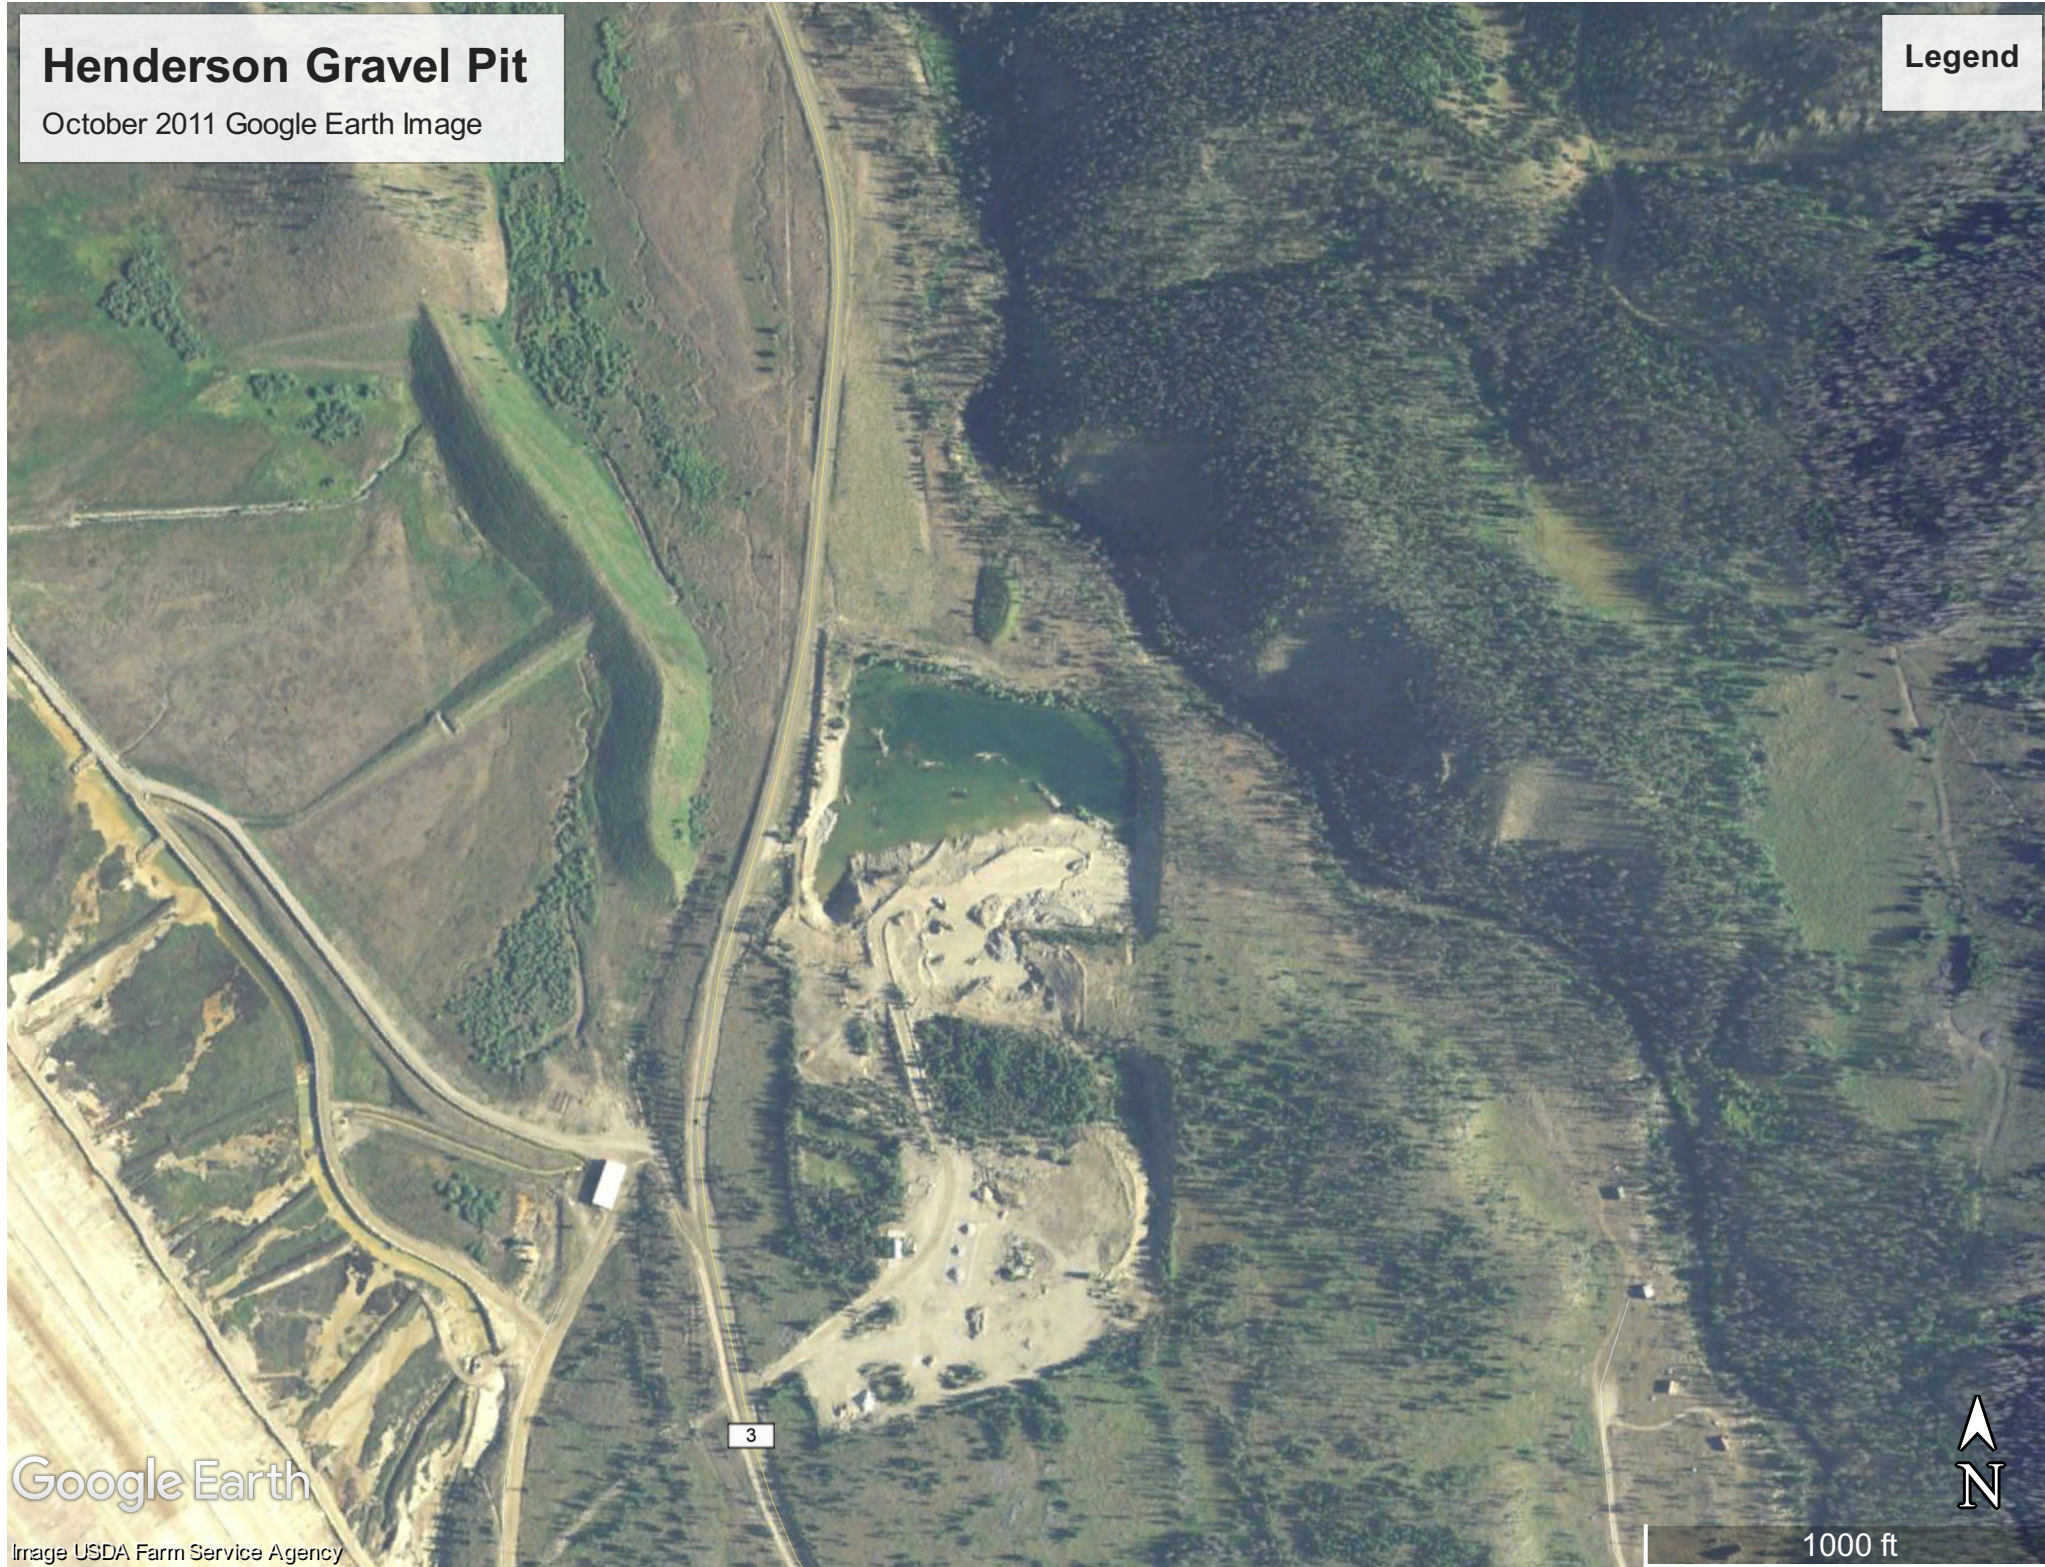
October 2011 Google Earth Image

The Henderson gravel pit was observed during the inspection. Henderson staff stated the gravel pit was last active in 2014 and 2015. Google Earth images from 2011 and 2015 show the mining activity at the pit to the north. The maps are attached for reference. The groundwater pond was estimated at 1.0 acres, which is less than the allowed pre-law exposure limit of 2.64 acres. Road base and cobble stockpiles were observed on the pit floor. The highwall elevations in the northern portion of the pit were estimated at 10 feet at a 1H:1V slope. The highwalls appeared stable with no observed erosion features. Evidence of noxious weed control spraying was observed in the pit. Henderson staff stated weed control measures for the entire site had been completed for the year. The southern portion of the pit was being used to stockpile imported filter sand material for the 3-Dam Buttress Project.
