MINERALS PROGRAM INSPECTION REPORT
PHONE: (303) 866-3567

MINE NAME: Nolte Pit #1	MINE/PROSPECTING ID#: M-2012-016	MINERAL: Borrow material	COUNTY: Garfield
INSPECTION TYPE: Monitoring	INSPECTOR(S): Amy C. Yeldell	INSP. DATE: September 11, 2018	INSP. TIME: 13:00
OPERATOR: Puckett Land Company	OPERATOR REPRESENTATIVE: None	TYPE OF OPERATION: 111 - Construction by Government Agency	
REASON FOR INSPECTION: Normal I&E Program	BOND CALCULATION TYPE: Complete Bond	BOND AMOUNT: \$36,250.00	
DATE OF COMPLAINT: NA	POST INSP. CONTACTS: None	JOINT INSP. AGENCY: None	
WEATHER: Windy	INSPECTOR'S SIGNATURE:

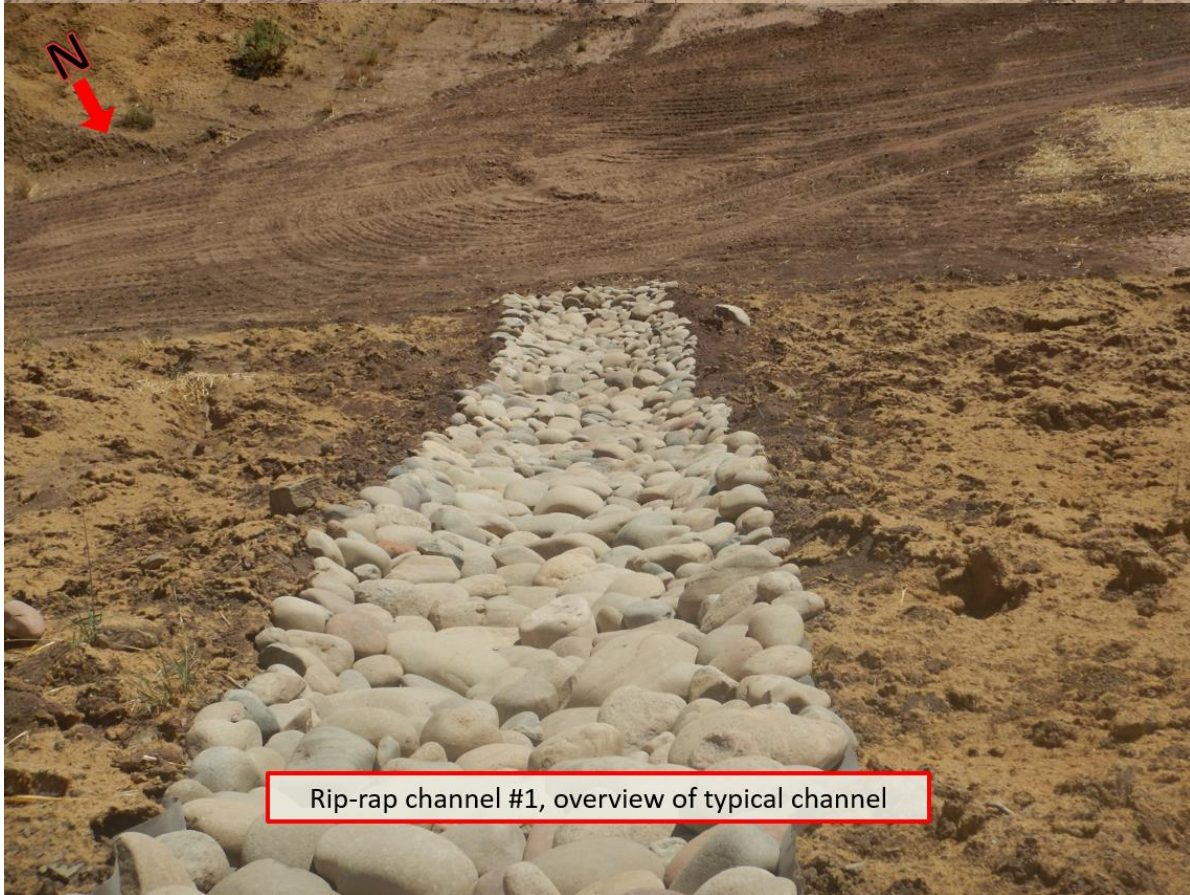
Staff was able to see the geotech liner that was installed prior to placement of the rip-rap. In most cases it appears that the geotech liner was keyed into place and should withstand undercutting at the top of the slope. There were some areas where the geotextile was observed improperly installed. Straw waddles were installed at the top of the slopes and used to direct run-on water into the rip-rap channels.

Geotextile under rock in channel not always keyed in, potential source of undercutting
