MINERALS PROGRAM INSPECTION REPORT
PHONE: (303) 866-3567

MINE NAME: Argo Gravel Pit	MINE/PROSPECTING ID#: M-1978-267	MINERAL: Sand and gravel	COUNTY: Otero
INSPECTION TYPE: Monitoring	INSPECTOR(S): Amy Eschberger	INSP. DATE: September 13, 2018	INSP. TIME: 10:20
OPERATOR: Otero County	OPERATOR REPRESENTATIVE: Lex Nichols	TYPE OF OPERATION: 112c - Construction Regular Operation	
REASON FOR INSPECTION: Normal I&E Program	BOND CALCULATION TYPE: None	BOND AMOUNT: \$0.00	
DATE OF COMPLAINT: NA	POST INSP. CONTACTS: None	JOINT INSP. AGENCY: None	
WEATHER: Clear	INSPECTOR'S SIGNATURE:

M1978-267 / Argo Gravel Pit / Otero County

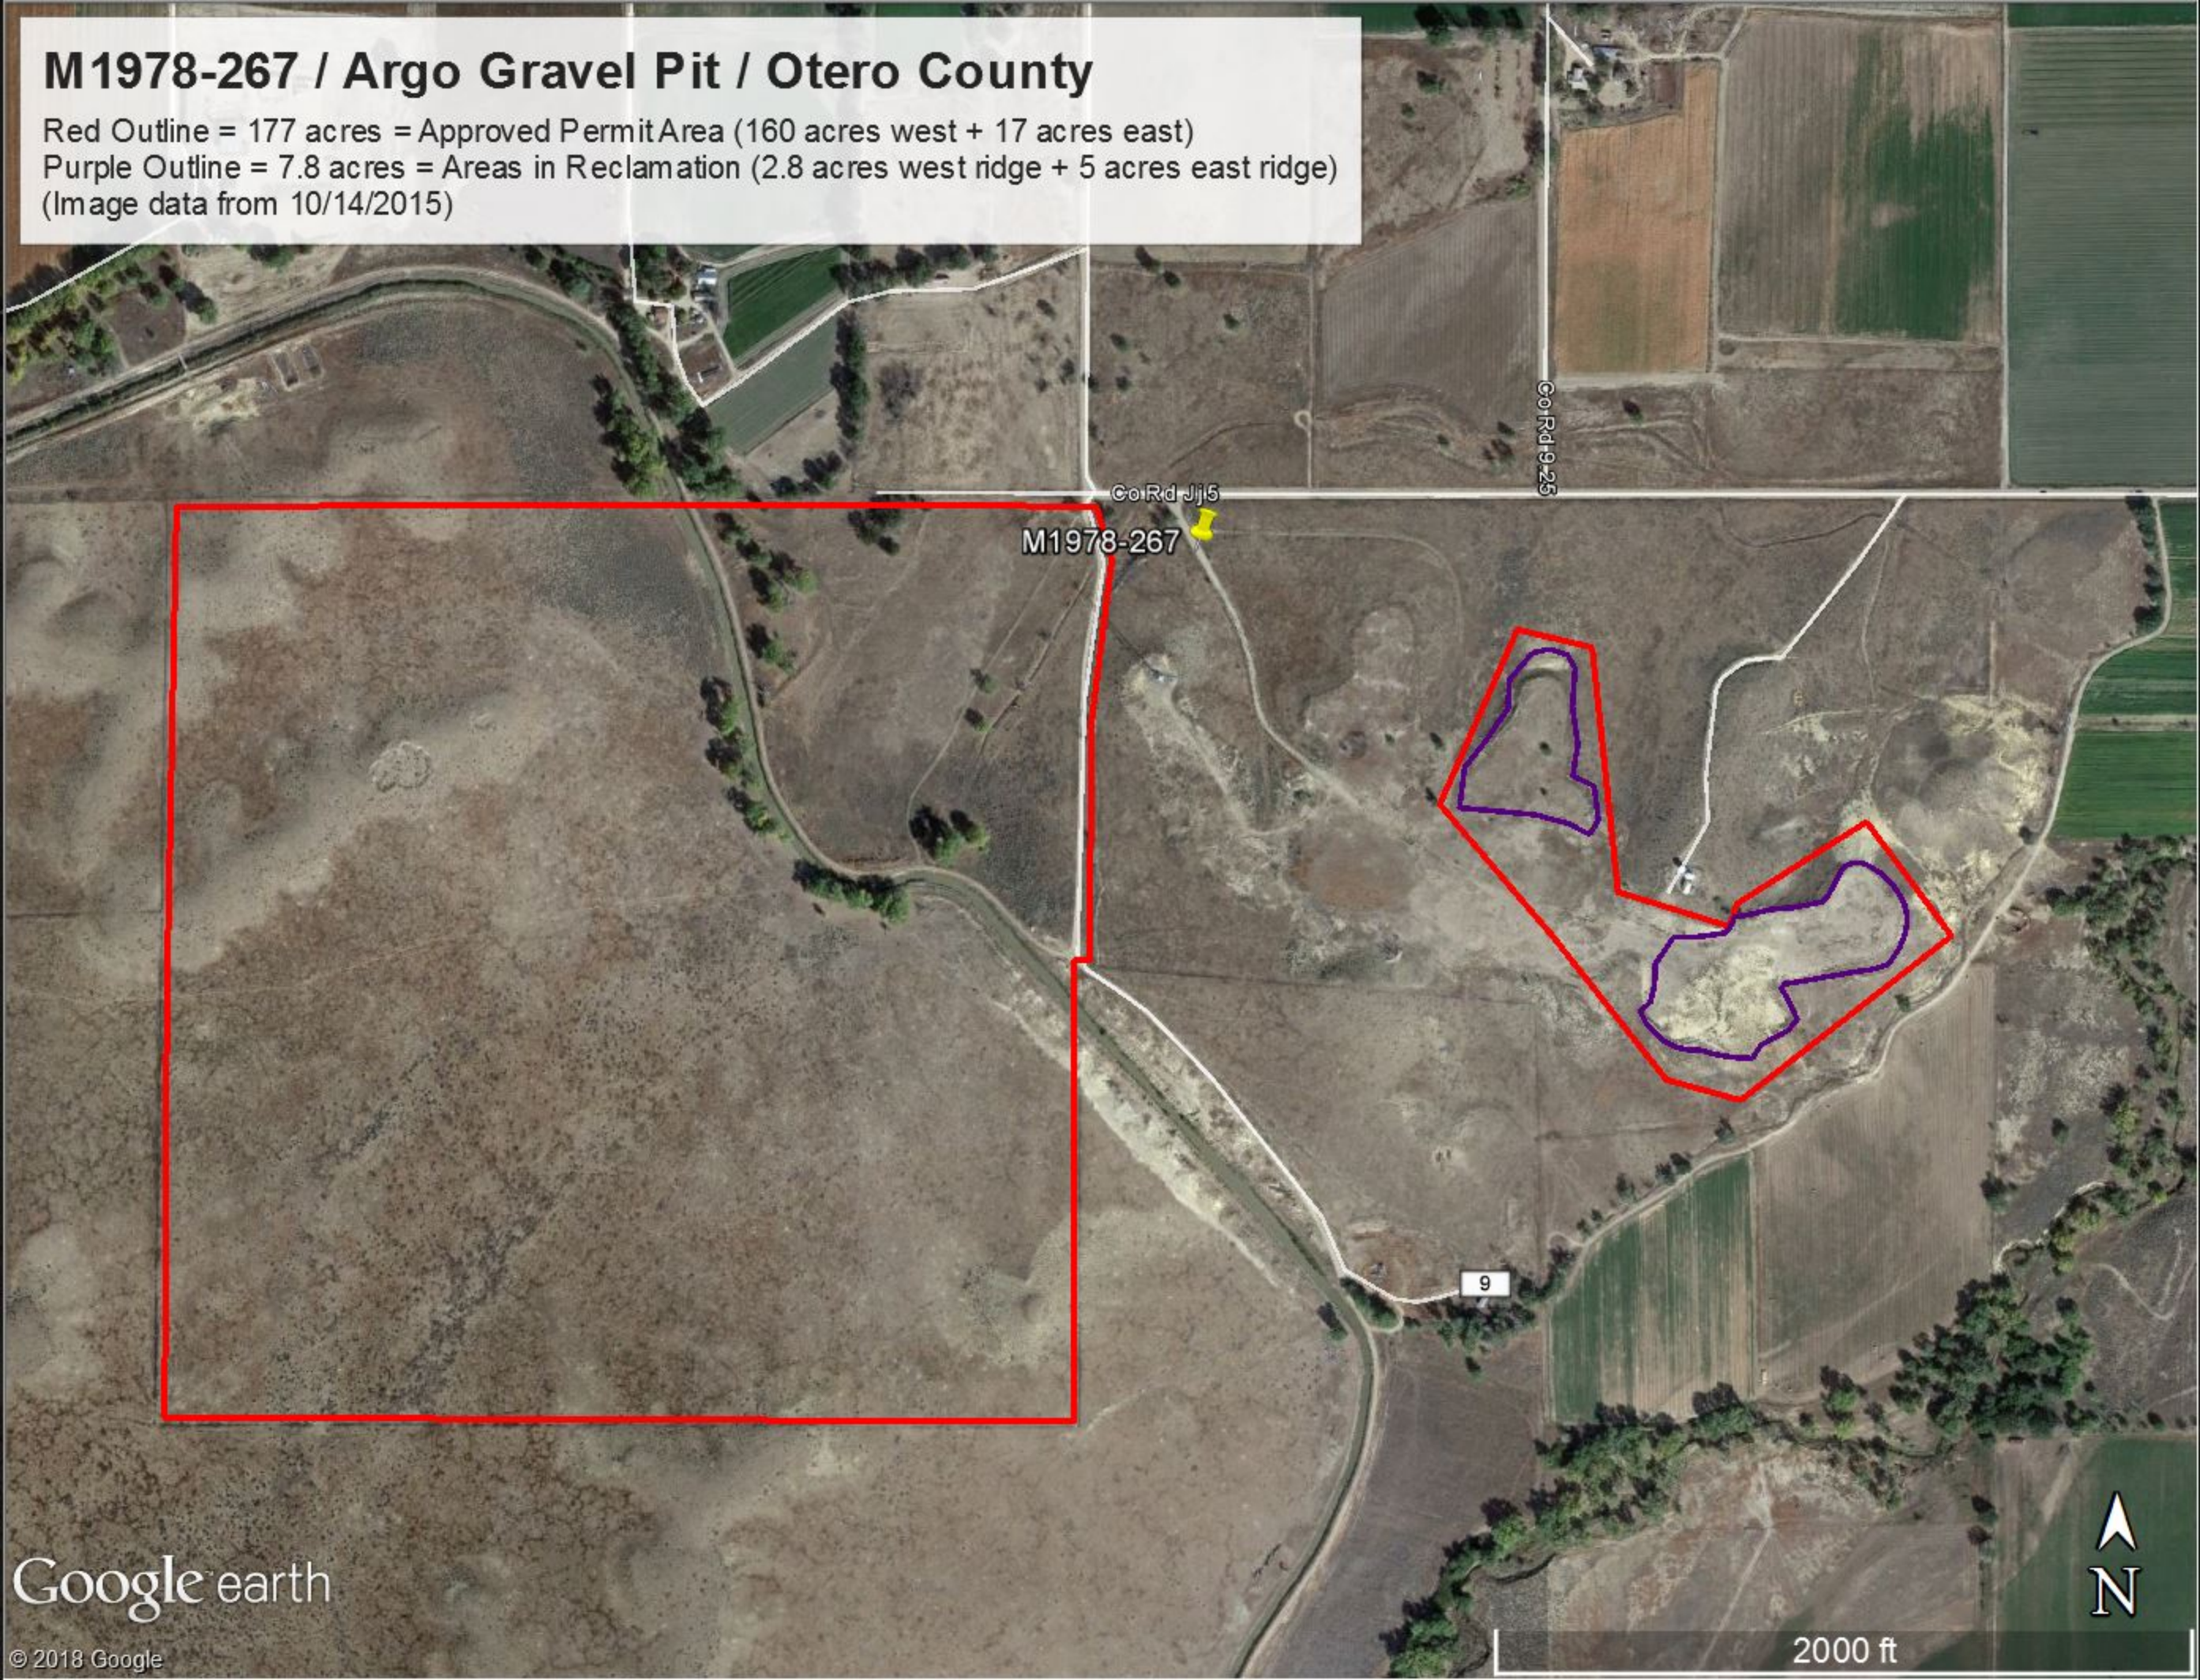
Purple Outline = 7.8 acres = Areas in Reclamation (2.8 acres west ridge + 5 acres east ridge)

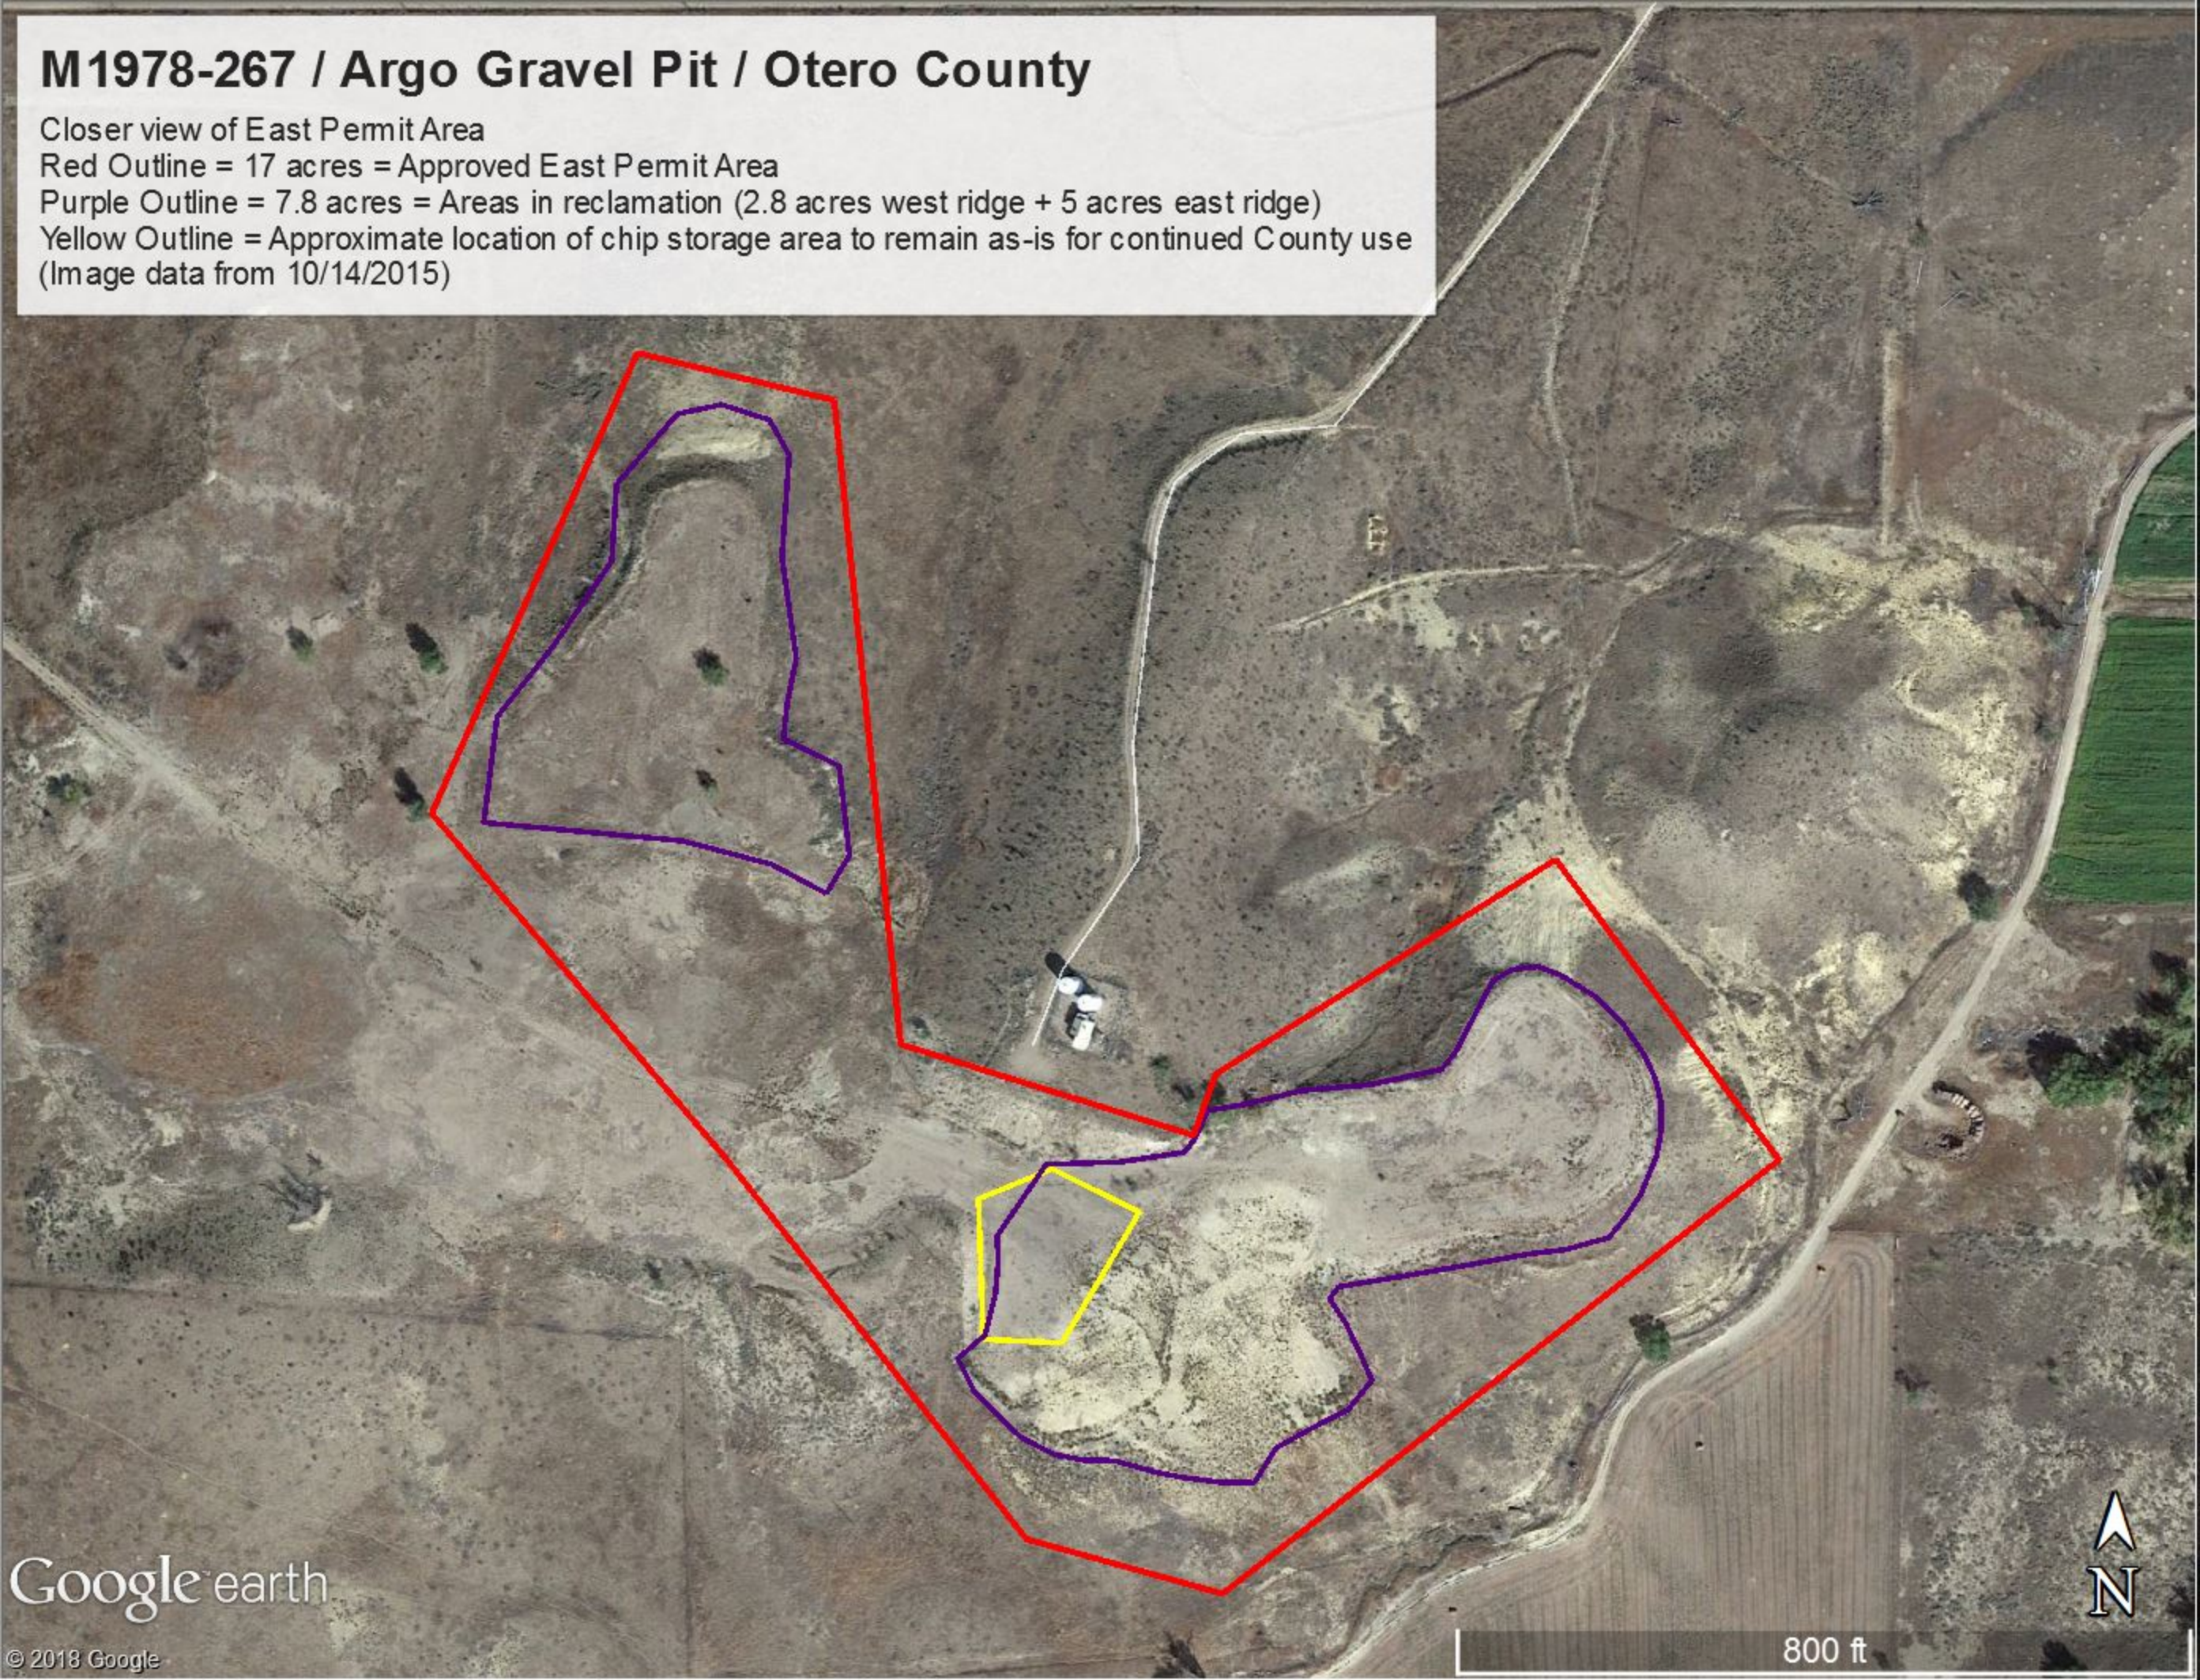
Closer view of East Permit Area

Red Outline = 17 acres = Approved East Permit Area

Purple Outline = 7.8 acres = Areas in reclamation (2.8 acres west ridge + 5 acres east ridge)

Yellow Outline = Approximate location of chip storage area to remain as-is for continued County use
(Image data from 10/14/2015)
