UNITED STATES ENVIRONMENTAL PROTECTION AGENCY  
REGION 8

Re: Inspection Report for the Golden Wonder Mine, NPDES Permit Nos. CO0048119 and  
COR040226

## NPDES Stormwater Inspection Report - Industrial

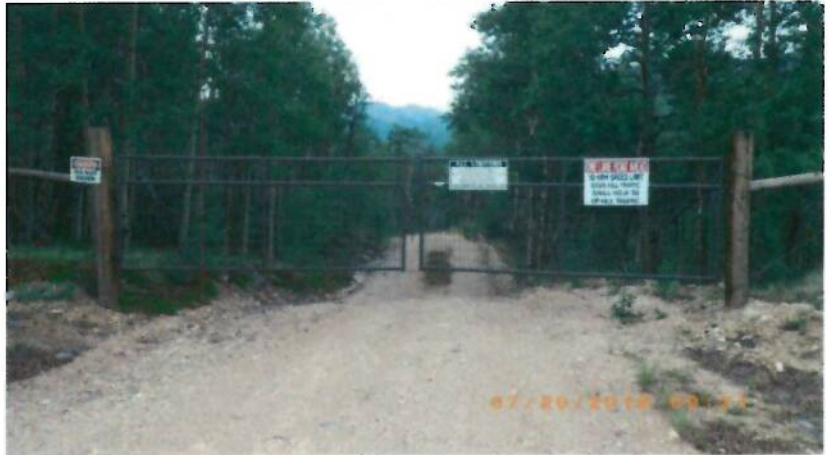
Photo number 1670 taken by D. Gwisdalla on 7/20/2018.

Golden Wonder Mine Pad 6 entrance gate, note that it was secured.

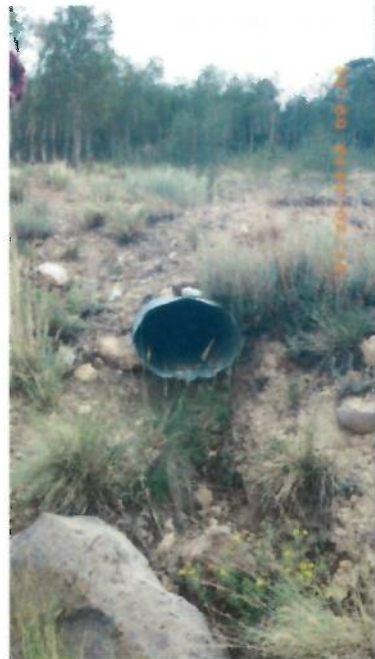
Culvert outlet directing stormwater runoff underneath the mine haul road for Pad 6. Located at (lat/long): 38° 0'26.35"N / 107°17'10.65"W.

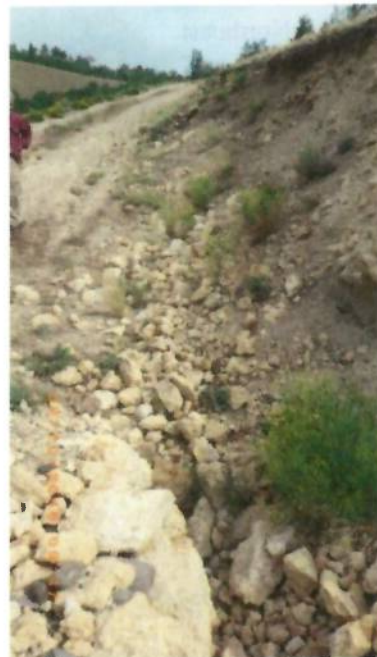
Photo number 1676 taken by D. Gwisdalla on 7/20/2018.

- A rock check dam along the haul and access roads serving Pad 6 need to be refreshed (photograph 1680);
- Rock armoring at two culvert outlets serving the haul and access roads serving Pad 6 need repair (photographs 1676 and 1679);
- Berming adjacent to the rock crusher and tram on Pad 6 needs to be regraded (photographs 1689 and 1690); and
- Covers for the ore storage need to be replaced on Pads 3 and 6 (photographs 1682 and 1711);

**Provide the EPA and CDPHE with photographs showing the above BMP deficiencies were corrected.**

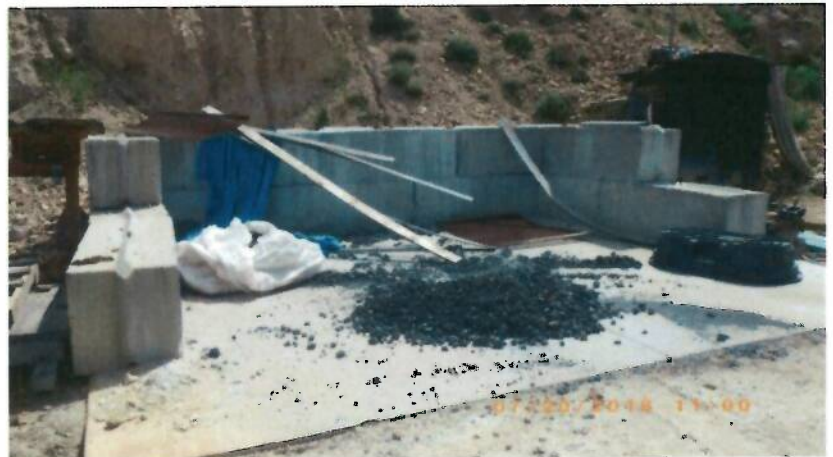
Constructed ore pad. Note the iron slag used for mine drainage treatment.

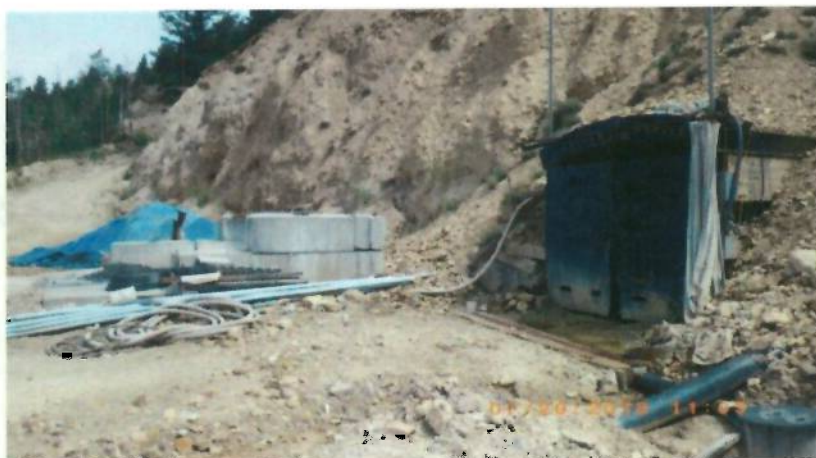
Golden Wonder Mine 6 Level mine portal entrance.  
Note the drain and treatment unit on the bottom right  
of the photograph.

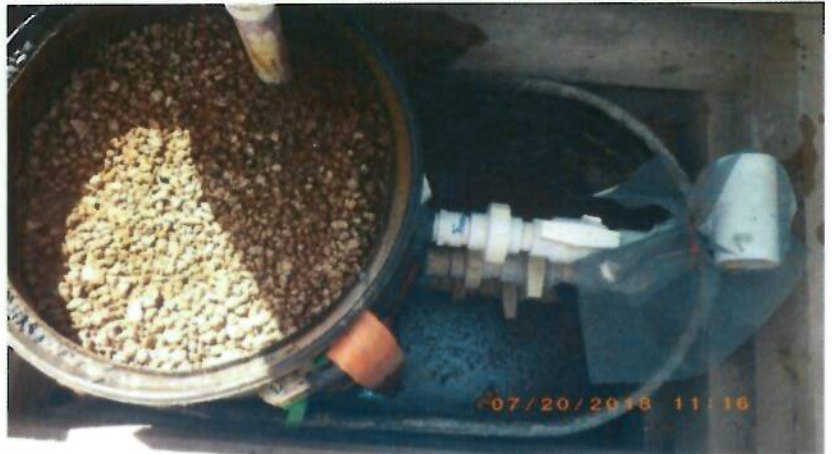
During the inspection of the mine water passive slag filter treatment unit prior to Outfall 001A, it was noted that the slag filter was overflowing at the elbow prior to, and also at, the inlet to the slag filter treatment unit (photographs 1699 and 1700). There appeared to be some sort of obstruction that prevented the mine water from flowing out of the treatment unit's discharge piping causing the mine water to back up and flow from the two connections. This is believed to be the case because when another valve on the treatment unit was opened, water discharged through the discharge pipe freely. The inspector also observed that the inlet pipe flowing into the settling basin was not secured (photographs 1702 and 1703). Kye Abraham stated that the settling basin's connection was disconnected prior to the winter season (Fall 2017). This was affirmed by the fact that the inspector heard a "gurgling" sound and saw air bubbles discharging from the connection prior to the discharge pipe in the settling basin. After Kye Abraham opened the valve from the slag filter after it was closed to assist in flushing the slag filter's outlet. While the mine water was by-passing the slag filter and the settling filter, no discharge was observed at the time of the inspection at Outfall 001A.

Interior of the treatment unit shown in photograph 1699 that is kept underneath the metal protective cover. Note the configuration of the valving as found during the inspection.

If the site is discharging and the treatment unit had an unanticipated bypass, such as was the case observed by the EPA inspector during the inspection, the facility has requirements in the Permit to notify the State.

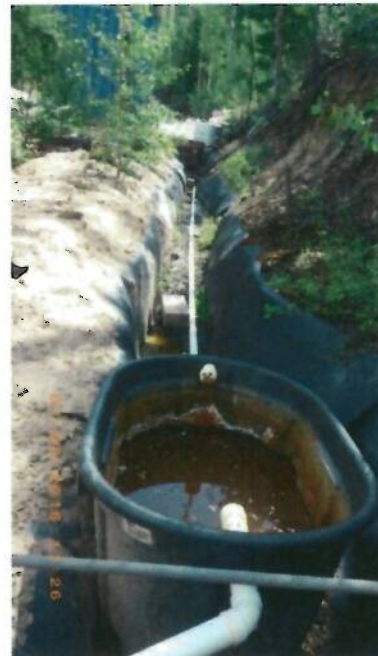
Photo number 1702 taken by D. Gwisdalla on 7/20/2018.

Post treatment sediment basin down gradient from the passive treatment unit ( the passive treatment unit is seen in the background). Note the level of the water in the basin. No water was flowing in or out of the basin at the time of the inspection.

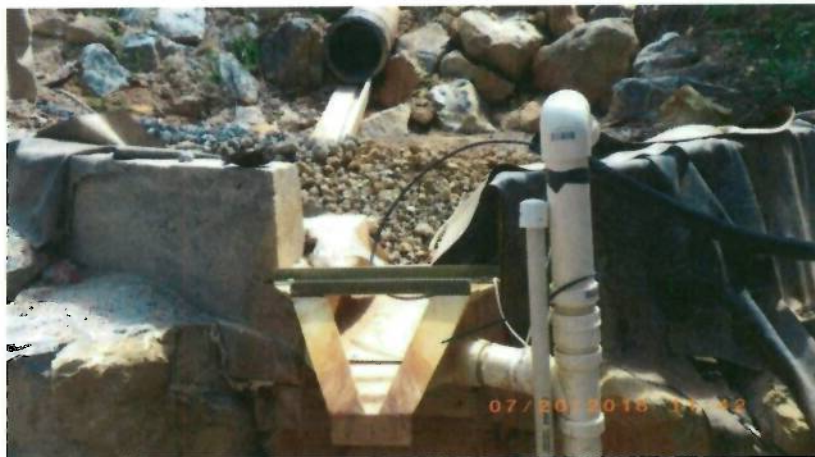
Photo number 1708 taken by D. Gwisdalla on 7/20/2018.

Weir at Outfall 001 looking upgradient. Note the black HDPE pipe in the top-center of the photograph. This pipe is the diversion from Deadman Gulch. Deadman Gulch flows into the discharge location, prior to discharging again back into Deadman Gulch.

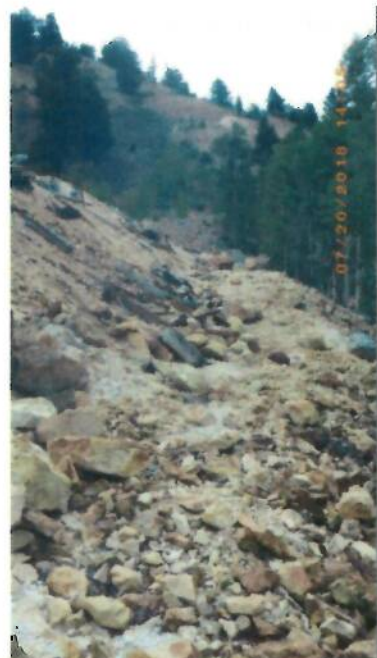
Along the waste rock berm on the northeast side of the berm looking up-gradient where the most likely point of runoff would occur, no erosion was noted.

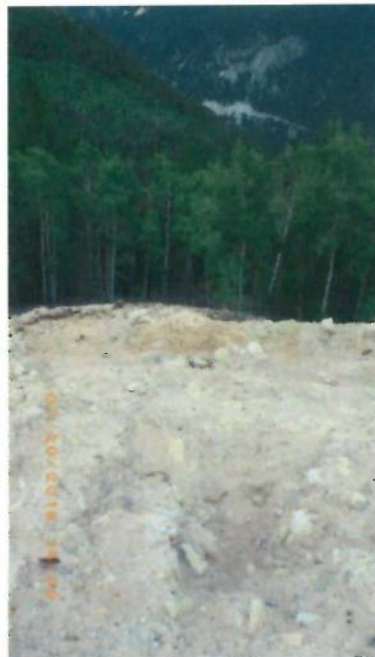
Looking back towards the toe of the berm at the point shown in photographs 1716 and 1717.

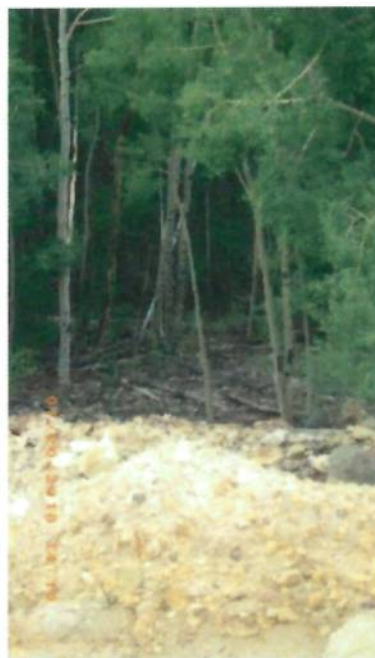
Photo number 1720 taken by D. Gwisdalla on 7/20/2018.

Looking back towards the toe of the berm at the point shown in photographs 1716 and 1717. This photograph used the telephoto lens to focus in on the toe of the waste rock pile.

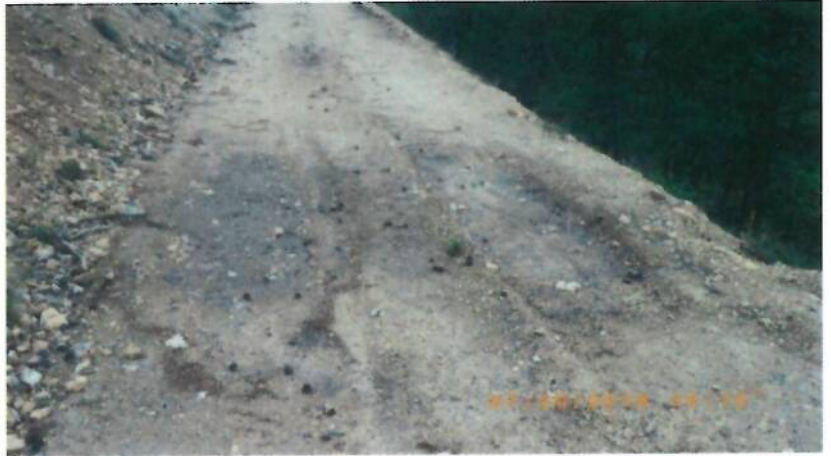
Depression on the Pad 3 mine haul road. This location was reportedly (per Kye Abraham) the point that CDPHE designated as a potential stormwater outfall in the proposed individual permit. It is located approximately at (lat/long): 38° 0'22.36"N / 107°1
