Re: Bowie Resources, LLC, Bowie No. 2 Mine
Coal Mine Waste Banks & Instrumentation Monitoring
Pond Quarterly Inspections
Permit C-1996-083

Coal Mine Waste Bank Nos. 1, 2, & 3 Inspections –2nd Quarter 2018

Subject: Summary of Instrumentation Monitoring
2nd Quarter 2018
Bowie Coal Waste Disposal Area No. 2
Paonia, Colorado

Subject: Summary of Instrumentation Monitoring
2nd Quarter 2018
Bowie Coal Waste Disposal Area No. 3
Paonia, Colorado

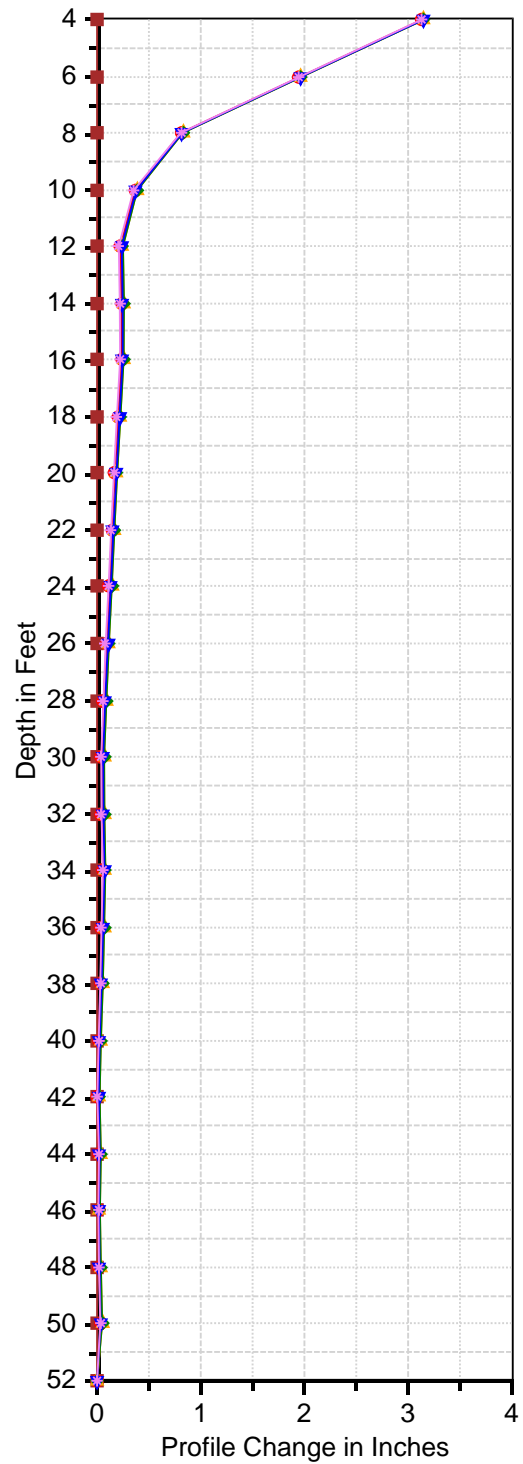
BOWIE BG05_4 B

The latest inclinometer readings indicate no major movements since the last quarterly reading. Slight deflection was indicated in the data for BG05-5 along the B-axis; however, the noted deflection is minimal. In addition, the overall profile of the data is the same as prior readings. This suggests an error in the deeper data which created an offset in the shallow data. However, additional evaluation will be conducted upon completion of the 3rd Quarter readings. In general, the 2nd Quarter 2018 monitoring data does not provide any indication of instability in CWDA No. 2.
