**MINERALS PROGRAM INSPECTION REPORT**  
**PHONE: (303) 866-3567**

<b>MINE NAME:</b> Stevens Clay Lease	<b>MINE/PROSPECTING ID#:</b> M-1996-064	<b>MINERAL:</b> Clay (general)	<b>COUNTY:</b> Douglas
<b>INSPECTION TYPE:</b> Monitoring	<b>INSPECTOR(S):</b> Peter S. Hays	<b>INSP. DATE:</b> November 14, 2018	<b>INSP. TIME:</b> 09:00
<b>OPERATOR:</b> The Denver Brick Company	<b>OPERATOR REPRESENTATIVE:</b> Rob Tibbetts	<b>TYPE OF OPERATION:</b> 112c - Construction Regular Operation	
<b>REASON FOR INSPECTION:</b> Normal I&E Program	<b>BOND CALCULATION TYPE:</b> Partial Bond	<b>BOND AMOUNT:</b> \$148,000.00	
<b>DATE OF COMPLAINT:</b> NA	<b>POST INSP. CONTACTS:</b> None	<b>JOINT INSP. AGENCY:</b> None	
<b>WEATHER:</b> Clear	<b>INSPECTOR'S SIGNATURE:</b>

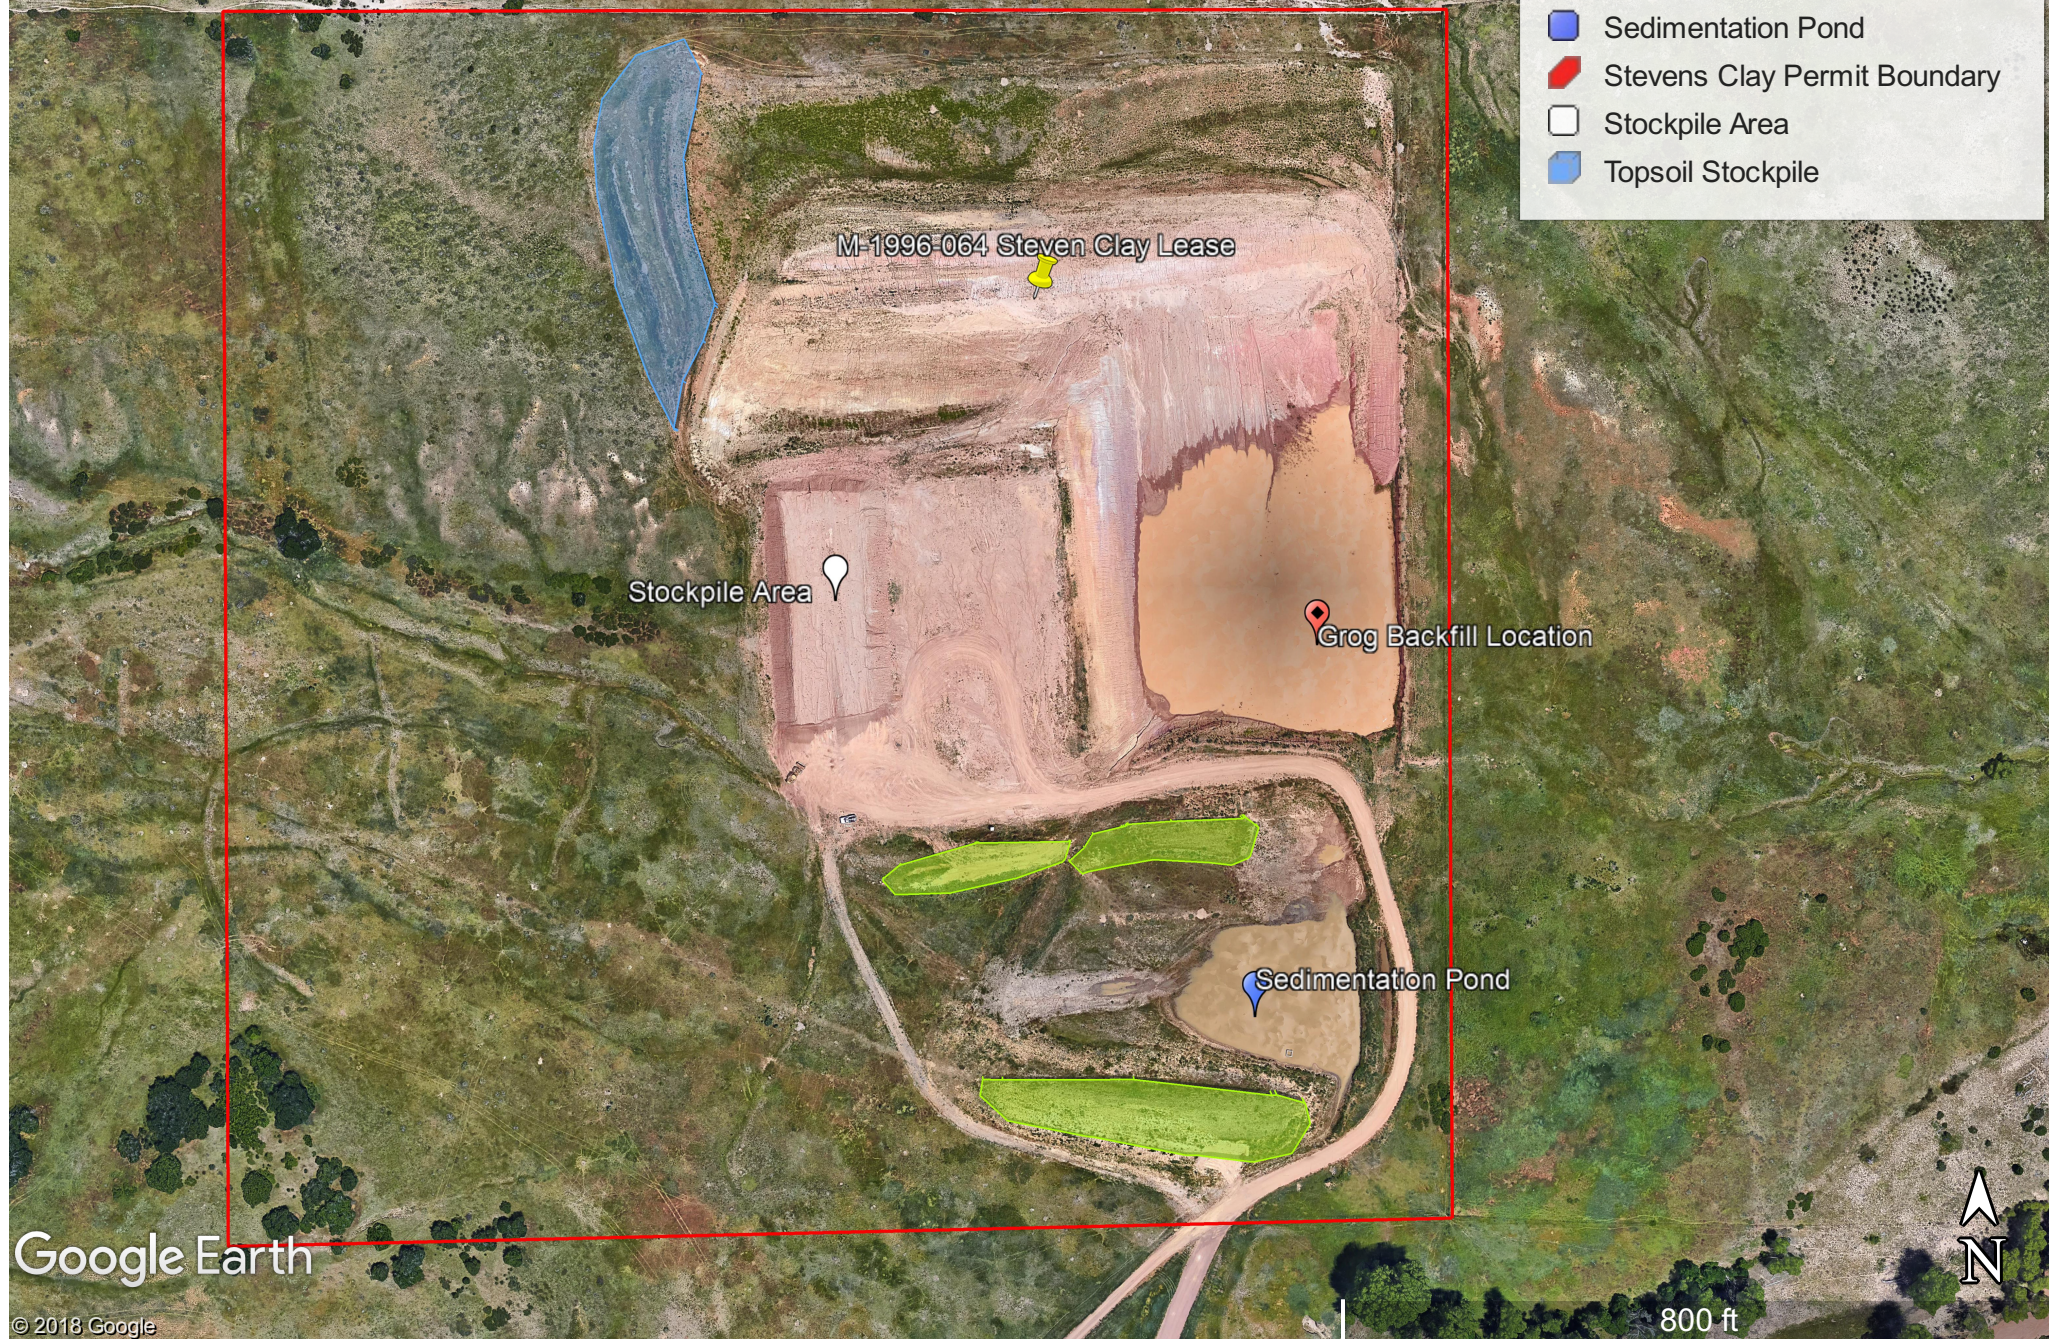
Topsoil Stockpile

The approved post-mining land use for the site is rangeland with a maximum reclaimed slope of 3H:1V with 8 inches of topsoil replaced on the disturbed areas. The northeast corner of the site has been regraded and revegetated by the Operator. The reclaimed area was stable and vegetation was establishing well. A topsoil
