MINERALS PROGRAM INSPECTION REPORT**PHONE: (303) 866-3567**

MINE NAME: Zadra Pit	MINE/PROSPECTING ID#: M-1989-030	MINERAL: Gravel	COUNTY: San Miguel
INSPECTION TYPE: Monitoring	INSPECTOR(S): Lucas J. West	INSP. DATE: October 23, 2018	INSP. TIME: 14:45
OPERATOR: San Miguel County	OPERATOR REPRESENTATIVE: Ryan Righetti, Alan Hatfield	TYPE OF OPERATION: 112c - Construction Regular Operation	
REASON FOR INSPECTION: Normal I&E Program	BOND CALCULATION TYPE: None	BOND AMOUNT: \$0.00	
DATE OF COMPLAINT: NA	POST INSP. CONTACTS: None	JOINT INSP. AGENCY: None	
WEATHER: Cloudy	INSPECTOR'S SIGNATURE:

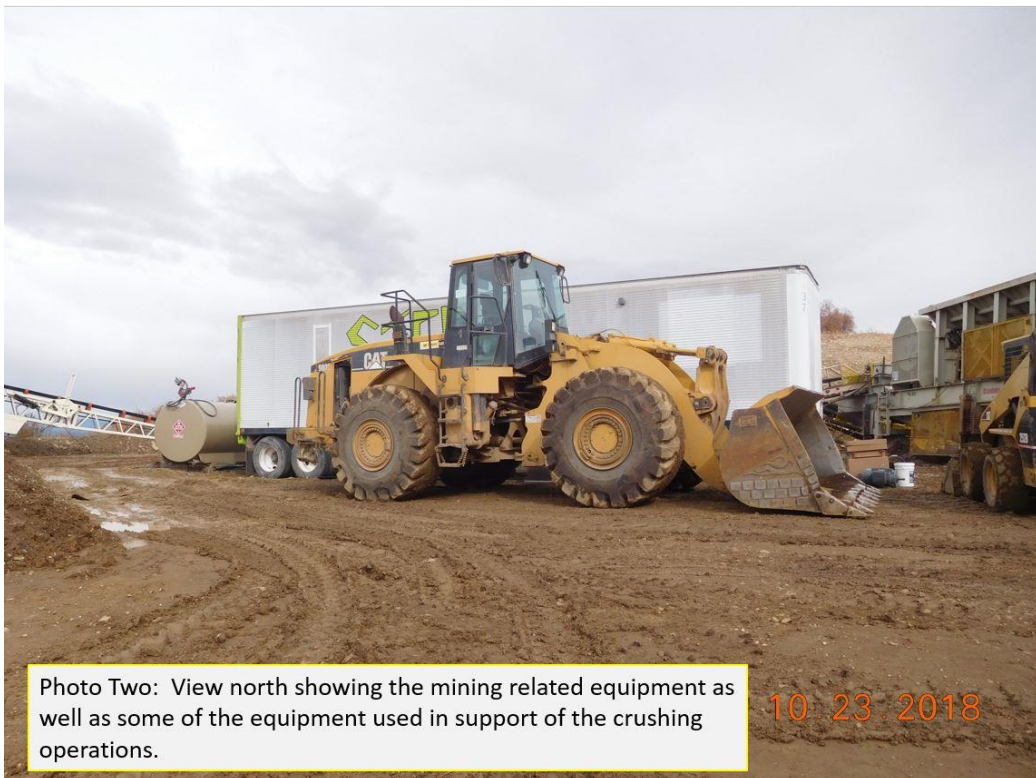
The proper mine identification signage was posted at the entrance to the site as seen in Photo One, and the permit boundaries were clearly marked. The site was not active during the inspection however mining related equipment as well as a crusher and it's support equipment were on site. All fuel and hazardous materials used in support of the crushing operations was verified to be in secondary containment Photos Two and Three show the equipment being utilized. The site crushes intermittently with a mobile crushing unit, stockpiling material for periodic use in the area. One large stockpile is located adjacent to the crusher, and can be seen in Photo Four. The stockpile appears to be in good condition and stable.
