Re: Bowie Resources, LLC, Bowie No. 2 Mine
Coal Mine Waste Banks & Instrumentation Monitoring
Pond Quarterly Inspections
Permit C-1996-083

Coal Mine Waste Bank Nos. 1, 2, & 3 Inspections –4th Quarter 2018

Subject: Summary of Instrumentation Monitoring
4th Quarter 2018
Bowie Coal Waste Disposal Area No. 2
Paonia, Colorado

Subject: Summary of Instrumentation Monitoring
4th Quarter 2018
Bowie Coal Waste Disposal Area No. 3
Paonia, Colorado

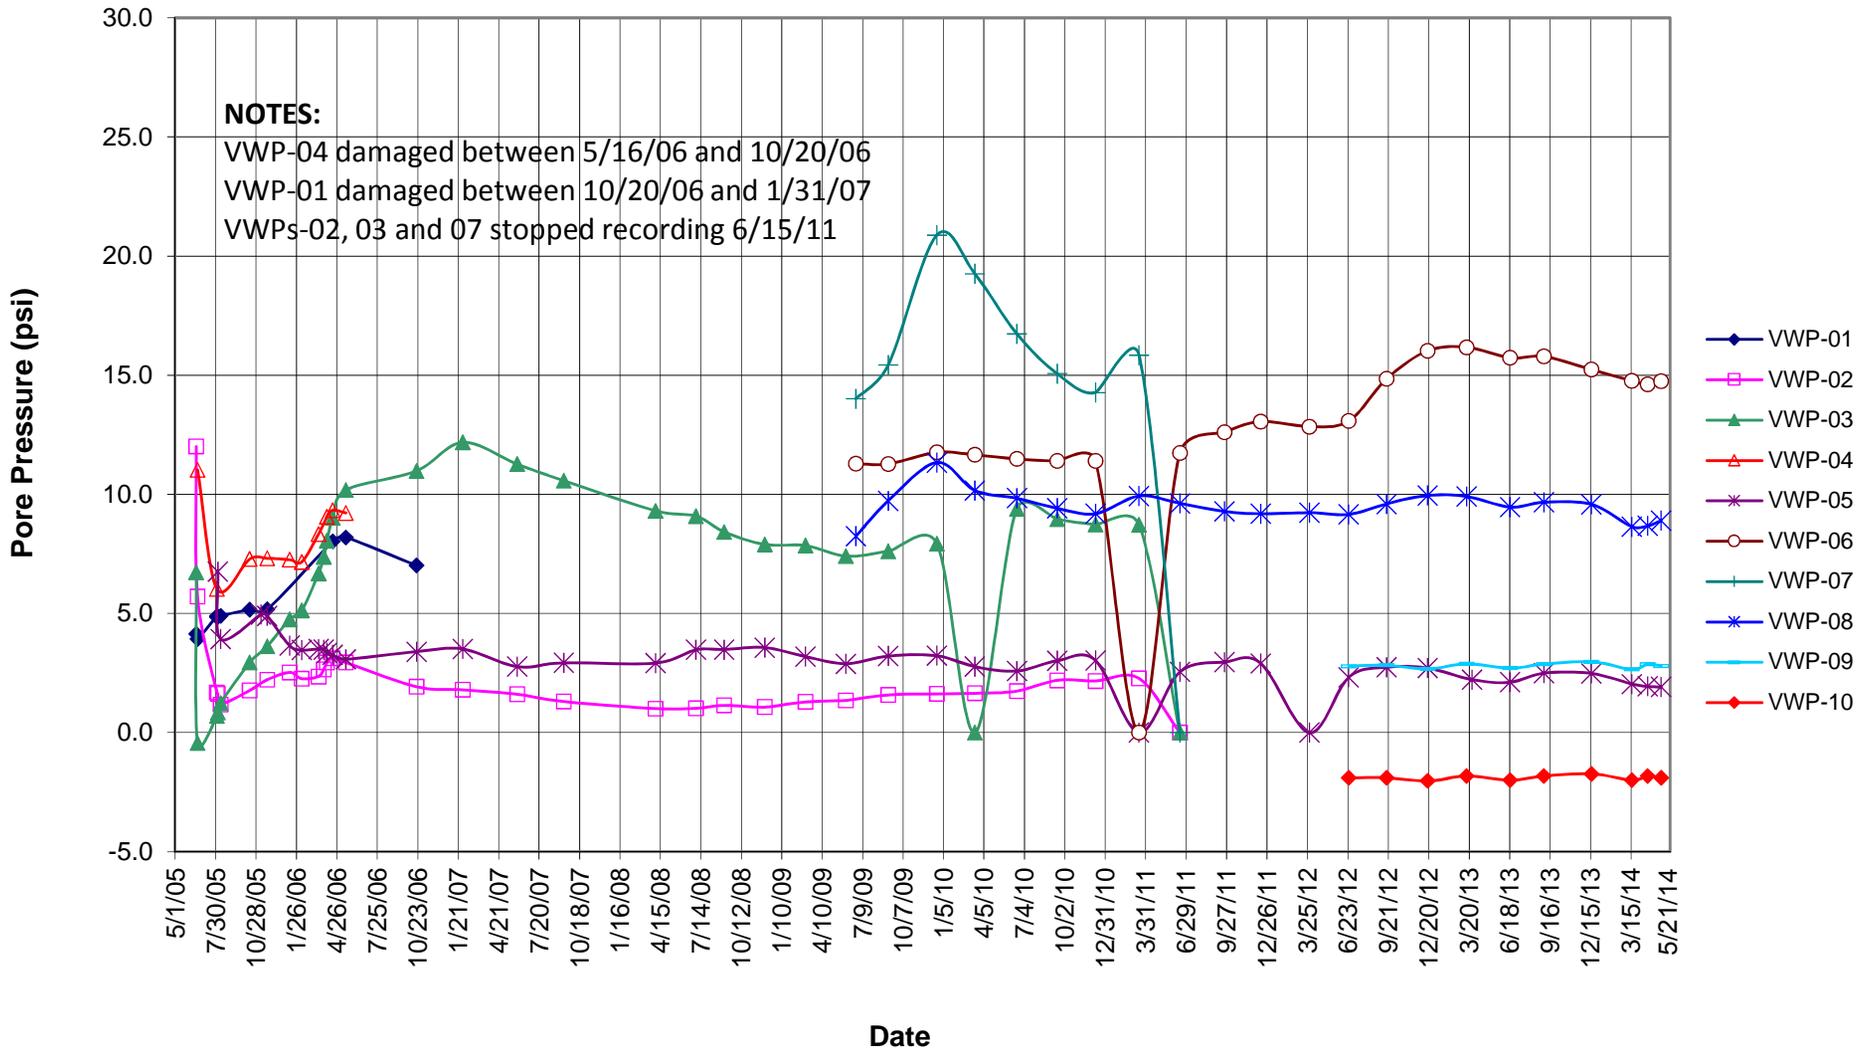
Figure 1 - Bowie Mine #2 - CWDA #2 Active and Damaged Vibrating Wire Piezometer Data

The physical locations of the piezometers are shown on the attached Instrumentation Site Plan (Map 1). As seen on this map, five of the original VWP's were damaged and some were replaced. Currently, there are five active VWP's and three of them are adjacent to the three inclinometers. The graph of historical data from 5/16/05 through 5/21/14 is presented for reference as Figure 1. A graph of measured pore pressures of active piezometers is presented on the attached Figure 2 and is presented numerically in Table 1 below.
