2019 ANNUAL REPORT STRUCTURAL GEOLOGY EVALUATION SPECIFICATIONS AGGREGATE QUARRY

**Martin Marietta Materials
Golden, Colorado**

18C64008.00
February 21, 2019

**Subject: Project 18C64008.00, 2019 Annual Report, Structural Geology Evaluation,
Specification Aggregates Quarry, Golden, Colorado**

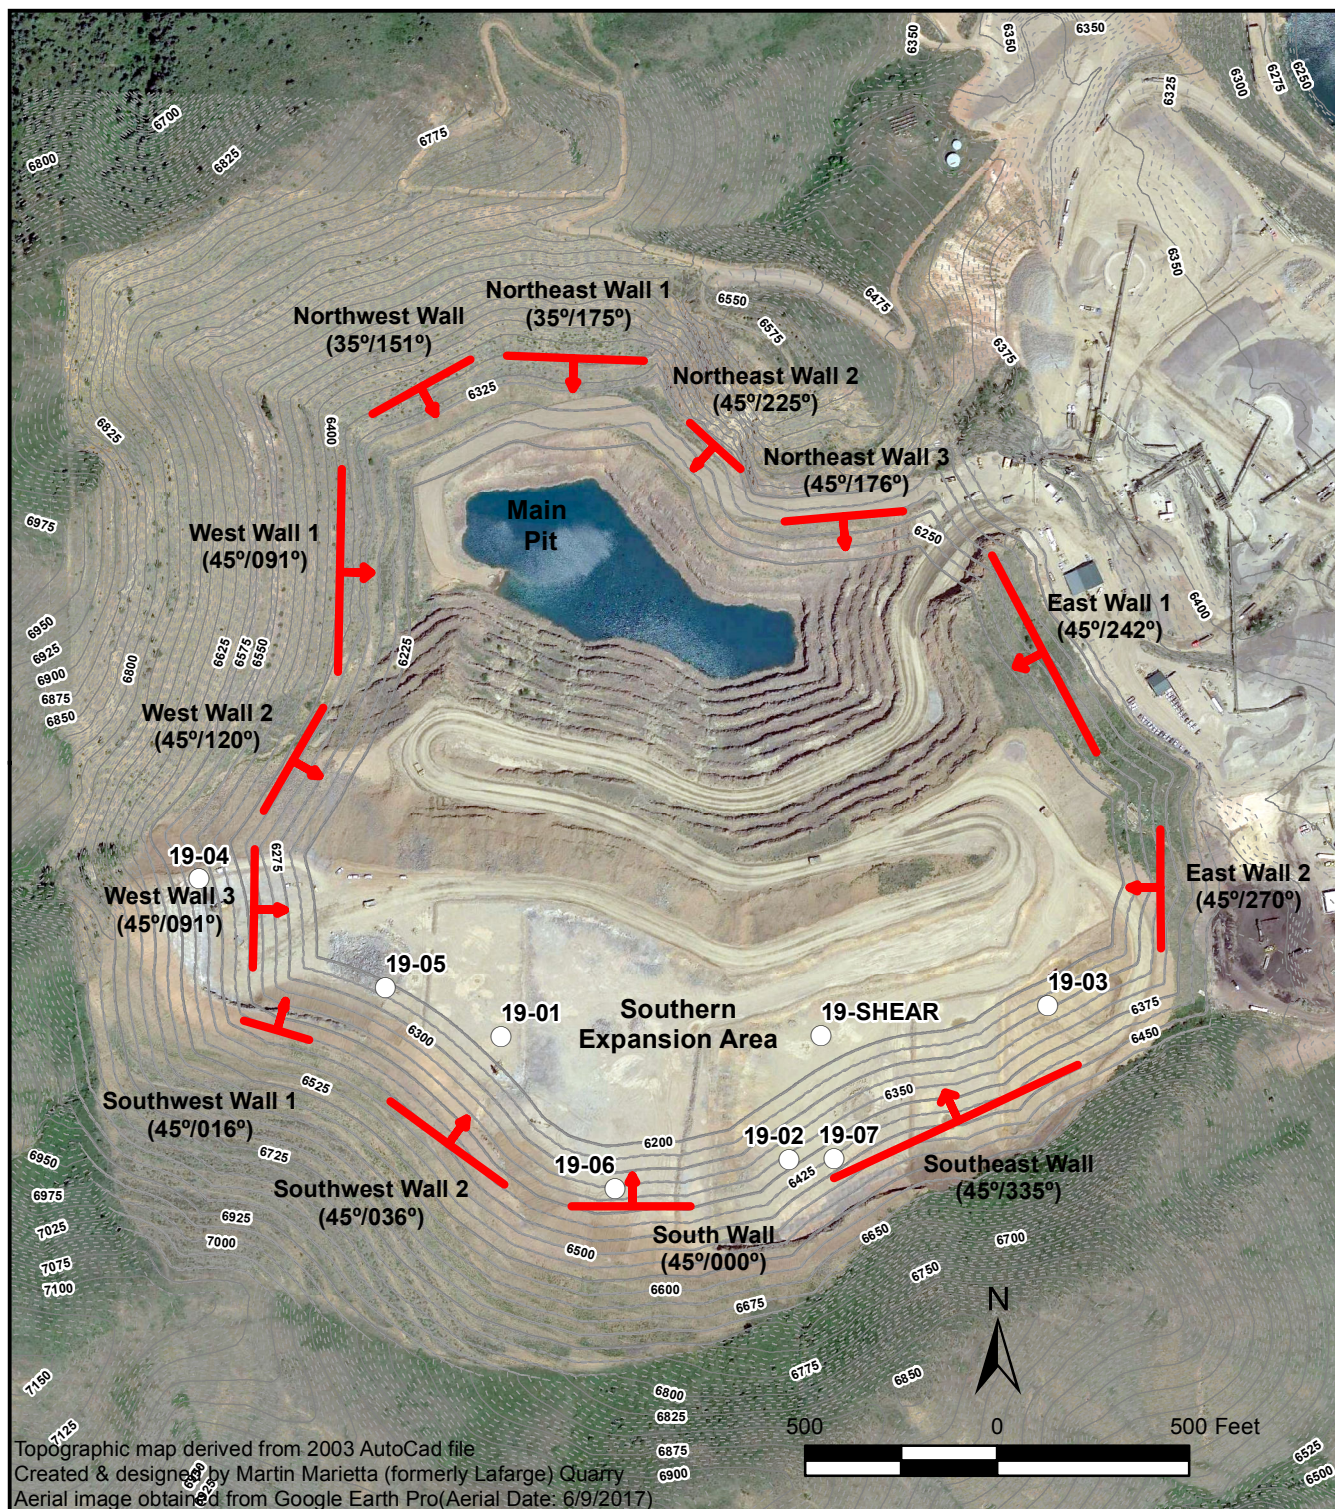
Figure 2

During our visits, we performed rock structure mapping to collect representative discontinuity measurements from recently mined rock exposures in the Southern Expansion Areas (Figure 2; Photos 1 through 3). Orientation measurements (i.e., dip/dip direction) of joints, foliation, and faults were taken from the faces of advancing benches. A geological compass was used to obtain discontinuity measurements by sighting along the discontinuity surfaces. A handheld GPS was used to record the location of data collection points (Figure 2).

A total of 112 discontinuity measurements were collected in 2018/2019 at eight (8) data collection points (Figure 2), and were added to the measurements from previous years. When combined with data collected from previous annual reports (1997-2002, 2004-2018) and with borehole geophysical data collected during the 2003 geotechnical investigation, a total of 3,655 discontinuity orientation measurements have been obtained over the past 22 years. Figure 5 shows the 112 discontinuity orientation measurements collected for this annual report overlain on a contour stereonet plot of the entire Spec-Agg structural dataset.

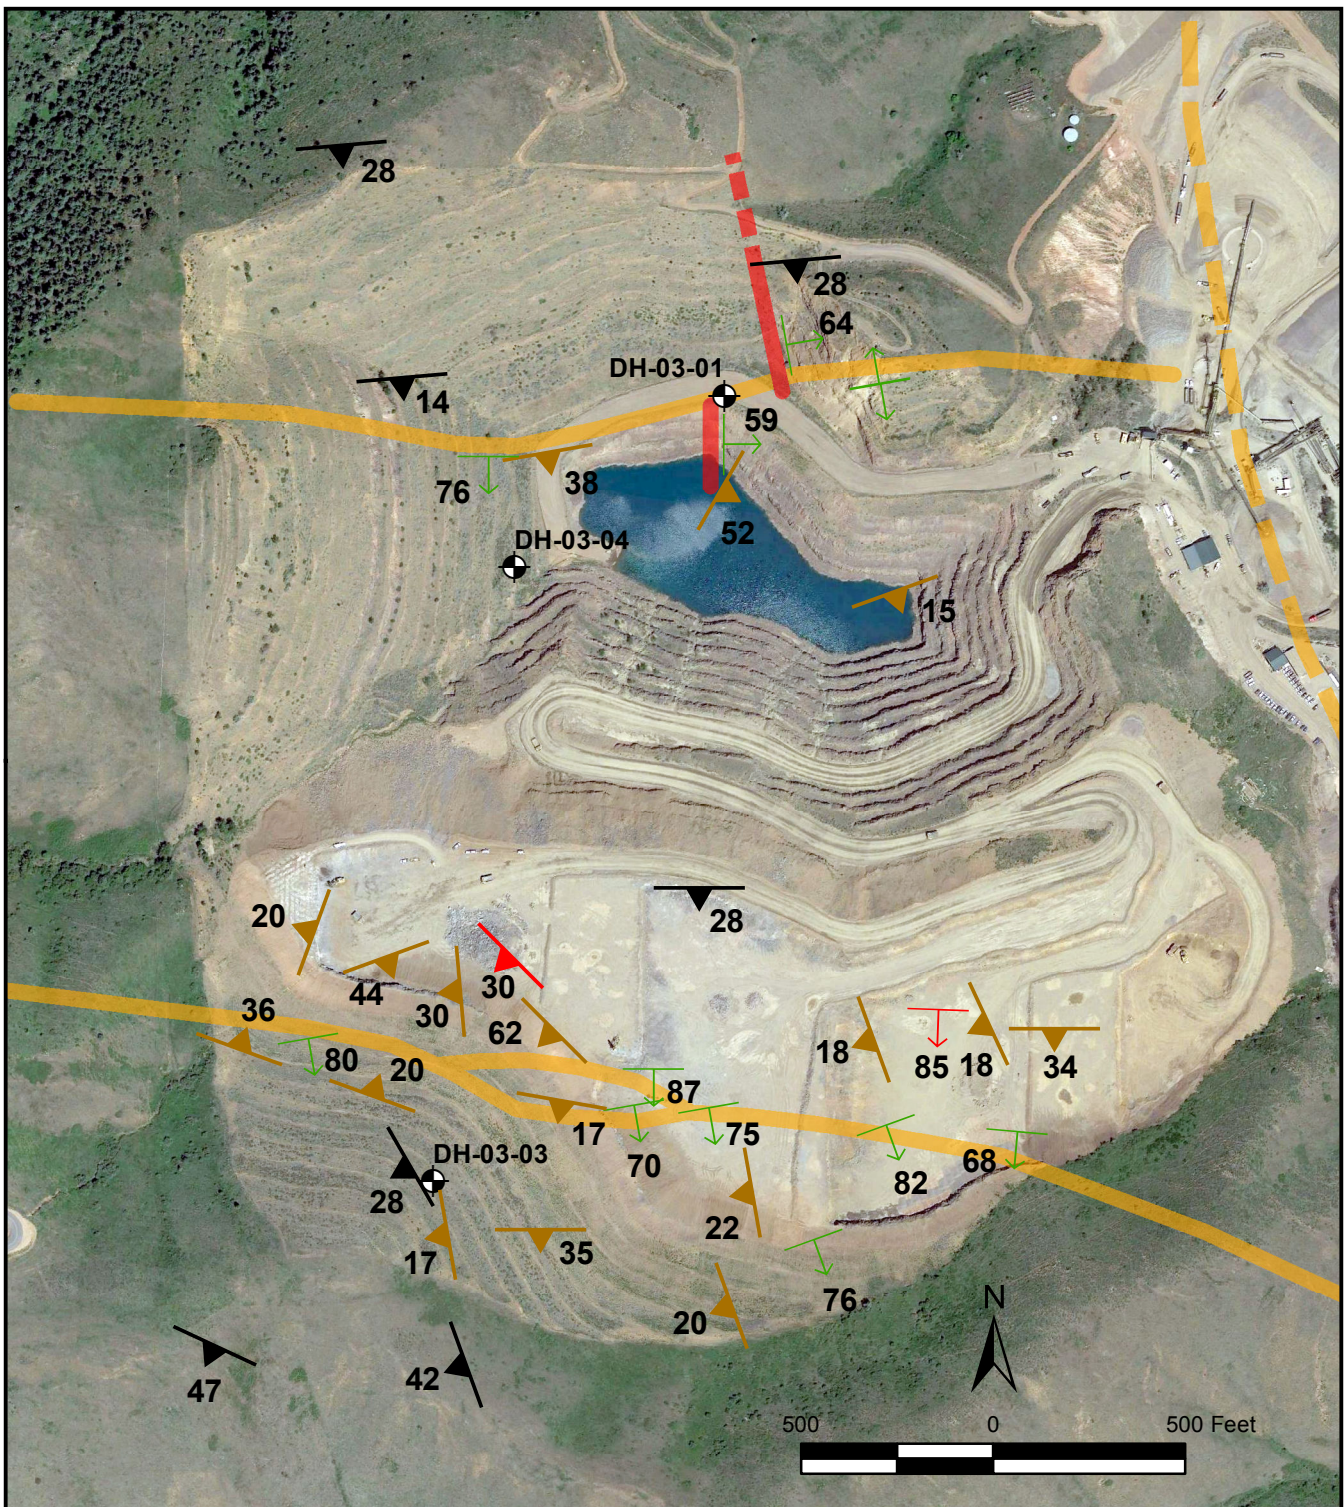
Figure 3

During our 2018/2019 site visits, we observed only one fault exposure along the temporary excavation wall in the Southern Expansion Area at station 19-SHEAR (Figure 2, and Photo 3). The fault is oriented approximately east-west, with apparent dip/dip direction of 85/185 and was exposed in the north to northwest facing temporary wall of the expansion area. The fault zone consists of orange-reddish weathered, broken and blocky pegamatite rock, with parallel fracturing with local clayey gouge. The location of this fault is, in general, a good match with the previously mapped trace. The apparent width of the fault zone varies from 3 to 5 feet. The fault orientation measurements for this annual report are presented with previous fault measurements and differentiated by the fault feature they represent in Figure 4.
